**SUBSTRUCTURE REPAIR & RIPRAP DETAILS**  
C.H. 49 (317th STREET) OVER I-88  
F.A.I. ROUTE 88  
SECTION: BRIDGE DECK REPAIRS 2007-1  
ROCK ISLAND COUNTY  
STATION 2130+77.86  
S.N. 081-0132  
DATE: 12-09-08  
GRAEF, ANHALT, SCHLOEMER & ASSOCIATES INC  
CHICAGO ILLINOIS

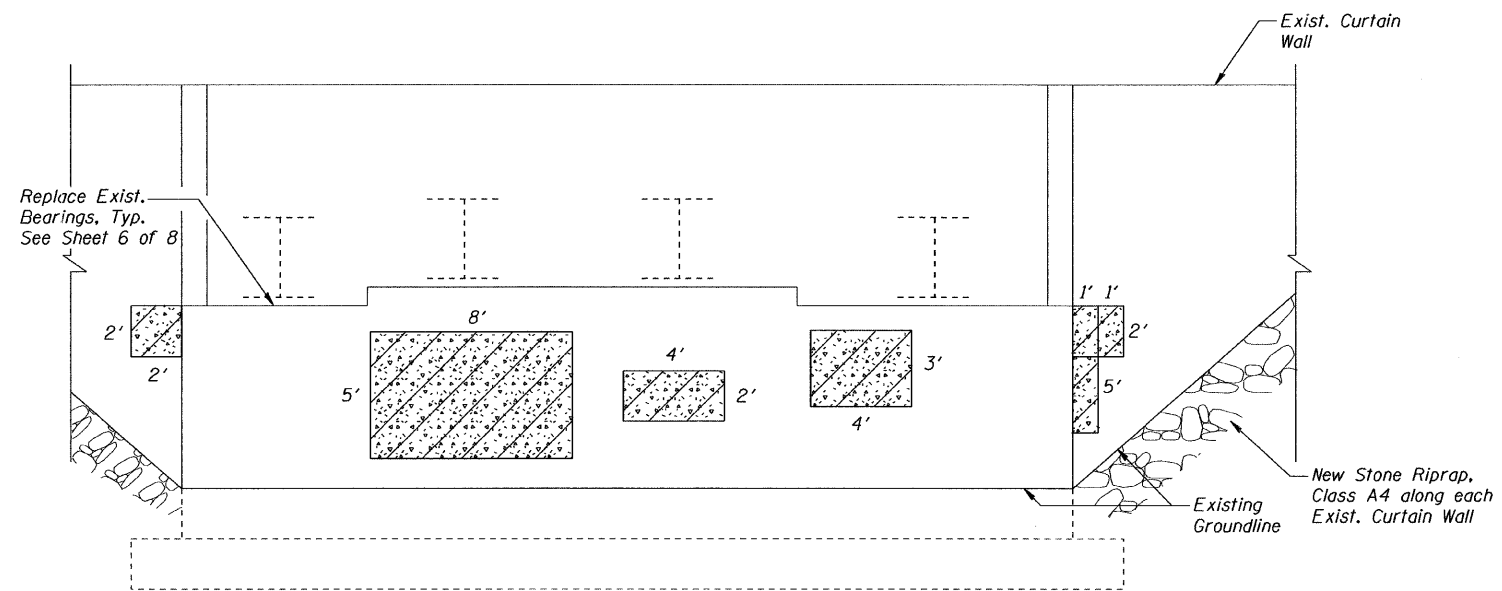
**EXIST. SOUTH ABUTMENT & UNFOLDED EXIST. CURTAIN WALLS ELEVATION**  
(Looking South)

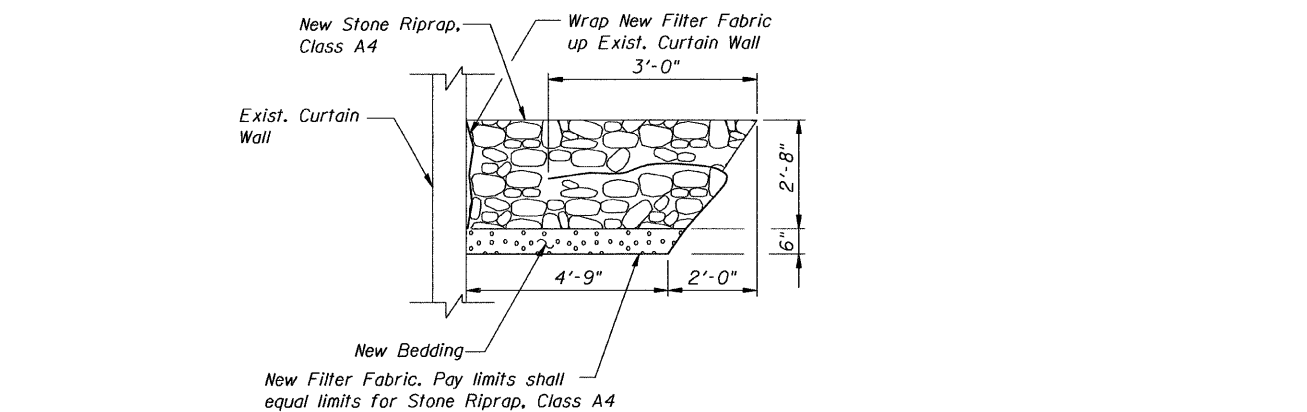
**SECTION A-A THRU RIPRAP**

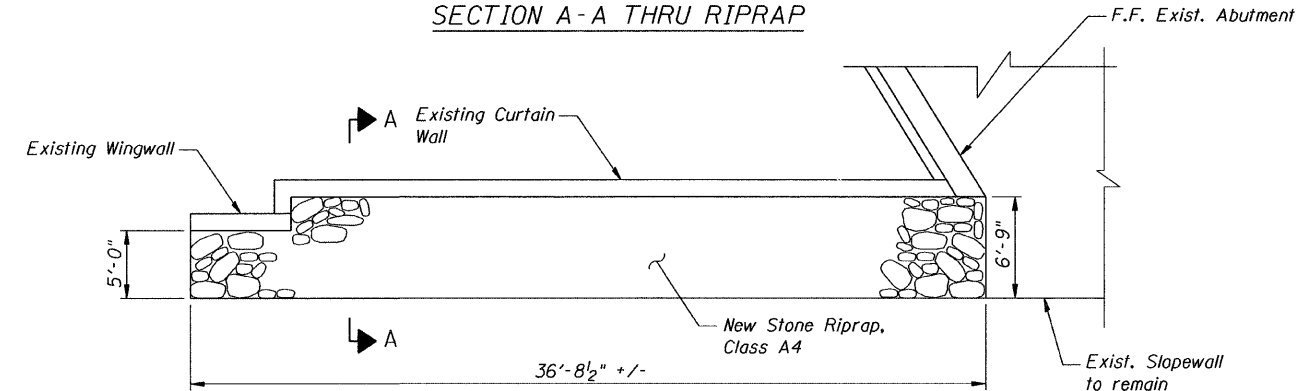
**RIPRAP PLAN AT ABUTMENTS**

(Exist. North Abutment, west side shown. Other locations similar)

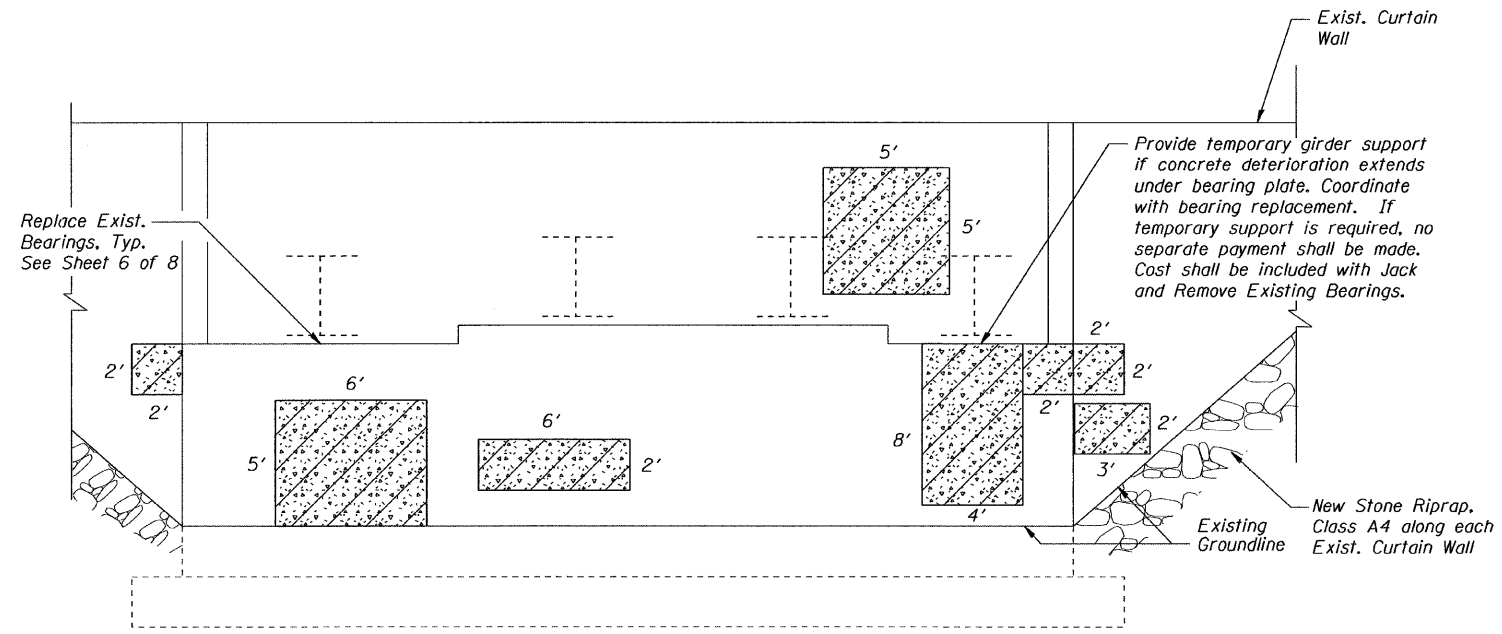
**EXIST. NORTH ABUTMENT & UNFOLDED EXIST. CURTAIN WALLS ELEVATION**  
(Looking North)

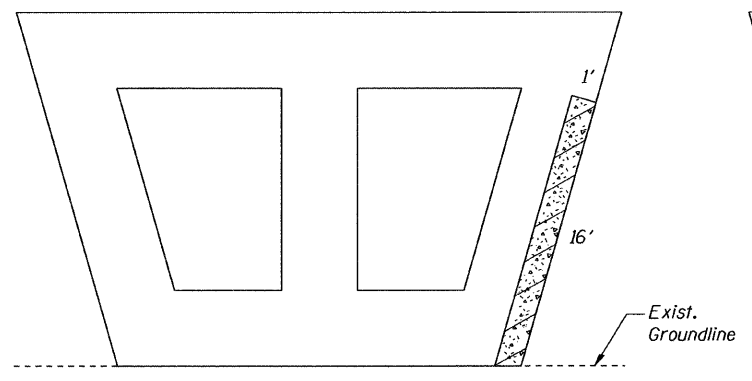
**EXISTING PIER ELEVATION**  
(Looking North)

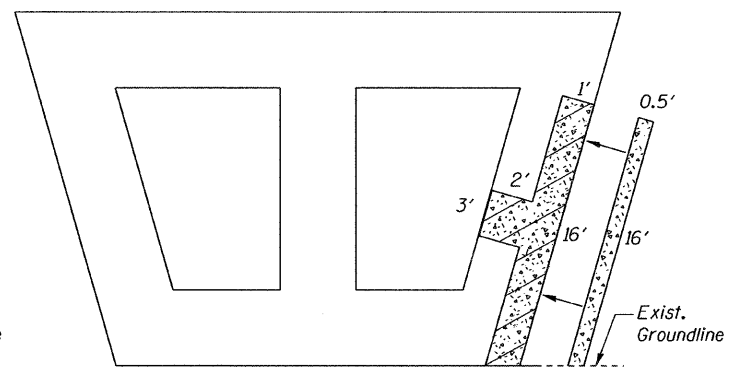
**EXISTING PIER ELEVATION**  
(Looking South)
