ROUTE NO.	SECTION	COUNTY	TOTAL SHEETS	SHEET NO.
FAP 68	101BR	LIVINGSTON	47	25
STA	TO STA			
FED. ROAD DIST. NO.	ILLINOIS	FED. AID PROJECT		
DWG. NO. 11 OF 17

CONTRACT NO. 66606

NORTH ABUTMENT
IL 23 OVER PRAIRIE CREEK
FAP ROUTE 68 - SECTION 101BR
LIVINGSTON COUNTY
STATION 280+55.00
STRUCTURE NO. 053-0153

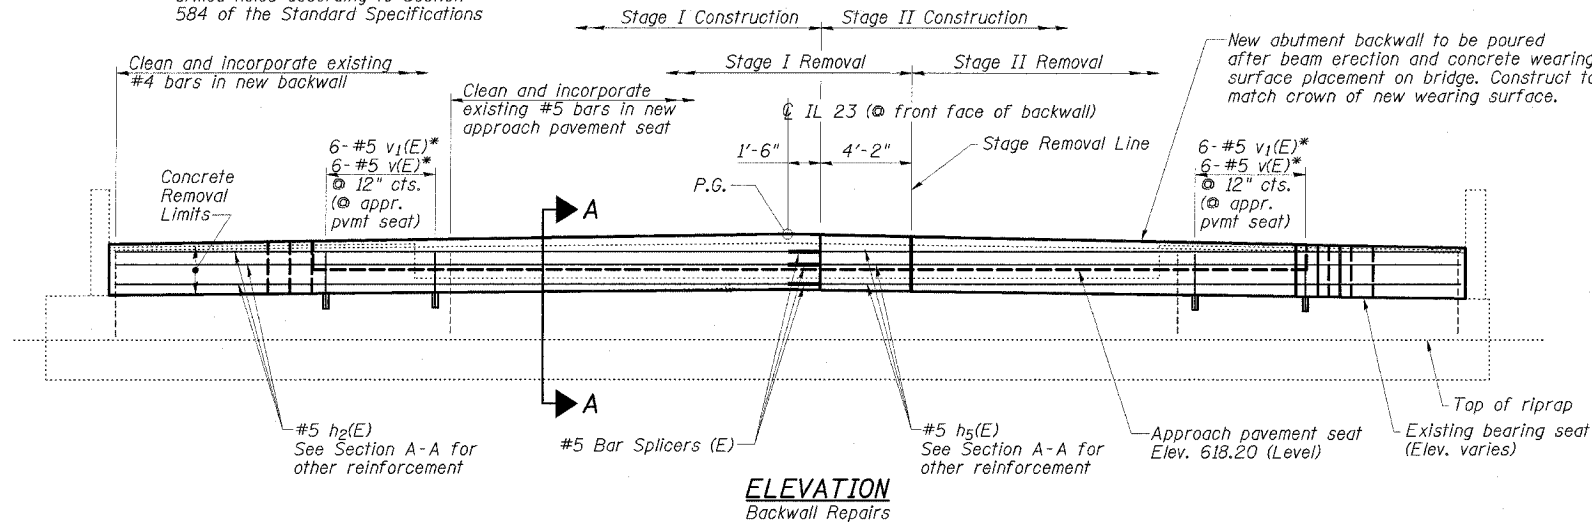
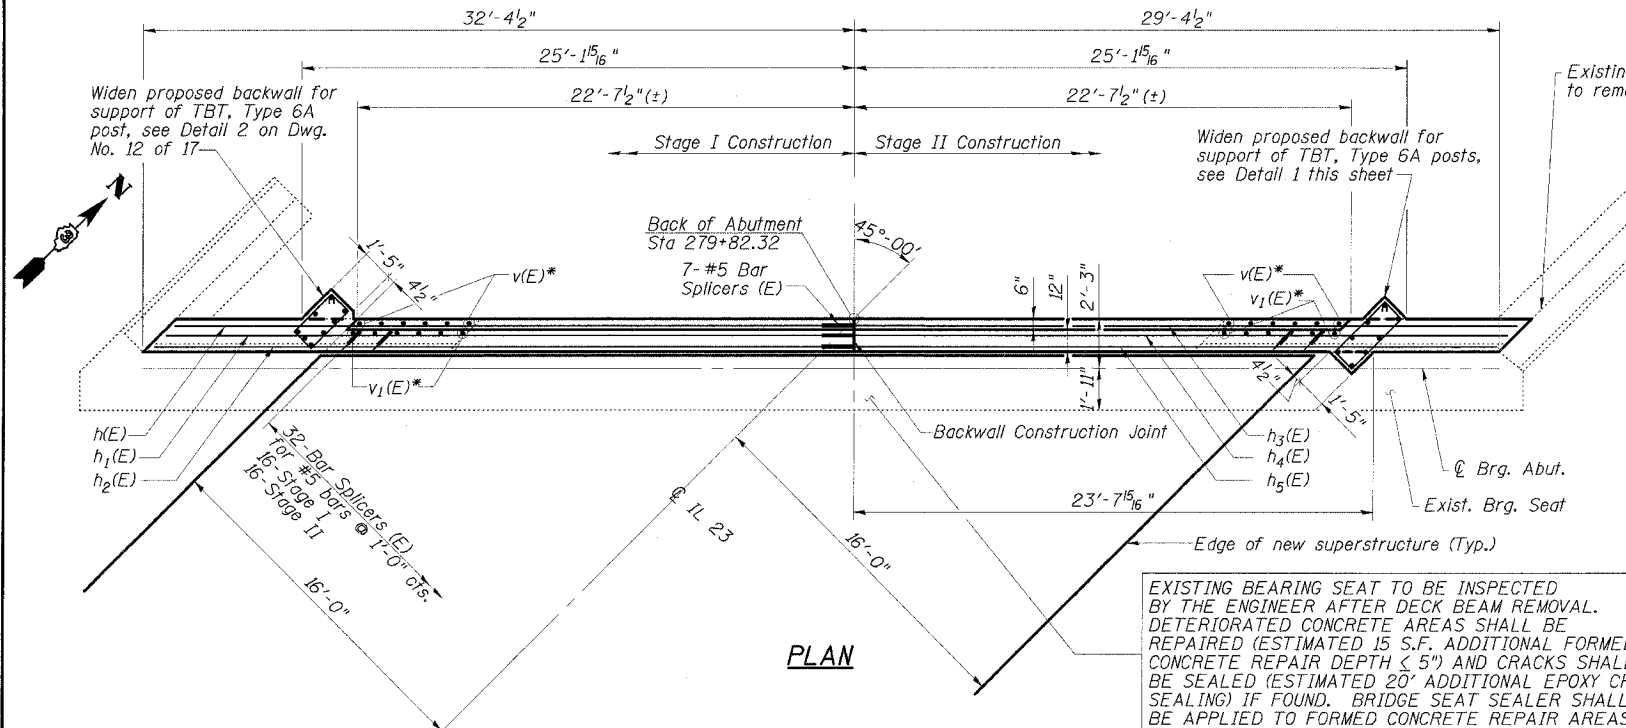
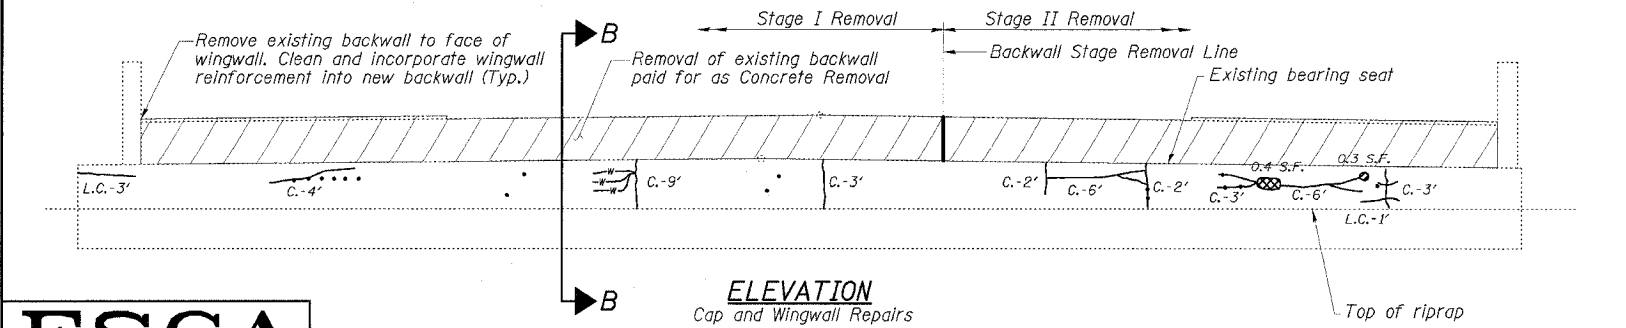
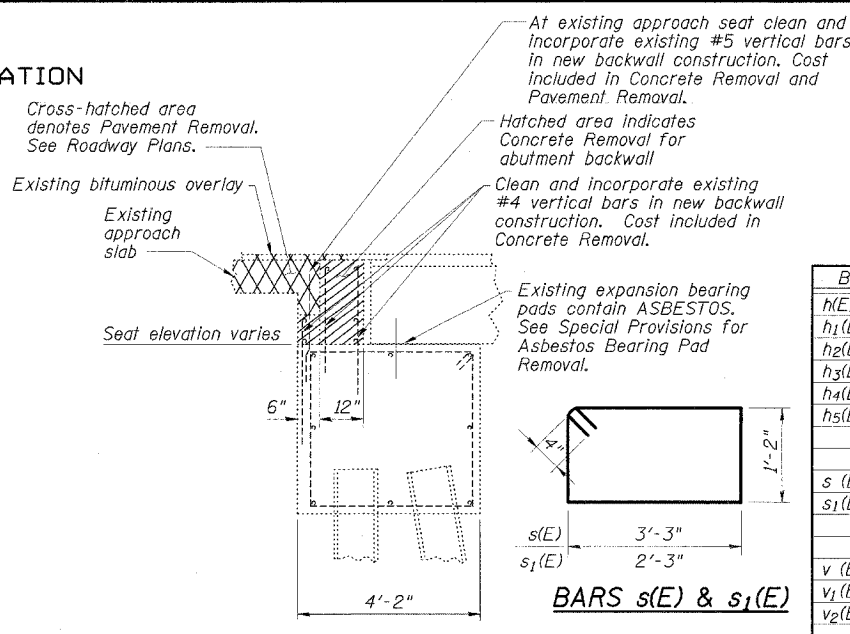
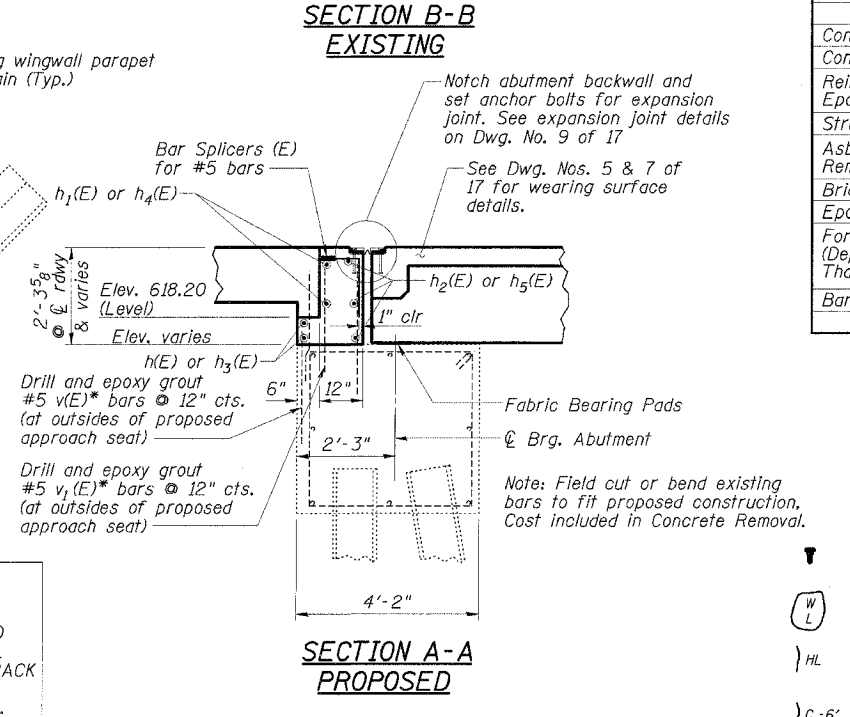
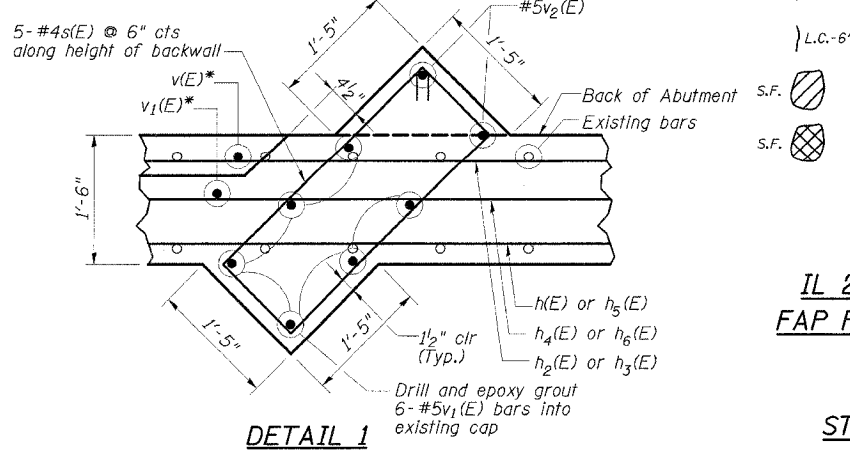
* Epoxy grout bars in 8" min. depth drilled holes according to Section 584 of the Standard Specifications

NOTE: ABUTMENT CRACK REPAIR LENGTHS AND FORMED CONCRETE REPAIR AREAS ARE ESTIMATED FROM 3-31-05 SURVEY WORK. ACTUAL LOCATIONS AND QUANTITIES OF REPAIRS SHALL BE SHOWN BY THE ENGINEER ON THE AS-BUILT PLANS FOR THIS SECTION.
