**DECK SLAB REPAIR PLAN
WB I-80 OVER DES PLAINES RIVER
STRUCTURE NO. 099-0057**

SHEET NO. S-5 OF S-35 SHEETS

F.A.I. RTE. 80	SECTION 99 (4 & 4)-IRS-3	COUNTY WILL	TOTAL SHEETS 203	SHEET NO. 114
CONTRACT NO. 60M66				
FED. ROAD DIST. NO. 1 ILLINOIS FED. AID PROJECT

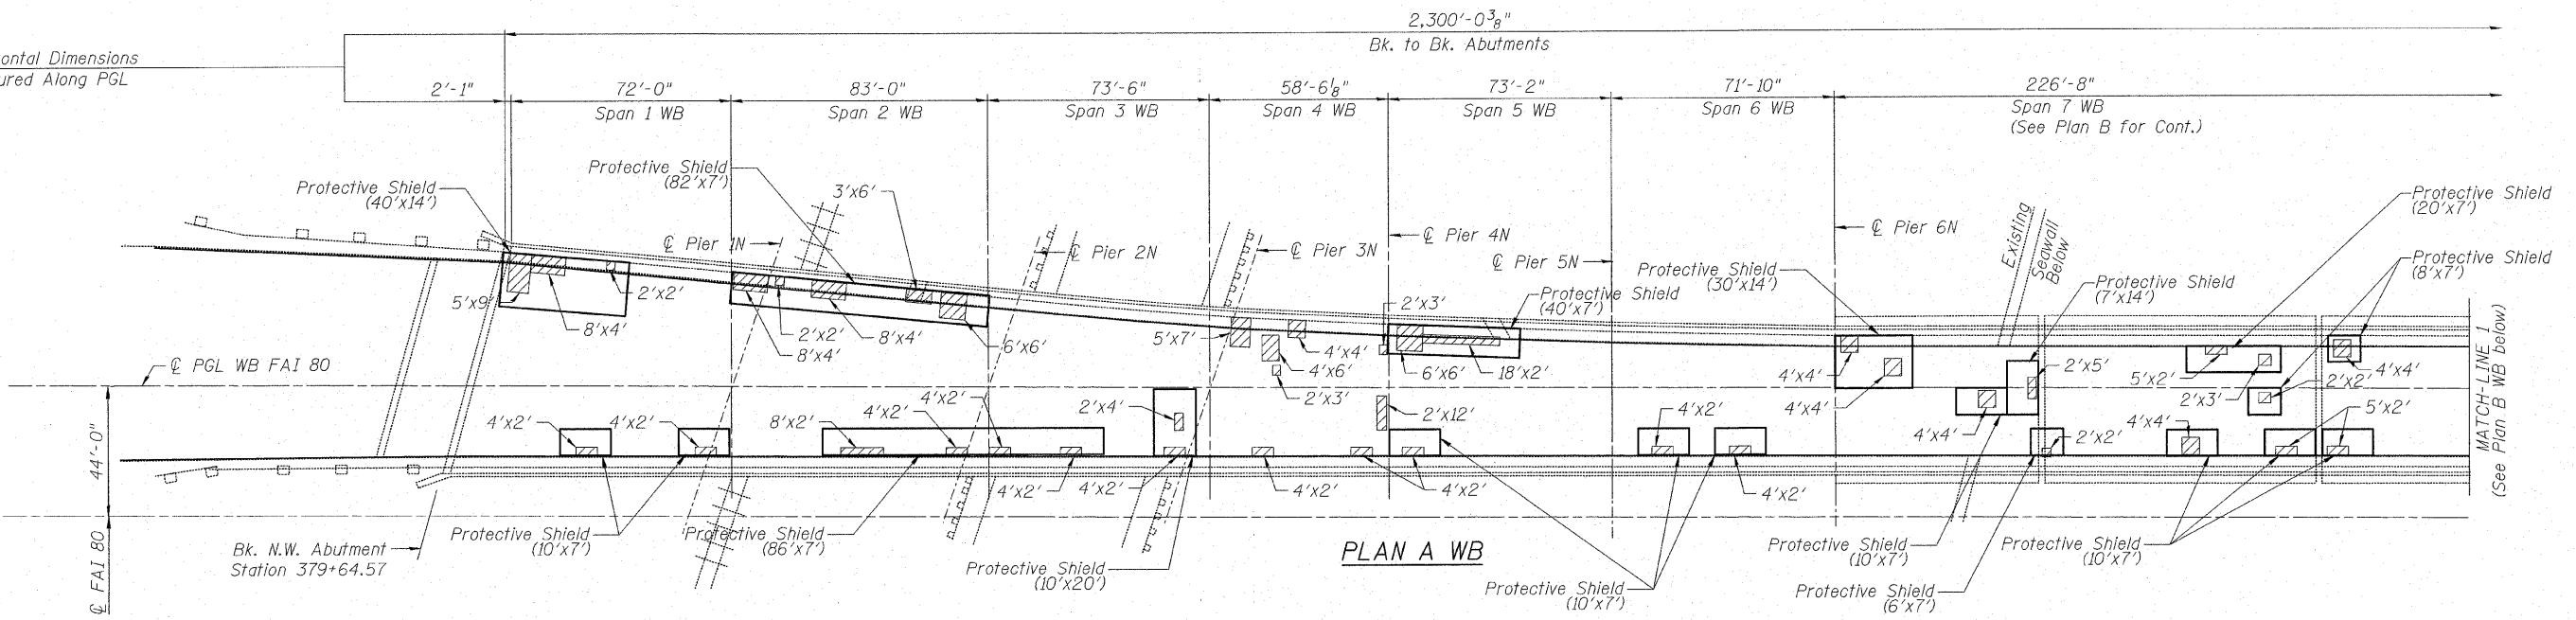
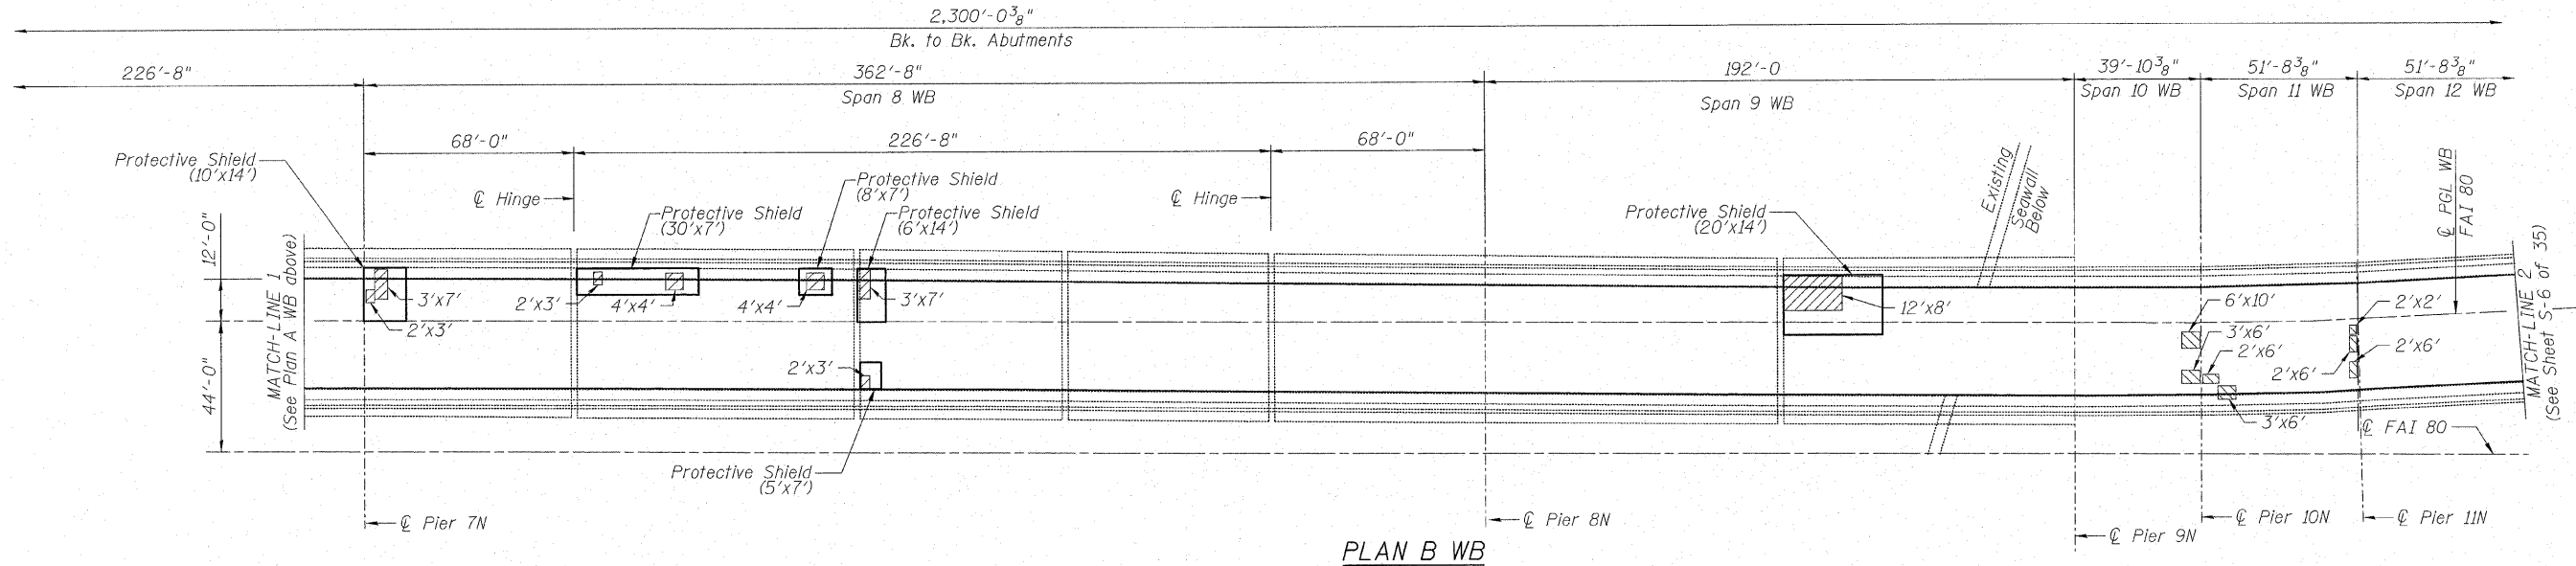
Horizontal Dimensions
Measured Along PGL

* Existing wearing surface contains welded wire fabric (WWF 3x3-D8xD8 (E)) in east approach spans (Span 10WB through Span 27WB). Remove and replace welded wire fabric when performing deck slab repair. Cost of removing and replacing WWF is incidental to Deck Slab Repair (Partial).

1. Areas of proposed deck repairs are estimated. Actual type, location and dimensions of deck repairs are to be determined by the Engineer during construction.
2. Reuse existing drain if drain falls within a full depth repair.
