DRAINAGE STRUCTURE IMPROVEMENT DETAIL

LOCATION #22 STA. 25 + 38

EASTBOUND OFF RAMP (RAMP CB)

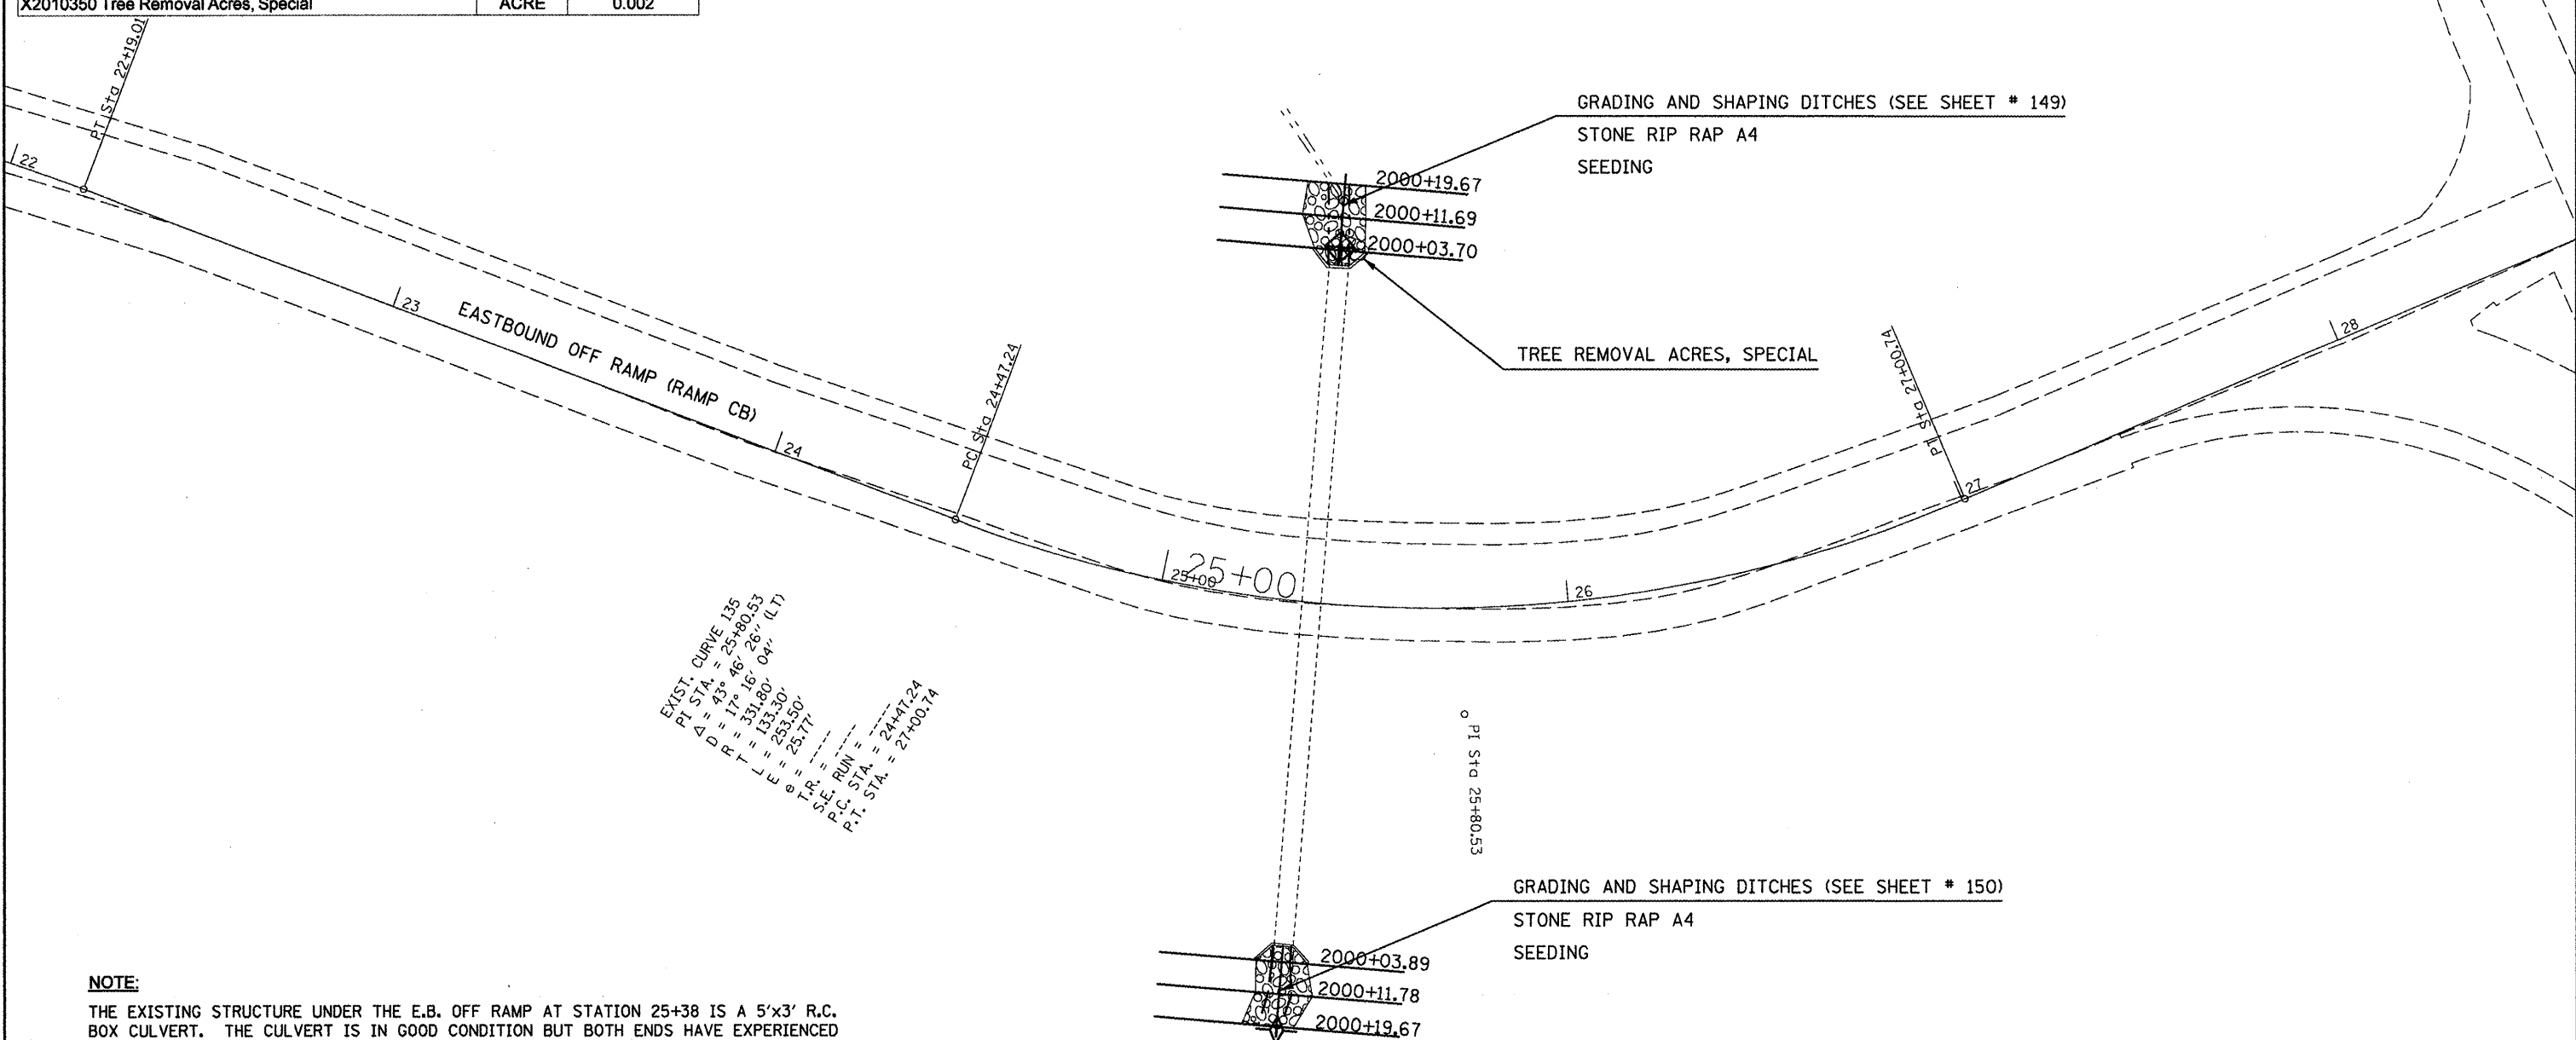
LOC. #22 STA. 25+38 EB OFF-RAMP "CB"

EXIST. CURVE 135
 PI STA. = 25+80.53
 $\Delta = 43^\circ 46' 26''$ (LT)
 $R = 17' 46' 26''$ (LT)
 $P.T. = 331+80'$
 $L = 133+30'$
 $E = 283+50'$
 $\theta = 25.77'$

S.E. RUN =
 P.C. STA. = 24+17.24
 P.T. STA. = 27+00.74

NOTE:
 THE EXISTING STRUCTURE UNDER THE E.B. OFF RAMP AT STATION 25+38 IS A 5'x3' R.C. BOX CULVERT. THE CULVERT IS IN GOOD CONDITION BUT BOTH ENDS HAVE EXPERIENCED APPROXIMATELY 1 FT. OF SCOUR. THE UPSTREAM WINGWALLS HAVE HAD SOME SLOPE FAILURE BEHIND THEM AS A RESULT OF THE SCOUR. ALSO, THERE IS A TREE GROWING AT THE UPSTREAM END IN FRONT OF THE WING.
 THE RECOMMENDED SCOPE OF WORK IS TO GRADE AND SHAPE THE CHANNEL UPSTREAM AND DOWNSTREAM OF THE STRUCTURE TO ACCEPT A TREATMENT OF RIPRAP. ALSO, THE TREE SHALL BE REMOVED FROM THE UPSTREAM END.
