DETAILS FOR HOT-MIX ASPHALT CURB AND SHOULDER REPAIR

CL FAP 322
(US 51)

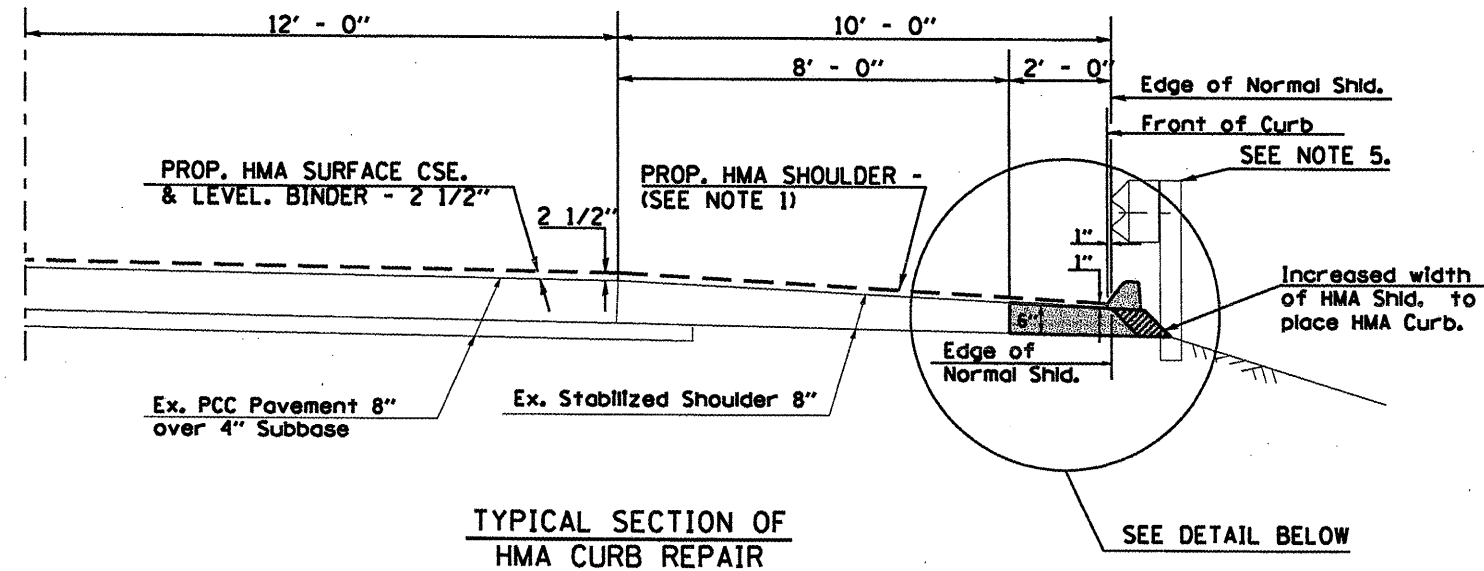
**TYPICAL SECTION OF
HMA CURB REPAIR**

1. THE LOCATION OF THE HMA SHOULDER AND CURB REPAIR IS AT LT. STA. 354+88 AND AS SHOWN ON THE PLANS.
2. THE CURB SHALL BE CONSTRUCTED WITH A MECHANICAL CURB LAYING MACHINE OF A TYPE APPROVED BY THE ENGINEER.

4. THE CONSTRUCTION OF THE CURB AND SHOULDER REPAIR WILL BE STAGED SO THE NEW CURB AND SHOULDER ARE CONSTRUCTED FIRST, THEN THE PRIMING AND RESURFACING OF THE EXISTING SHOULDER WILL BE DONE.

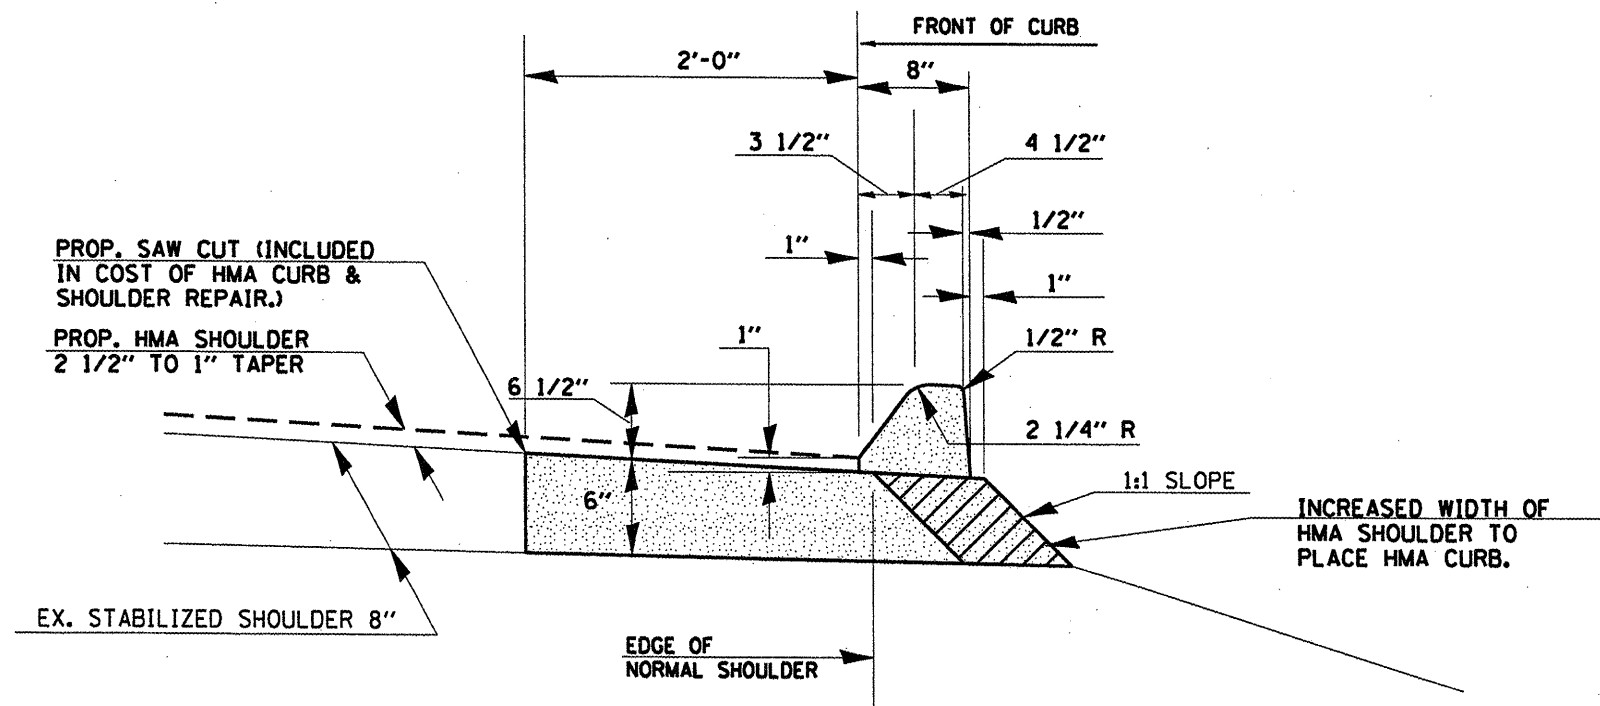
**DETAIL SECTION OF
HMA CURB AND SHOULDER REPAIR**

3. THE CURB AND SHOULDER REPAIR WILL BE INCLUDED IN THE CONTRACT UNIT PRICE PER TON FOR HMA SHOULDERS, WHICH PRICE SHALL ALSO INCLUDE THE COST OF THE ADDITIONAL HMA SHOULDER UNDER THE CURB AND THE SAW CUT. THE HOT-MIX ASPHALT CURB AND SHOULDER MIXTURE FOR THE REPAIR LOCATION SHALL BE HOT-MIX ASPHALT SURFACE COURSE, MIXTURE C, N70. SEE MIXTURE REQUIREMENTS, SHT. 4, FOR FURTHER MIXTURE INFORMATION.

5. EXISTING GUARDRAIL AND POST IN AREA OF CURB REPAIR WILL BE REMOVED DURING REPAIR WORK AND REERECT AFTER WORK IS COMPLETED. THIS WORK SHALL BE PAID FOR AT THE CONTRACT UNIT PRICE PER FOOT FOR REMOVE AND REERECT STEEL PLATE BEAM GUARDRAIL.

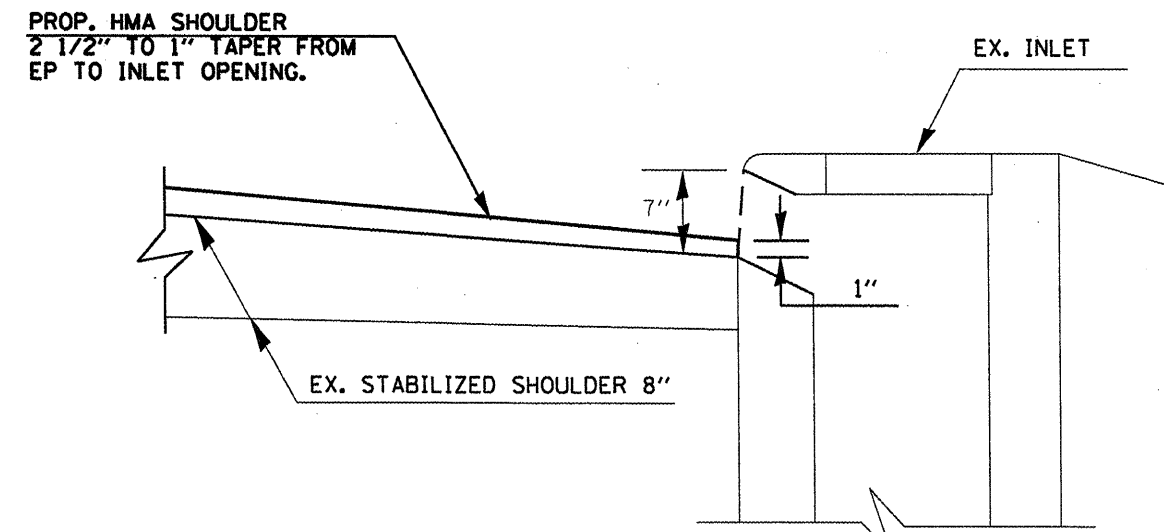
**DETAIL SECTION OF
SHOULDER SURFACING AT
EXISTING INLETS**
