QUINCY REGIONAL AIRPORT
BALDWIN FIELD
ADAMS COUNTY, ILLINOIS

REHABILITATE
RUNWAY 18-36

CONSTRUCTION
PLAN

STA 161+20 TO STA 176+00

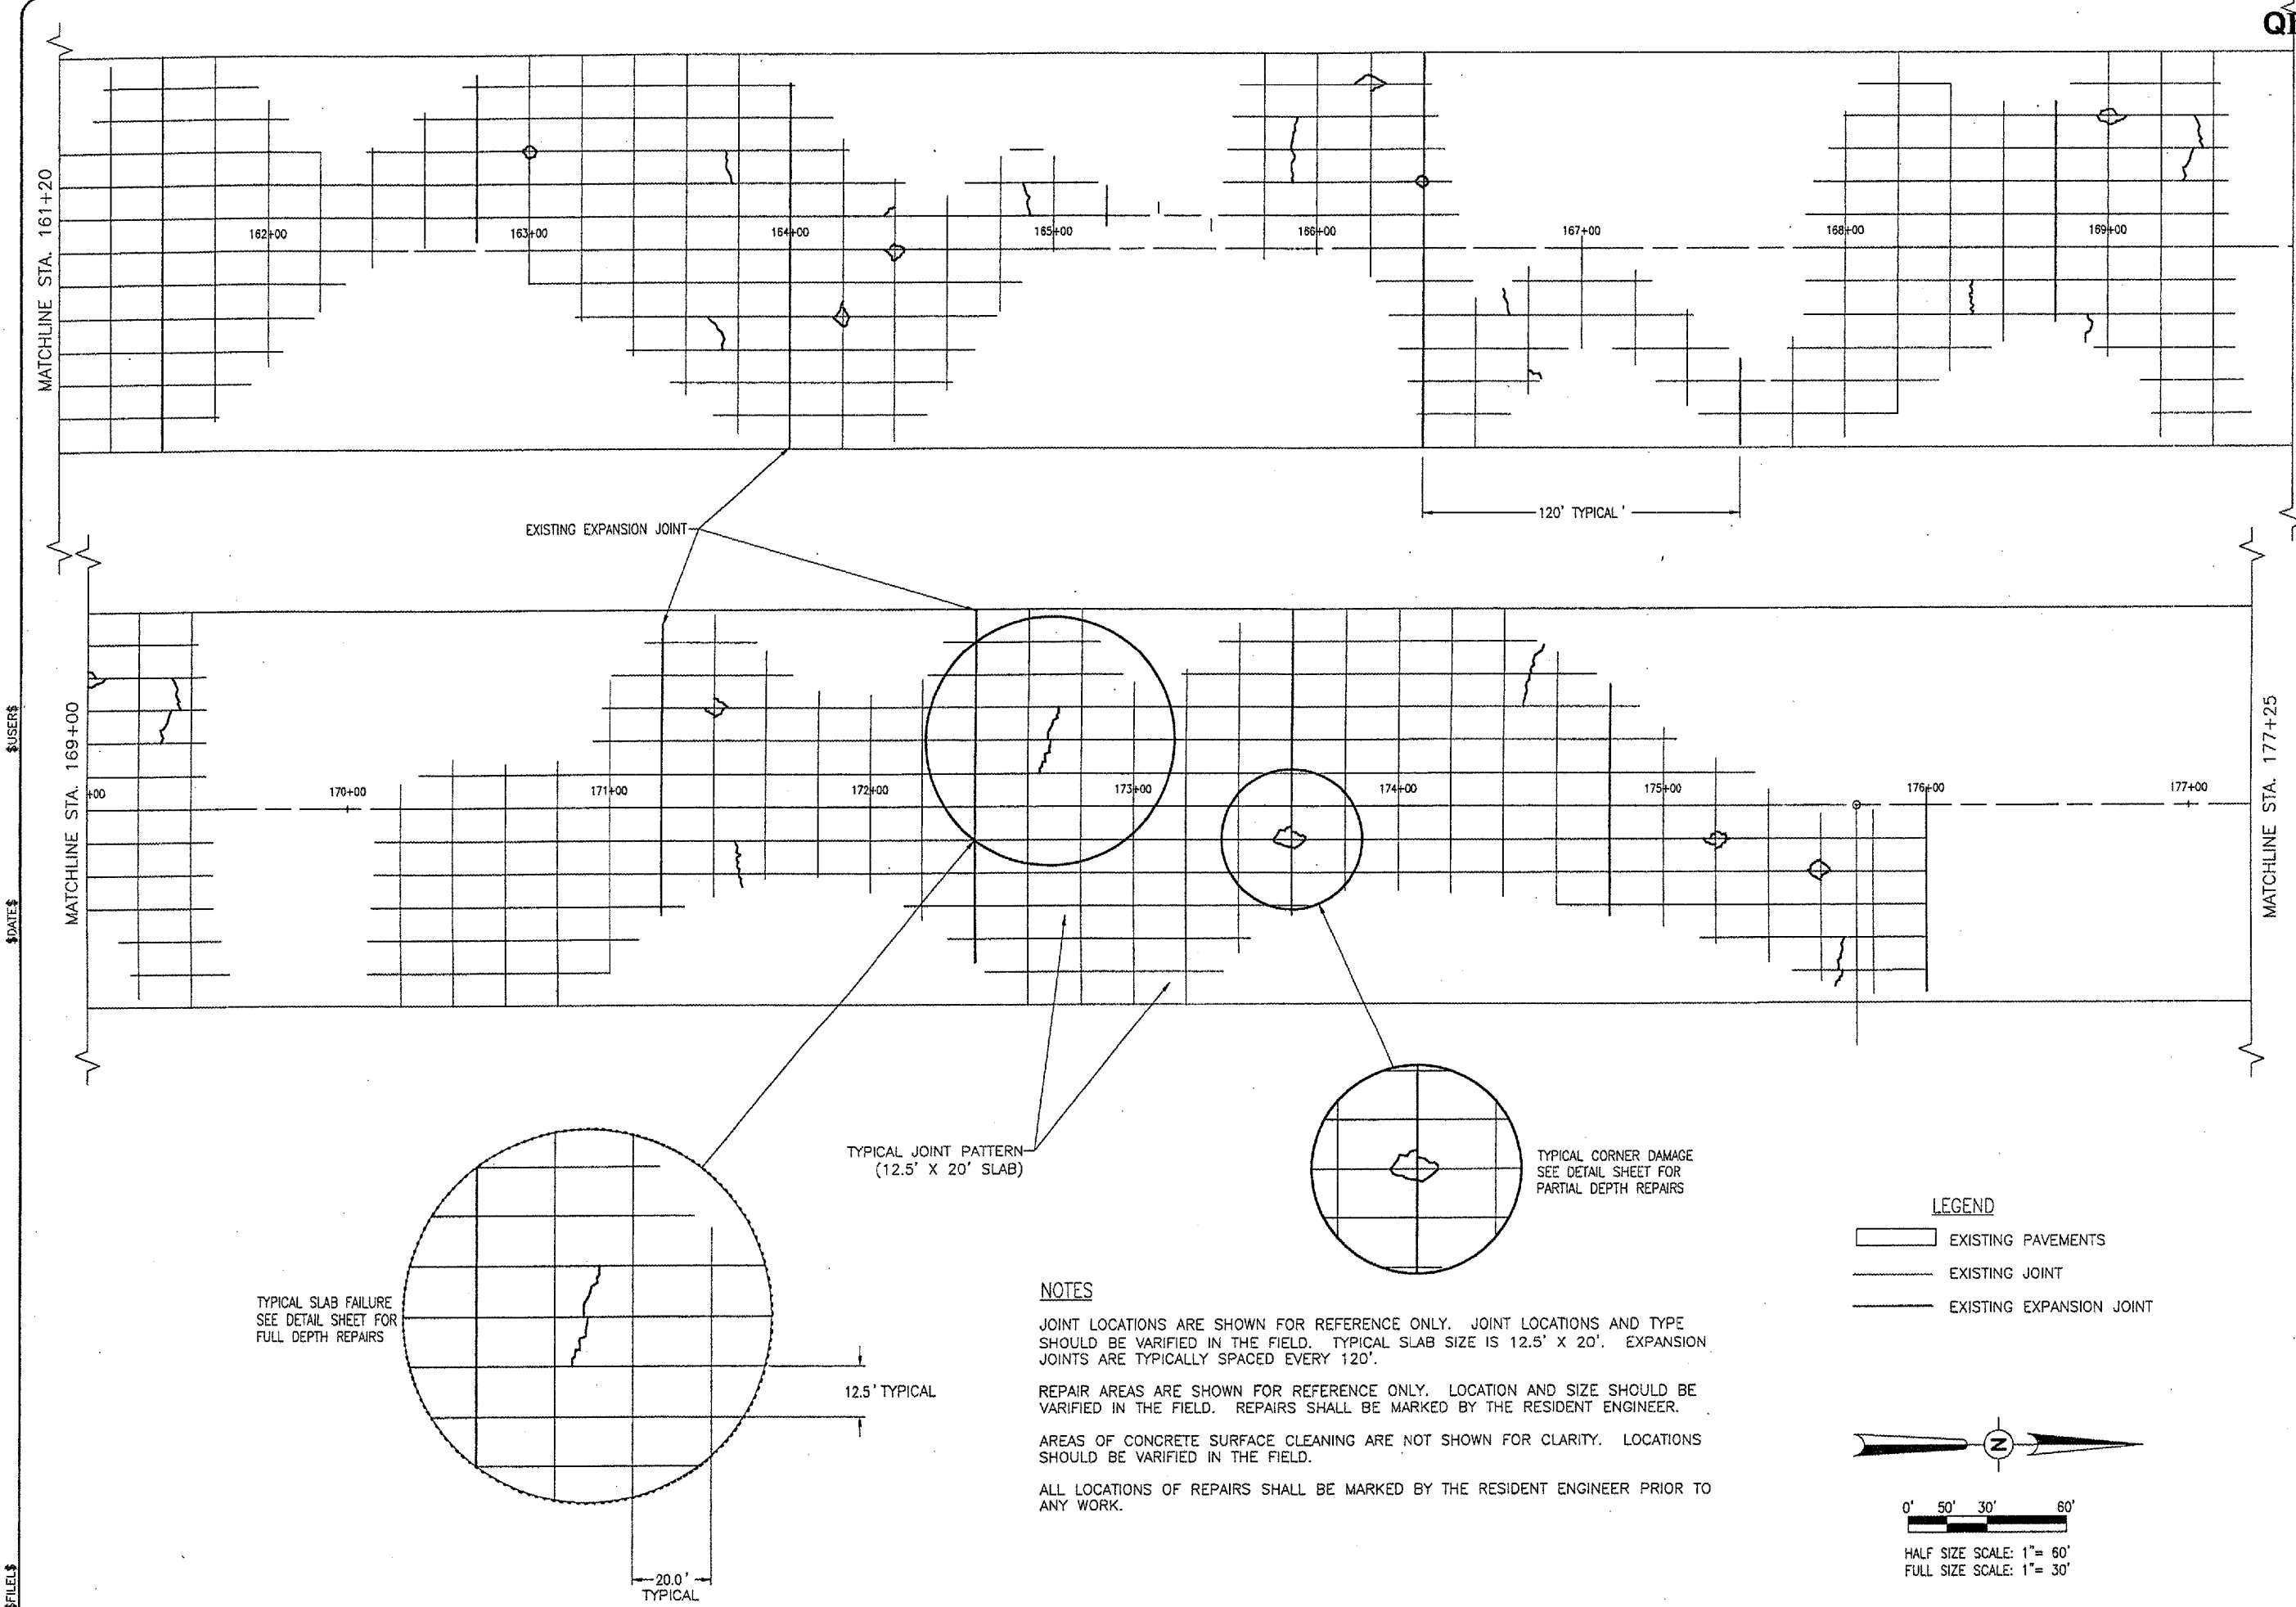
TYPICAL SLAB FAILURE
SEE DETAIL SHEET FOR
FULL DEPTH REPAIRS

TYPICAL JOINT PATTERN
(12.5' X 20' SLAB)

TYPICAL CORNER DAMAGE
SEE DETAIL SHEET FOR
PARTIAL DEPTH REPAIRS
