STATE OF ILLINOIS
DEPARTMENT OF TRANSPORTATION

PIER CONCRETE REPAIR DETAILS
STRUCTURE NO. 016-0488

SHEET NO. SH27 OF SH36 SHEETS

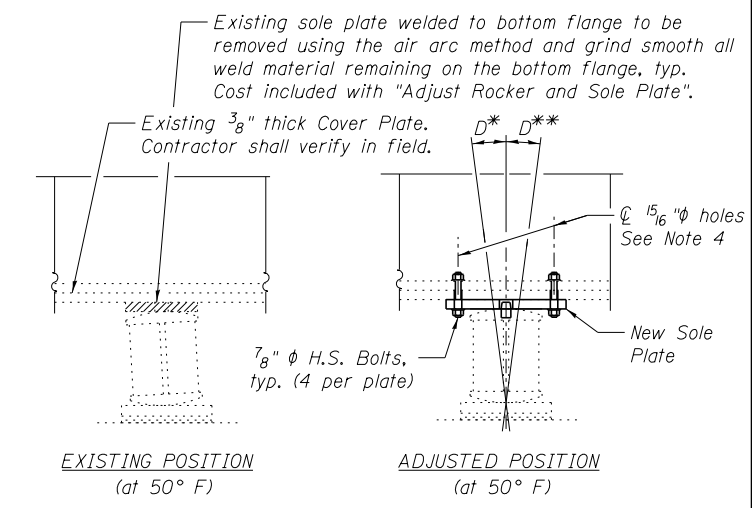
REPOSITION EXISTING BEARINGS AT PIER 2
8 Required

$D^* = \frac{1}{8}''$ per each 100' of expansion for every 15° rise above the normal temp of 50° F.

$D^{**} = \frac{1}{8}''$ per each 100' of expansion for every 15° fall below the normal temp of 50° F.

- Jacking shall not commence until the deck has been removed entirely.
- The service steel dead load reaction for each bearing location at Pier 2 is 8.01 kips. Min. Jack capacity = 12 kips.
- For jacking and cribbing and other requirements, see special provision for "Adjust Rocker and Sole Plate".
- Field drill holes in existing bottom flange using new sole plate as a template. Cost of field drilling included with "Adjust Rocker and Sole Plate".
