STATE OF ILLINOIS
DEPARTMENT OF TRANSPORTATION

**SOUTH ABUTMENT REPAIRS
AND MODIFICATIONS
STRUCTURE NO. 077-0016**

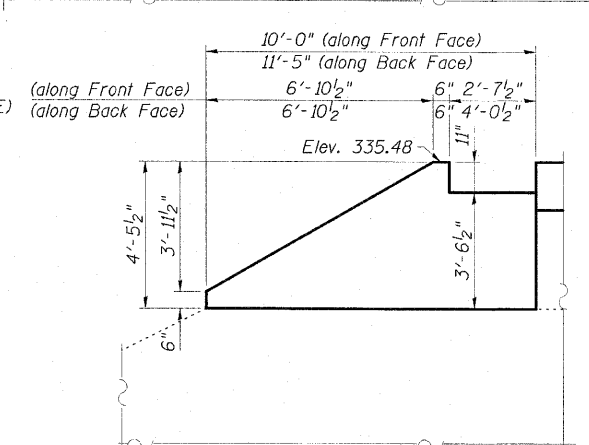
WEST WING ELEVATION

SHOWING DIMENSIONS

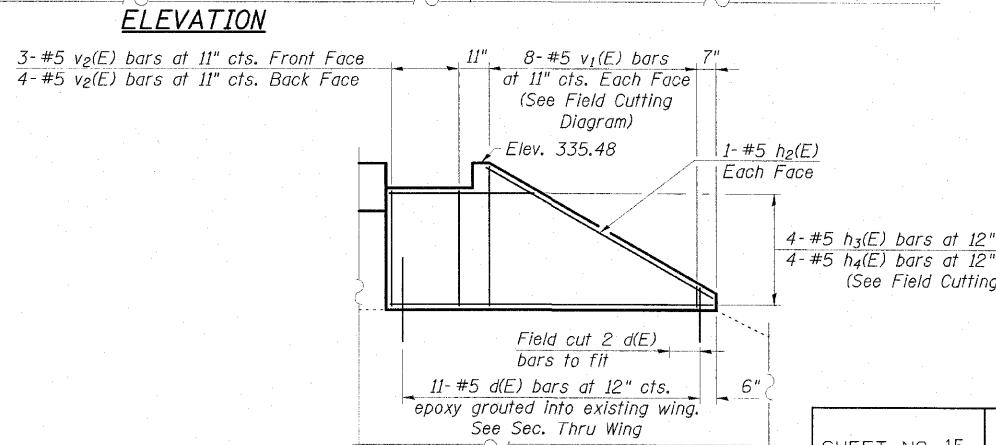
EAST WING ELEVATION

SHOWING REINFORCEMENT
