STATE OF ILLINOIS
DEPARTMENT OF TRANSPORTATION

MISCELLANEOUS STEEL
REPAIR DETAILS - 1
I-80 OVER
MISSISSIPPI RIVER
STRUCTURE NO. 081-0011

SHEET NO. 17	F.A.I. RTE.	SECTION	COUNTY	TOTAL SHEETS	SHEET NO.
	80	(81-1B)M-4	ROCK ISLAND	75	44
33 SHEETS	SN 081-0011		CONTRACT NO. 64F31		
	FED. ROAD DIST. NO. 7 ILLINOIS		FED. AID PROJECT

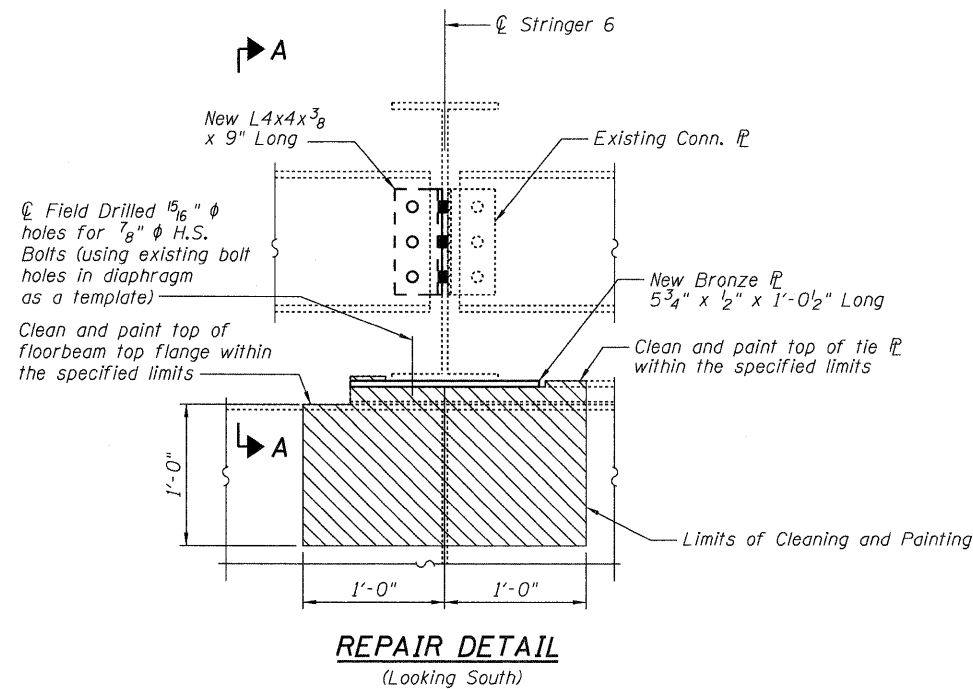
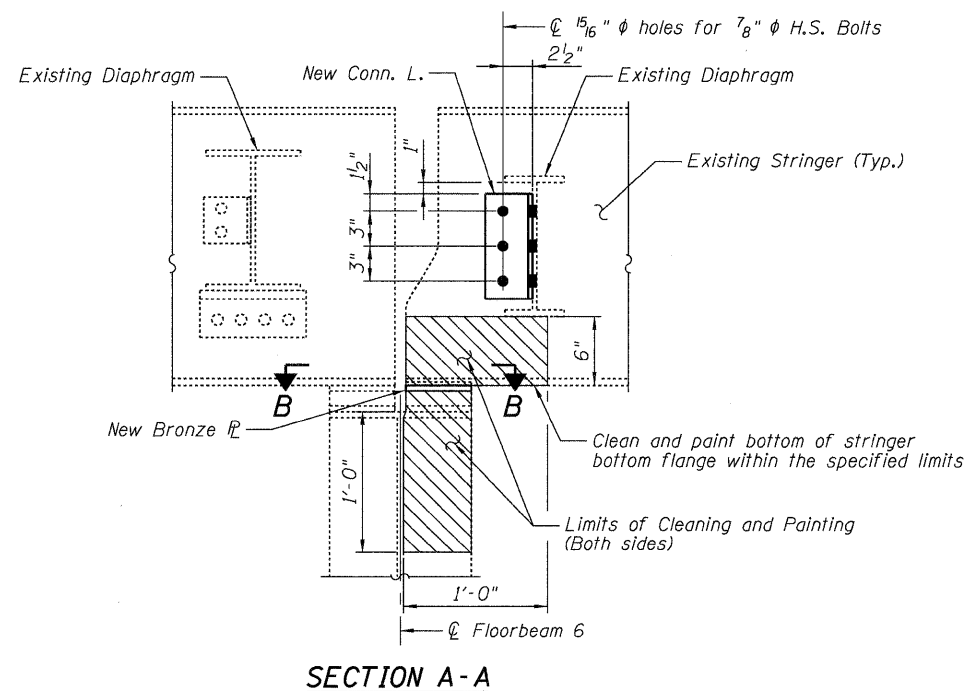
STRUCTURAL STEEL REPAIR A
SPAN 11, STRINGER 6 AT FLOORBEAM 6

Notes:
The Contractor shall submit Temporary Jacking Details to the Engineer for approval prior to bronze plate replacement. The stringer service level dead load reaction is 17 kips. Cost of Temporary Jacking shall be included in Jacking and Cribbing.
The bronze plate shall conform to ASTM B22. Cost of bronze plate is included with the cost for Structural Steel Repair.
Coordinate Structural Steel Repair A with cantilever floorbeam replacement and stringer end repair. See Sheets 8 and 13 of 33 for details.
