**STATE OF ILLINOIS
 DEPARTMENT OF TRANSPORTATION**

**DECK REPAIRS
 STRUCTURE NO. 082-0166**

SHEET NO. 5 OF 11 SHEETS

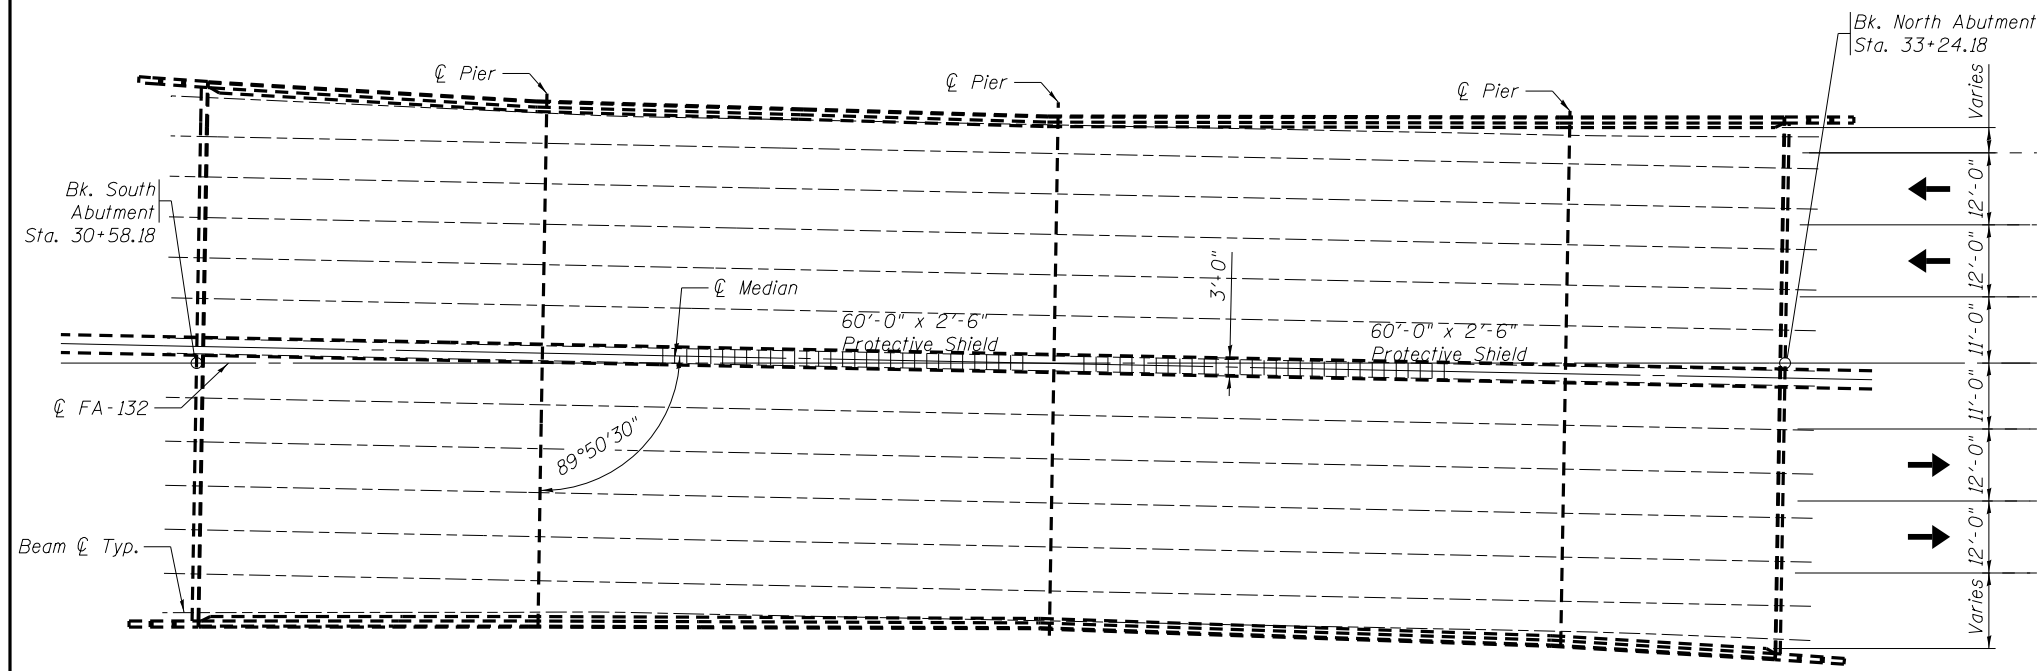
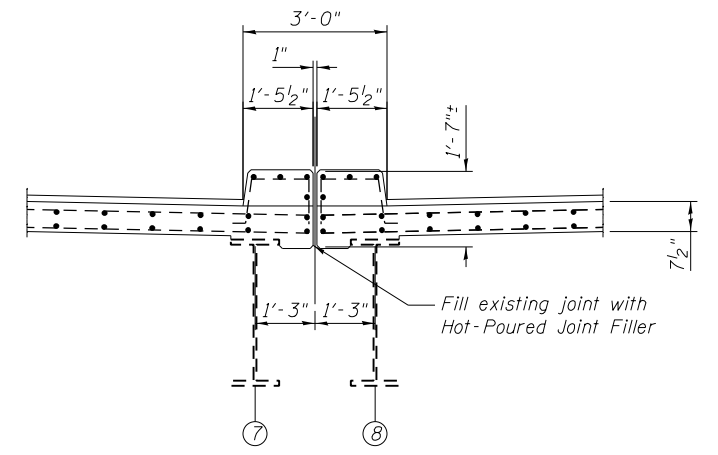
DECK PLAN

MEDIAN JOINT REPLACEMENT

Notes:
 Part of the underside deck is obstructed from view. Additional damage to the underside deck may exist. Contractor to field verify amount of damage and repair what is needed. Contractor to confirm all related quantities.
