**STATE OF ILLINOIS
DEPARTMENT OF TRANSPORTATION**

**LOCATION NO 1. IL 53 EXTENSION AT LAKE-COOK RD (SN 016-3215)
CURTAIN WALL REPAIRS**

SCALE: _____ SHEET 5 OF 7 SHEETS STA. _____ TO STA. _____

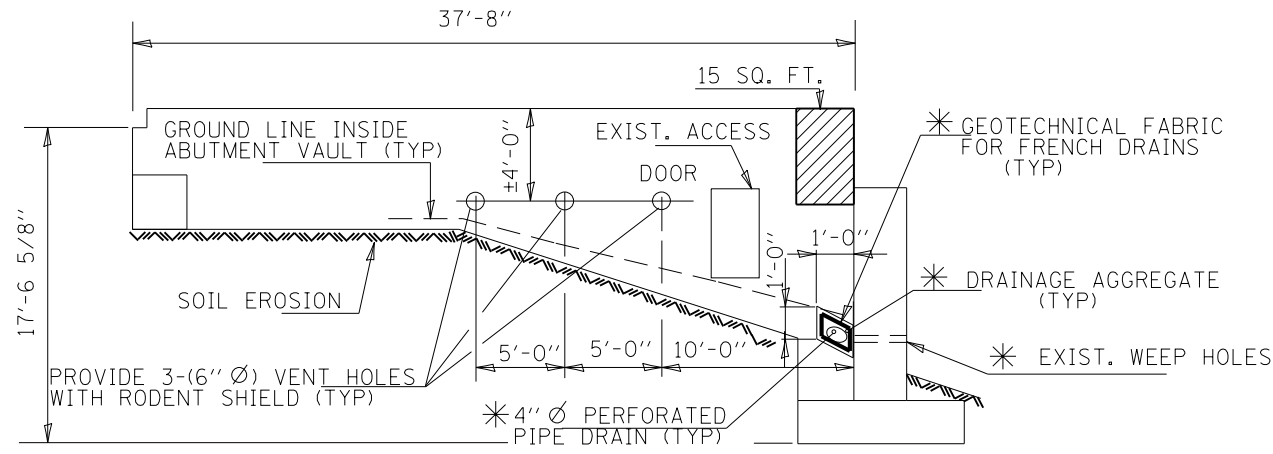
**EAST ABUTMENT CURTAIN WALL
LOOKING SOUTH**

COST OF CORING 12 VENT HOLES (3 EACH SIDE AT EACH ABUTMENT) AND SHIELDS INCLUDED WITH "STRUCTURAL REPAIR OF CONCRETE \leq 5".

* CLEAN EXISTING WEEP HOLE IN THE EXIST. WINGWALL TO ACCOMODATE THE 4"Ø PERFORATED PIPE DRAIN. AFTER INSTALLATION SEAL AROUND THE PIPE DRAIN. COST INCLUDED IN THE COST OF PIPE UNDERDRAINS FOR STRUCTURES 4".

EXCAVATED SOIL FOR PIPE UNDERDRAIN INSTALLATION SHALL BE PLACED ON TOP OF SLOPED GROUND INSIDE VAULT. COST INCLUDED IN " PIPE UNDERDRAIN FOR STRUCTURES 4".

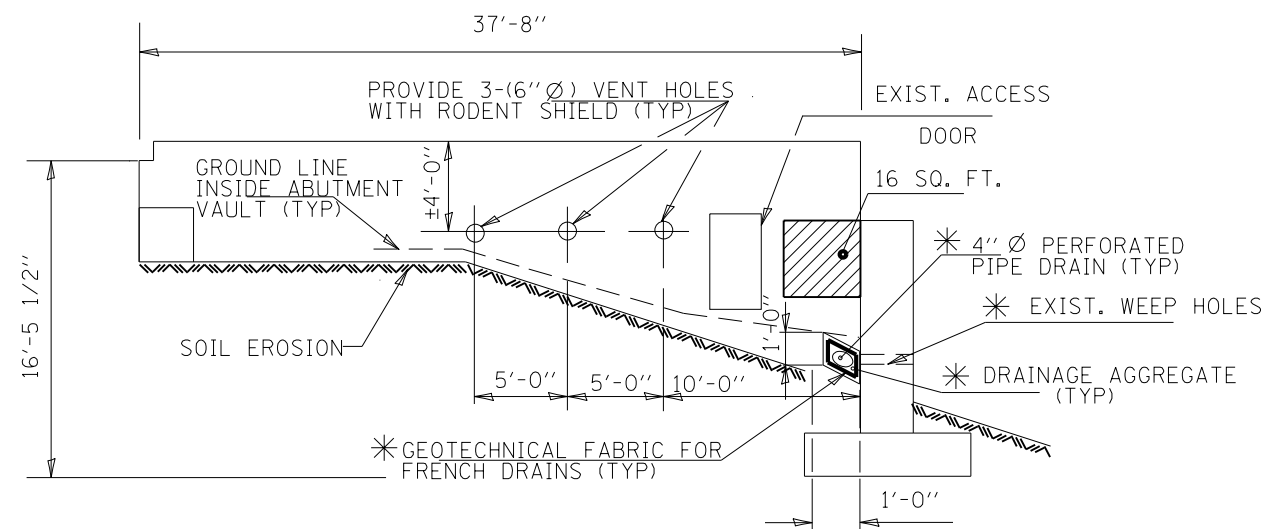
**WEST ABUTMENT CURTAIN WALL
LOOKING NORTH**
