STATE OF ILLINOIS
DEPARTMENT OF TRANSPORTATION

PIER 2 DETAILS
STRUCTURE NO. 006-0140
SHEET NO. S21 OF S26 SHEETS

F.A.P. RTE. 613	SECTION (8D-BR) BR	COUNTY BUREAU	TOTAL SHEETS 63	SHEET NO. 43
CONTRACT NO. 66A17				
ILLINOIS FED. AID PROJECT

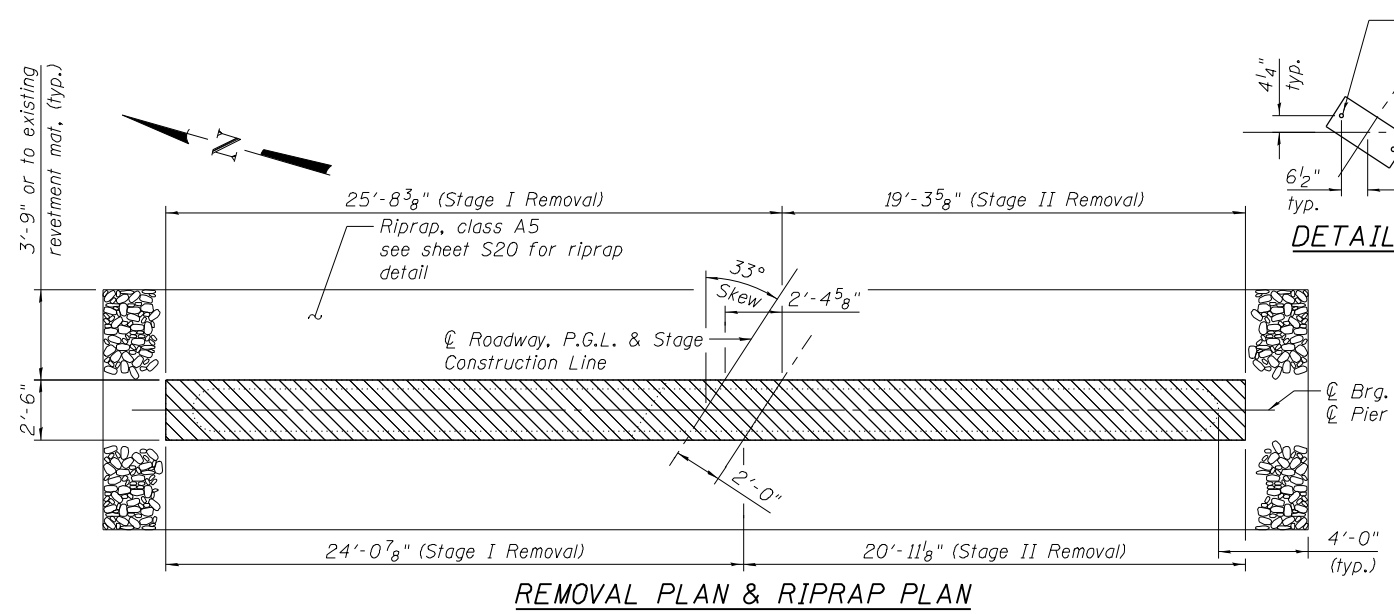
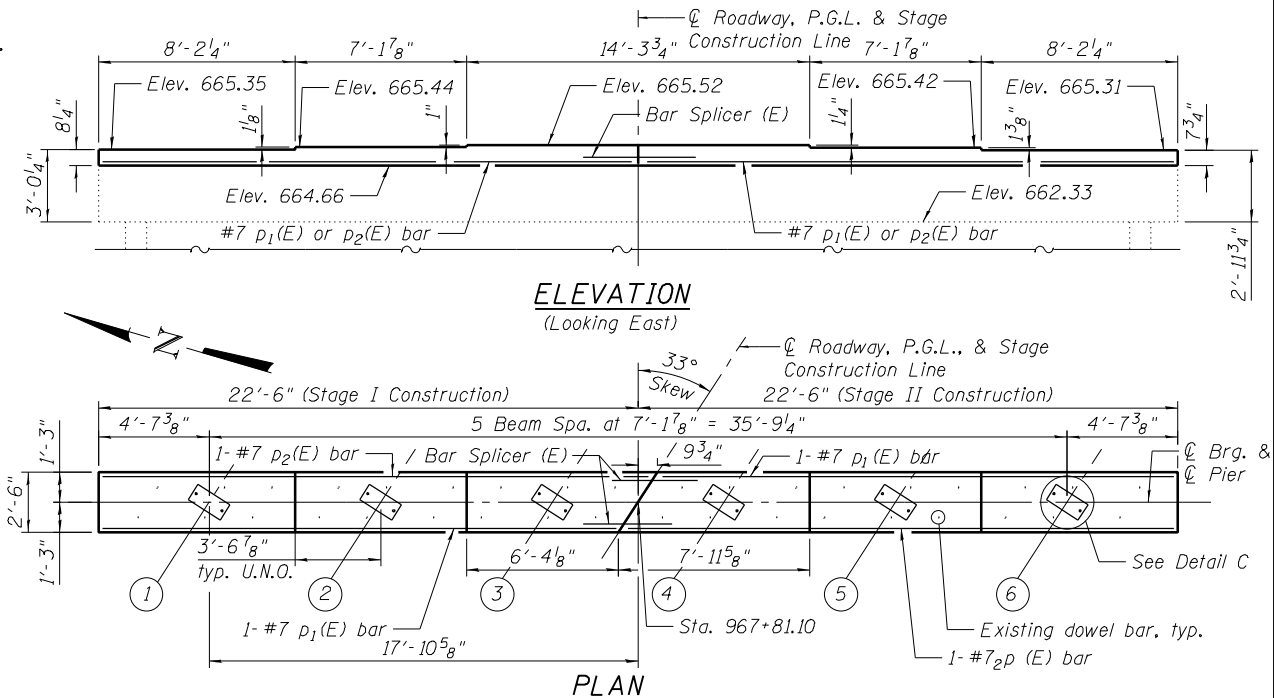
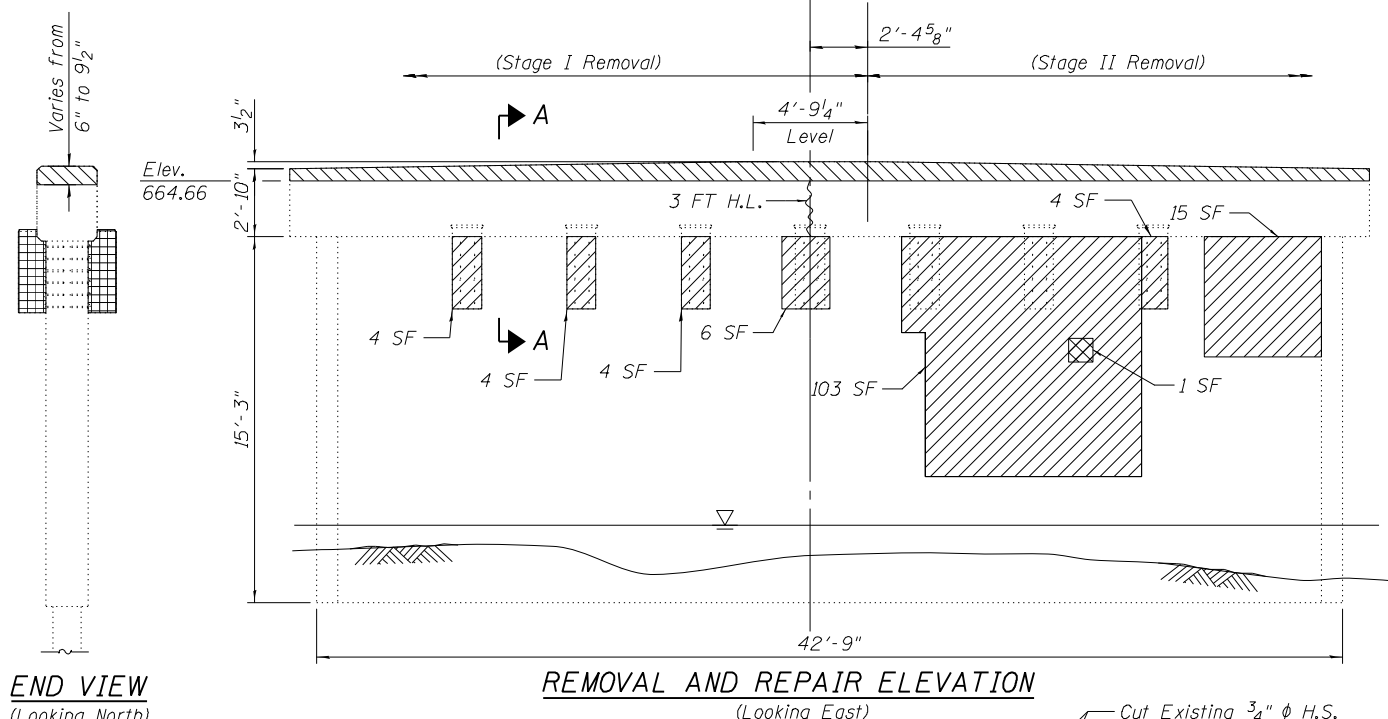
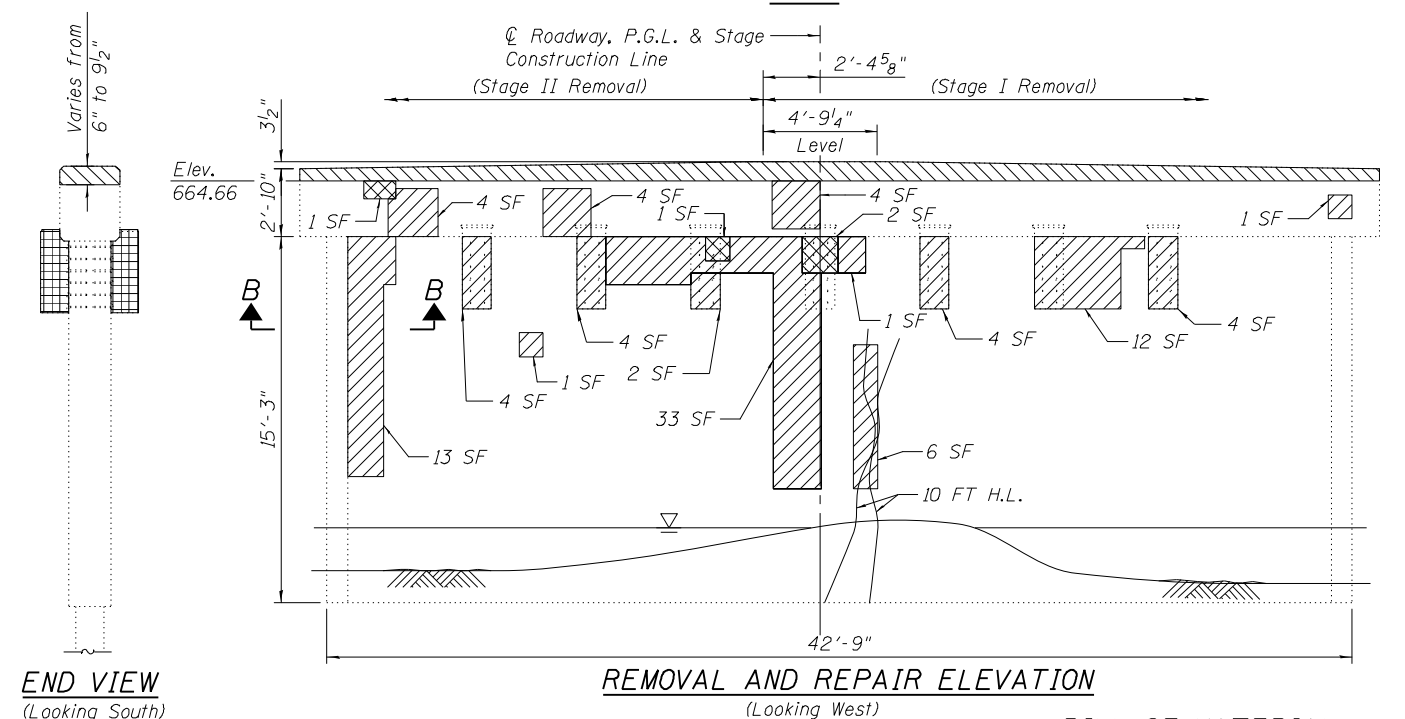
Note:
Structural Repair of Concrete includes both existing damage to substructure and repair due to Steel Beam Seat Removal.
