SUPERSTRUCTURE
EAST BOUND LANES
STRUCTURE NO. 081-0020 (E.B.)
FAI ROUTE 280 Section D2 Br Wear Surf I-280
Rock Island County
Sta. 241+69.27

| FILE NAME = G:\BRV\CADD plans\Rock Island County\2010 | USER NAME = lmkdj | DESIGNED - | REVISED - | STATE OF ILLINOIS DEPARTMENT OF TRANSPORTATION | SUPERSTRUCTURE 081-0020 | F.A.J. RTE. 280 | SECTION * | COUNTY ROCK ISLAND | TOTAL SHEETS 19 | SHEET NO. 9 | |

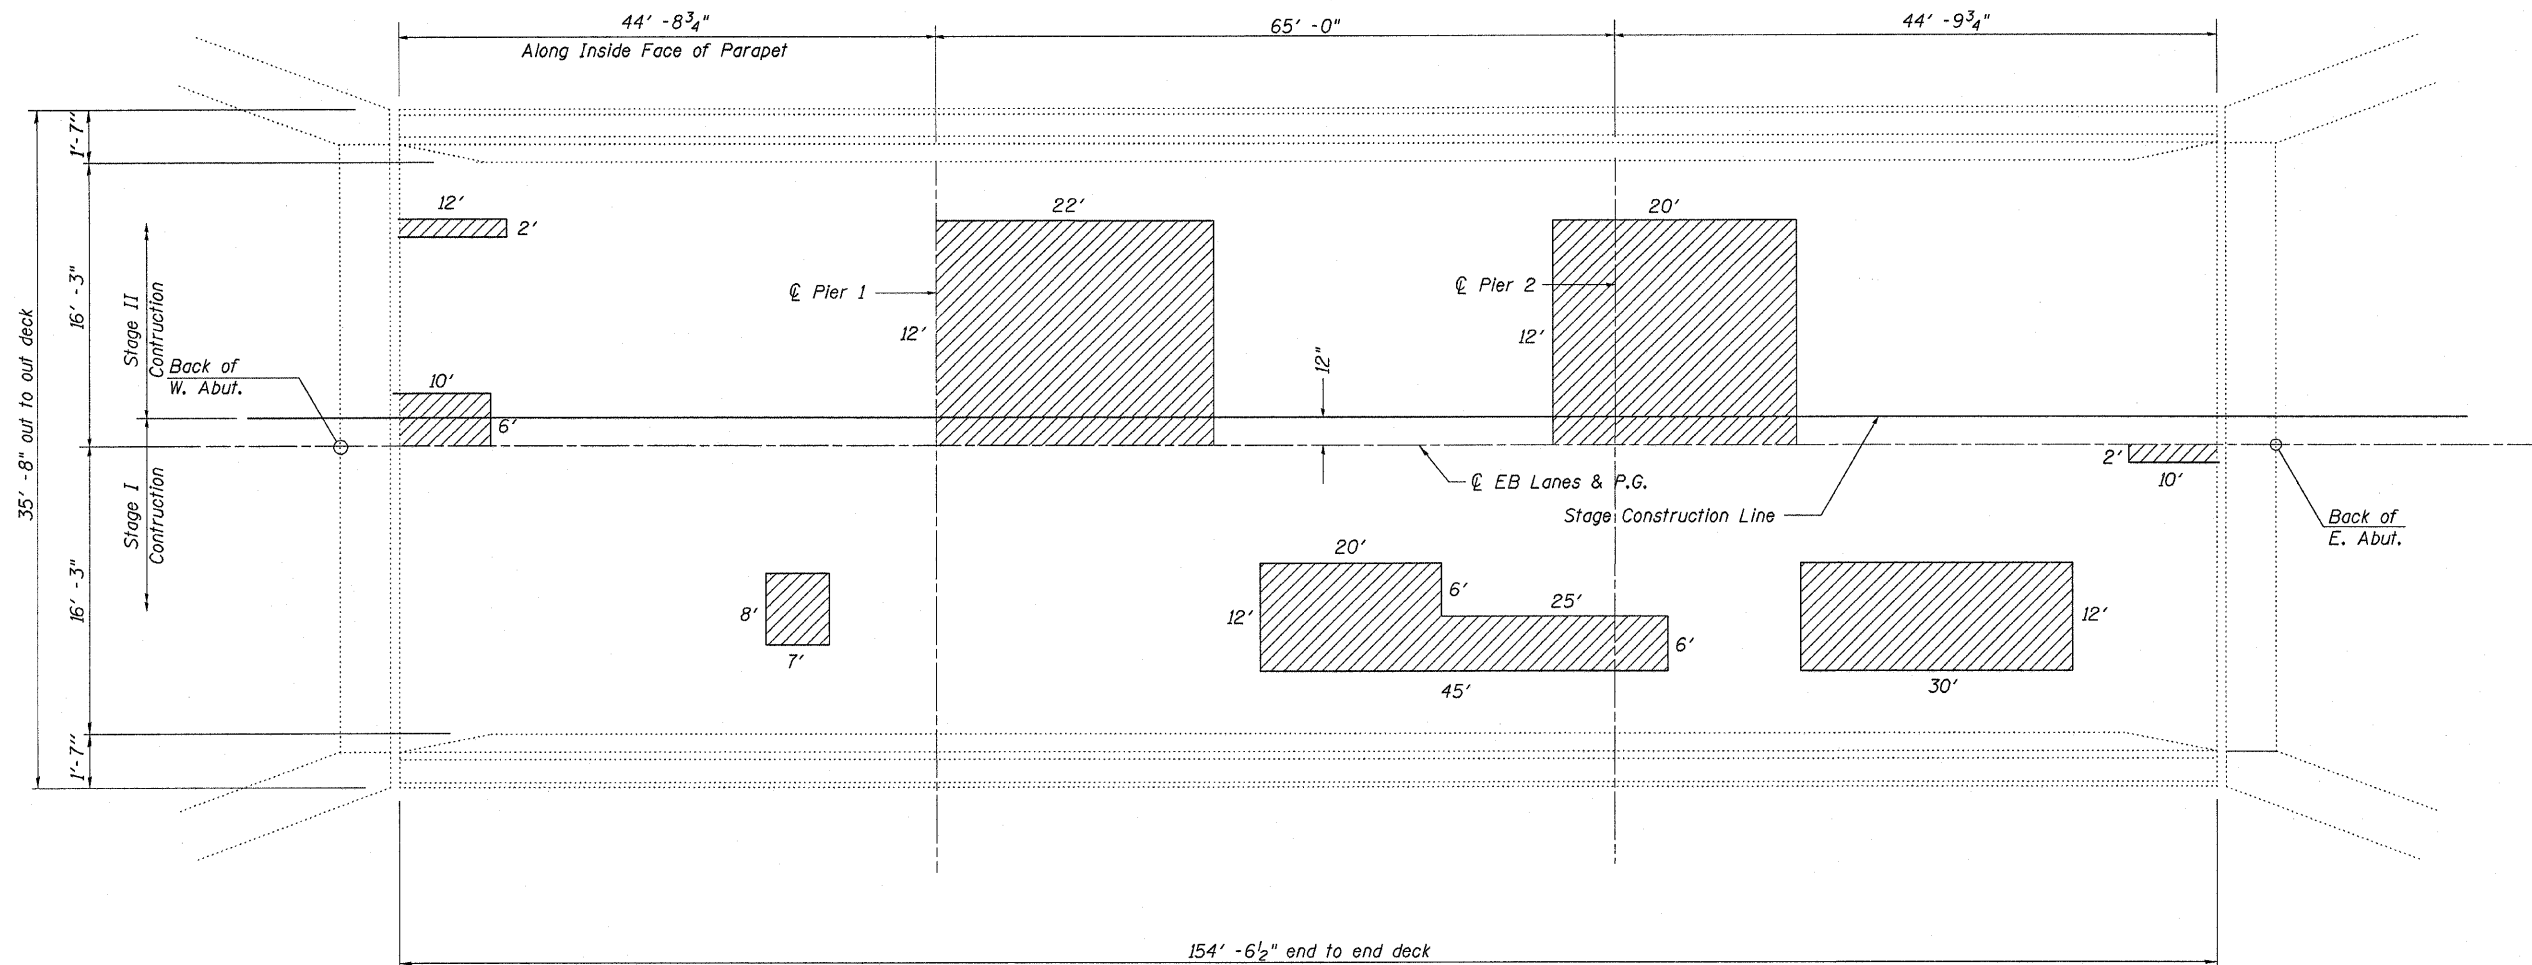
PLAN

Potential Deck Slab Repair (Partial)

Date of Survey 10/2009

Areas shown for repair are potential areas of deck slab repair. Actual locations and quantities to be determined in the field. Resident Engineer to contact District Bridge Office for assistance with locating patches.

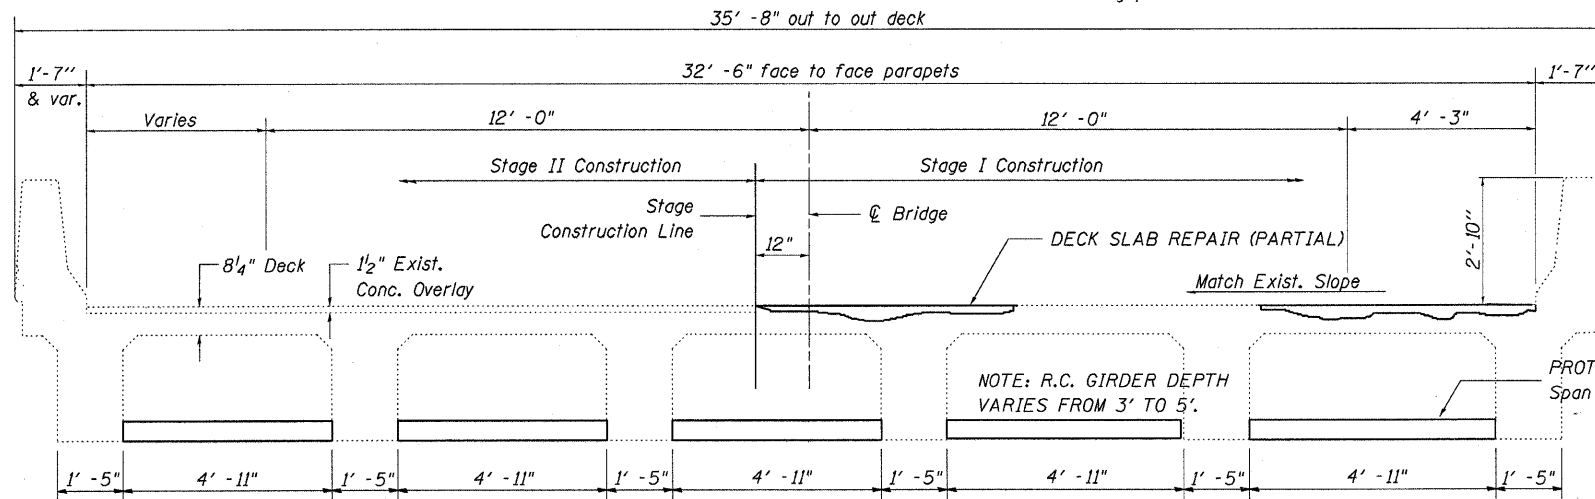
CROSS SECTION
(Looking East)

Contractor is not allowed to drill into the stems of the T-girders in order to anchor the required Protective Shield system.
