SUPERSTRUCTURE
WEST BOUND LANES
 STRUCTURE NO. 081-0021 (W.B.)
 FAI ROUTE 280 Section D2 Br Wear Surf I-280
 Rock Island County
 Sta. 241+69.27

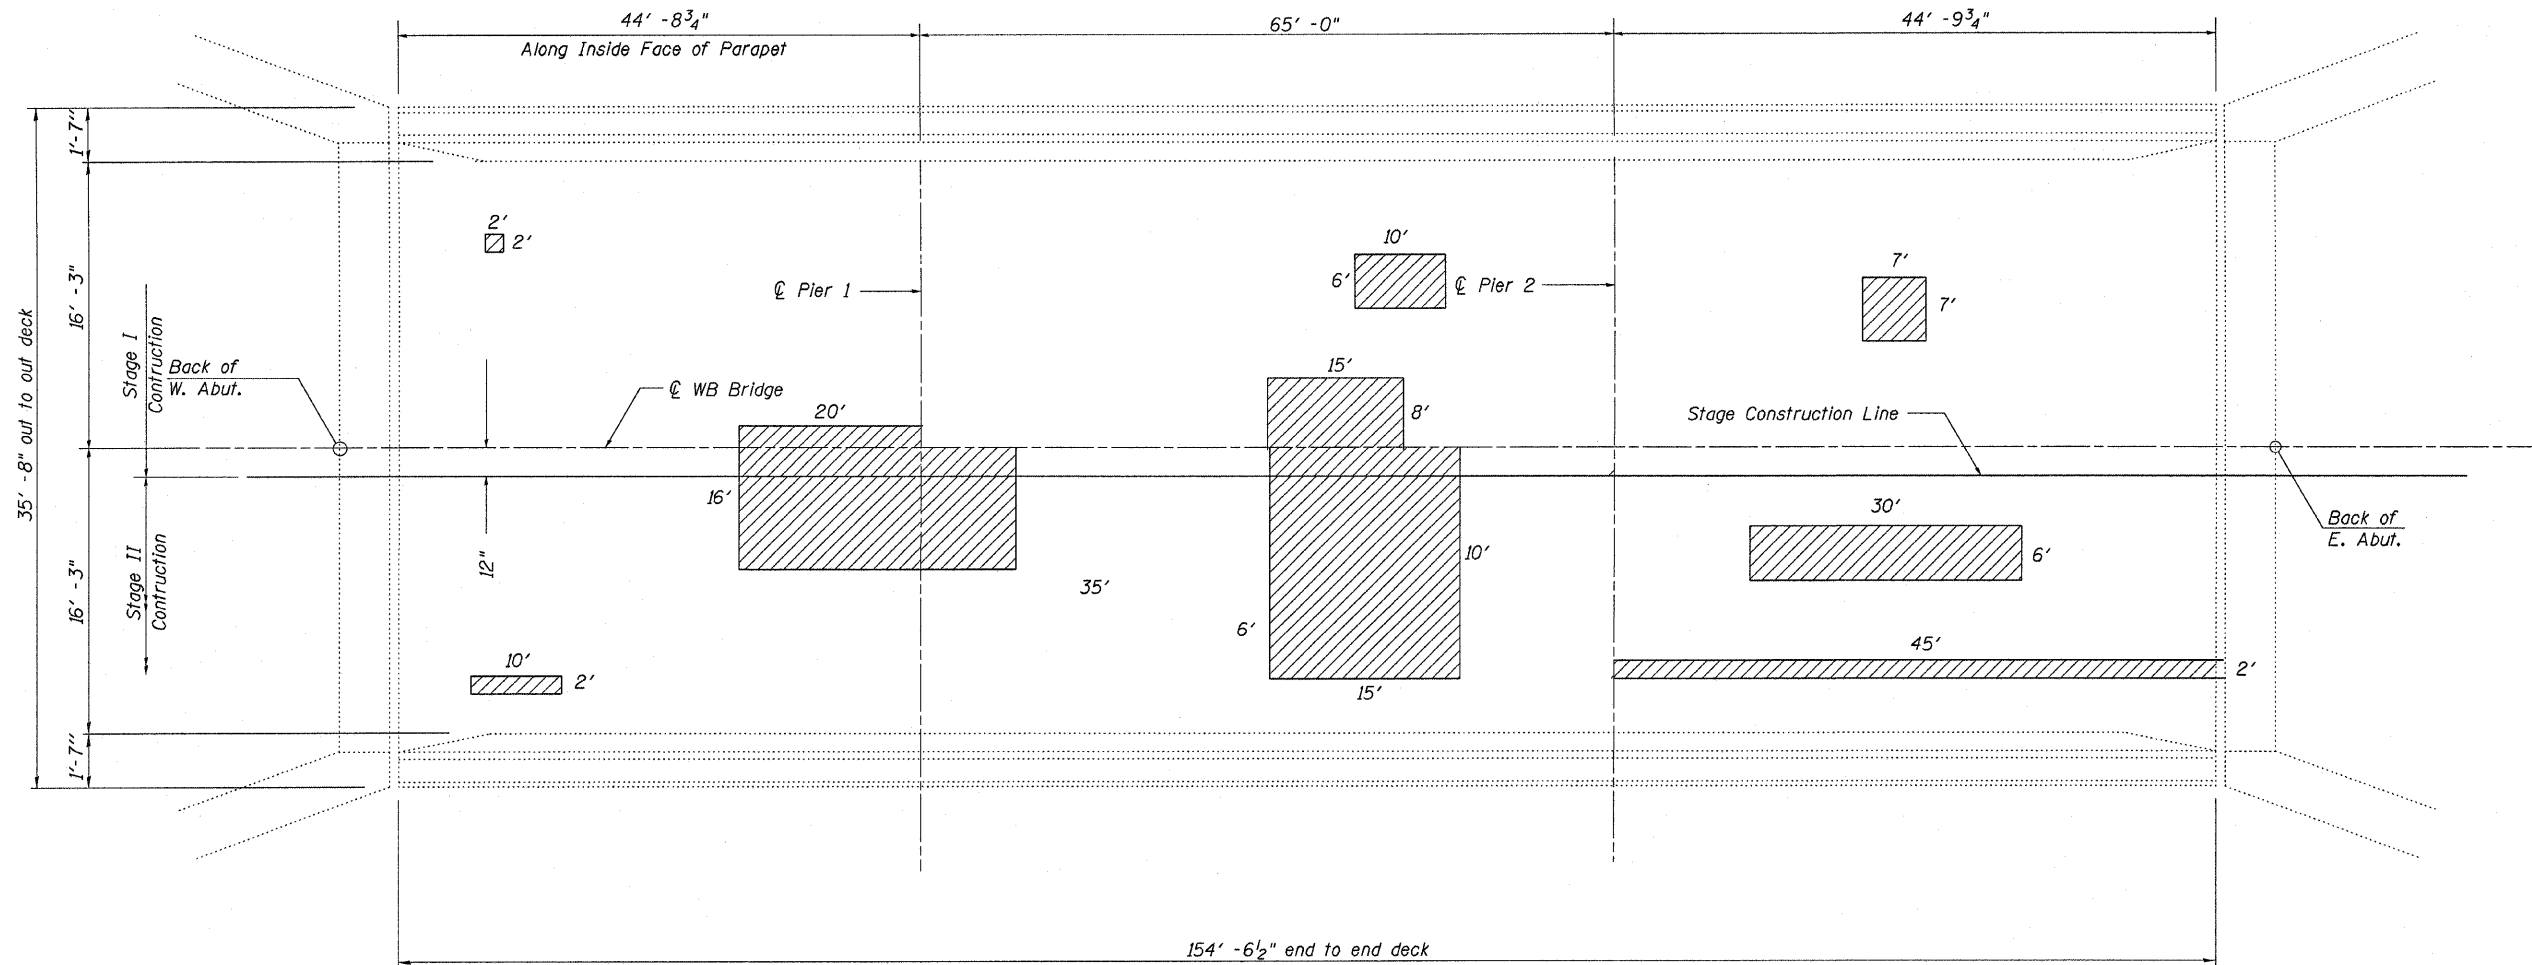
Legend
 Potential Deck Slab Repair (Partial)
 Date of Survey 10/2009

PLAN
 Areas shown for repair are potential areas of deck slab repair. Actual locations and quantities to be determined in the field. Resident Engineer to contact District Bridge Office for assistance with locating patches.

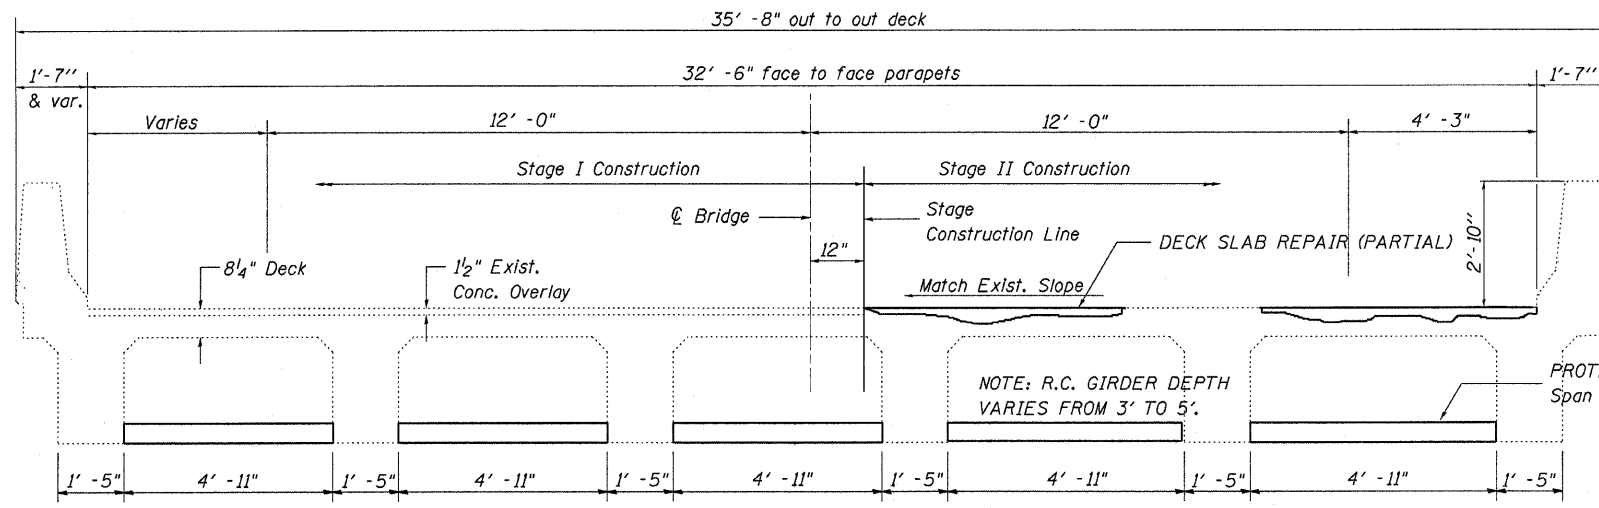
CROSS SECTION
 (Looking East)

Contractor is not allowed to drill into the stems of the T-girders in order to anchor the required Protective Shield system.
