**HALF SECTION
BEAM END REPAIRS AT PIER 7**
Looking East, Ahead Station

IL 161 OVER CROOKED CREEK

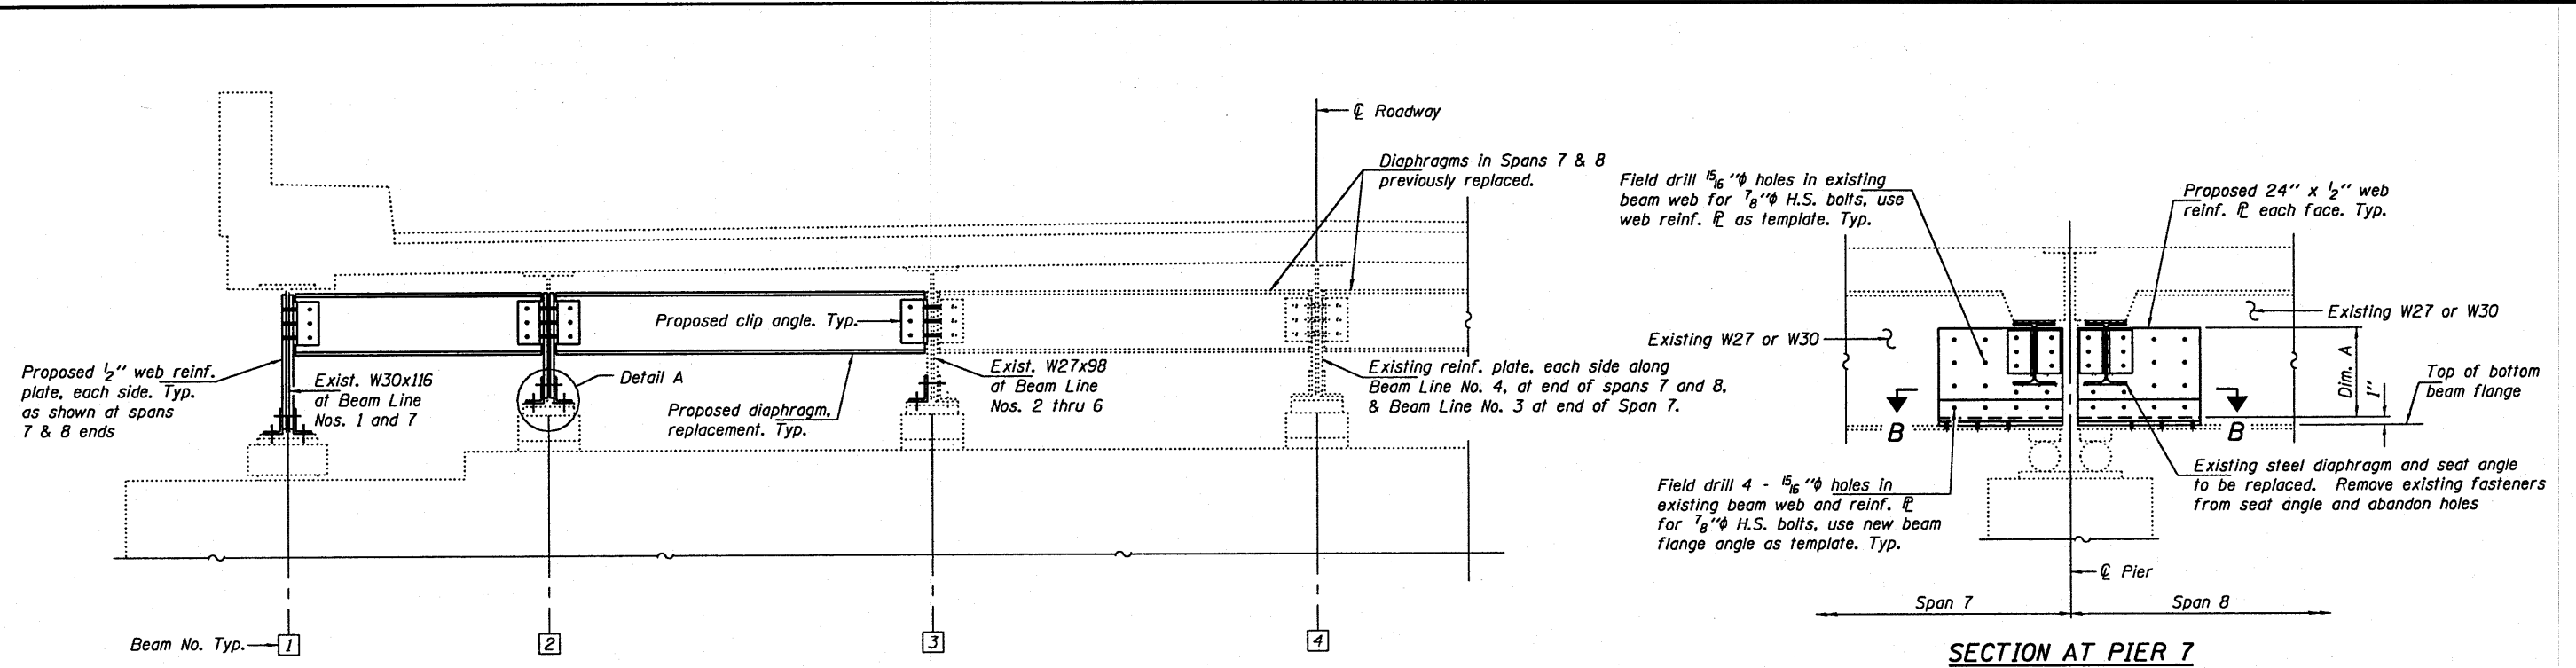
SECTION AT PIER 7
Looking North, Beam Line No. 1, 2, 3, 5 and 6 shown
Beam Line No. 7 similar

Beam No.	Dim. A
1 & 6	1'-9"
2 & 3	1'-6"
5	1'-7 1/2"
7	2'-1"
