**STATE OF ILLINOIS
 DEPARTMENT OF TRANSPORTATION**

**PIER 2 REPAIRS
 STRUCTURE NO. 049-0062**

SHEET NO. S22 OF S23 SHEETS

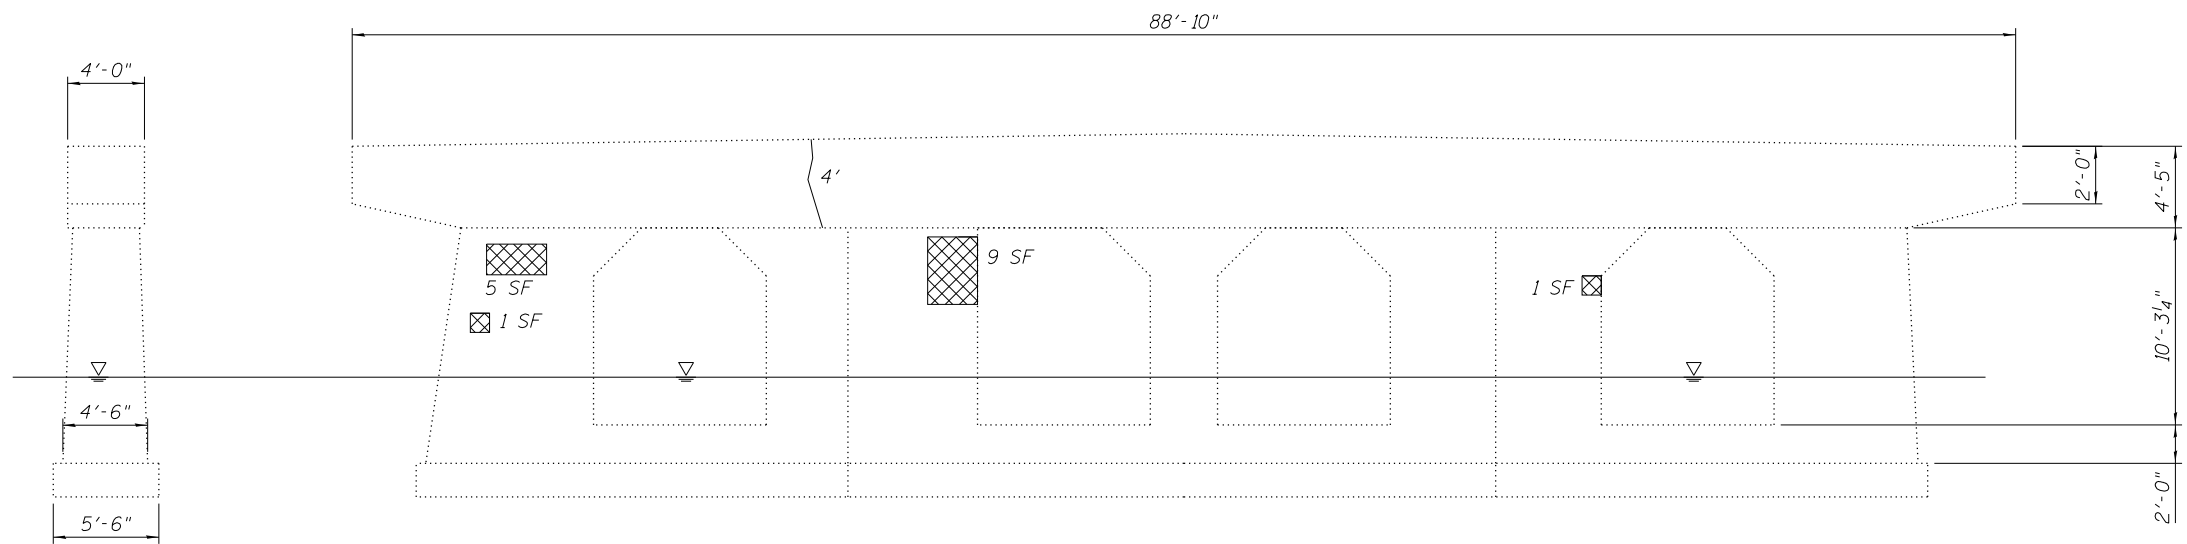
NORTH FACE

WEST FACE

Notes:
 After removing PPC Deck Beams, the Contractor shall sound top of pier and mark all deteriorated spalled and delaminated concrete. Those areas when confirmed by the engineer shall be repaired at the contract price for Structural Repair of Concrete (Depth less than 5") and Epoxy Crack Injection.
 The repairs shown on this sheet follow the defects reported in the Bridge Condition Report. Field verification of the extent of repairs will be required.

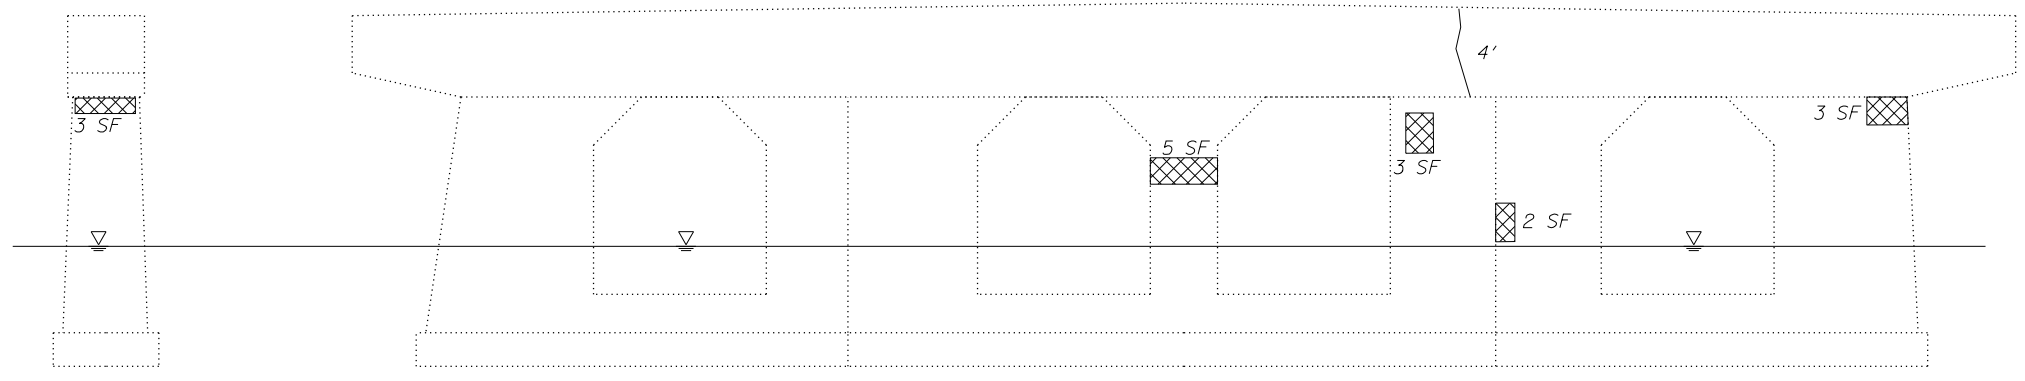
SOUTH FACE

EAST FACE
