Existing Structure: The existing structure (S.N. 016-1292) was built in 1942 with a length of 79'-4 1/4" and was extended at both ends in two rehabilitation projects to be 127'-8" long (sta. 76+44.12). It is a single cast-in-place reinforced concrete box culvert with 6 spans by 4' rise and 34.5° skew angle. Structure to be removed and replaced. One lane shall be maintained in each bound utilizing stage construction.

STA. 76+44.64  
BUILT 2013 BY  
STATE OF ILLINOIS  
FAP RT. 305 SEC. 1920.01-B-R  
LOADING HL-93  
STRUCTURE NO. 016-1392

**LONGITUDINAL SECTION ALONG Q̄ CULVERT**

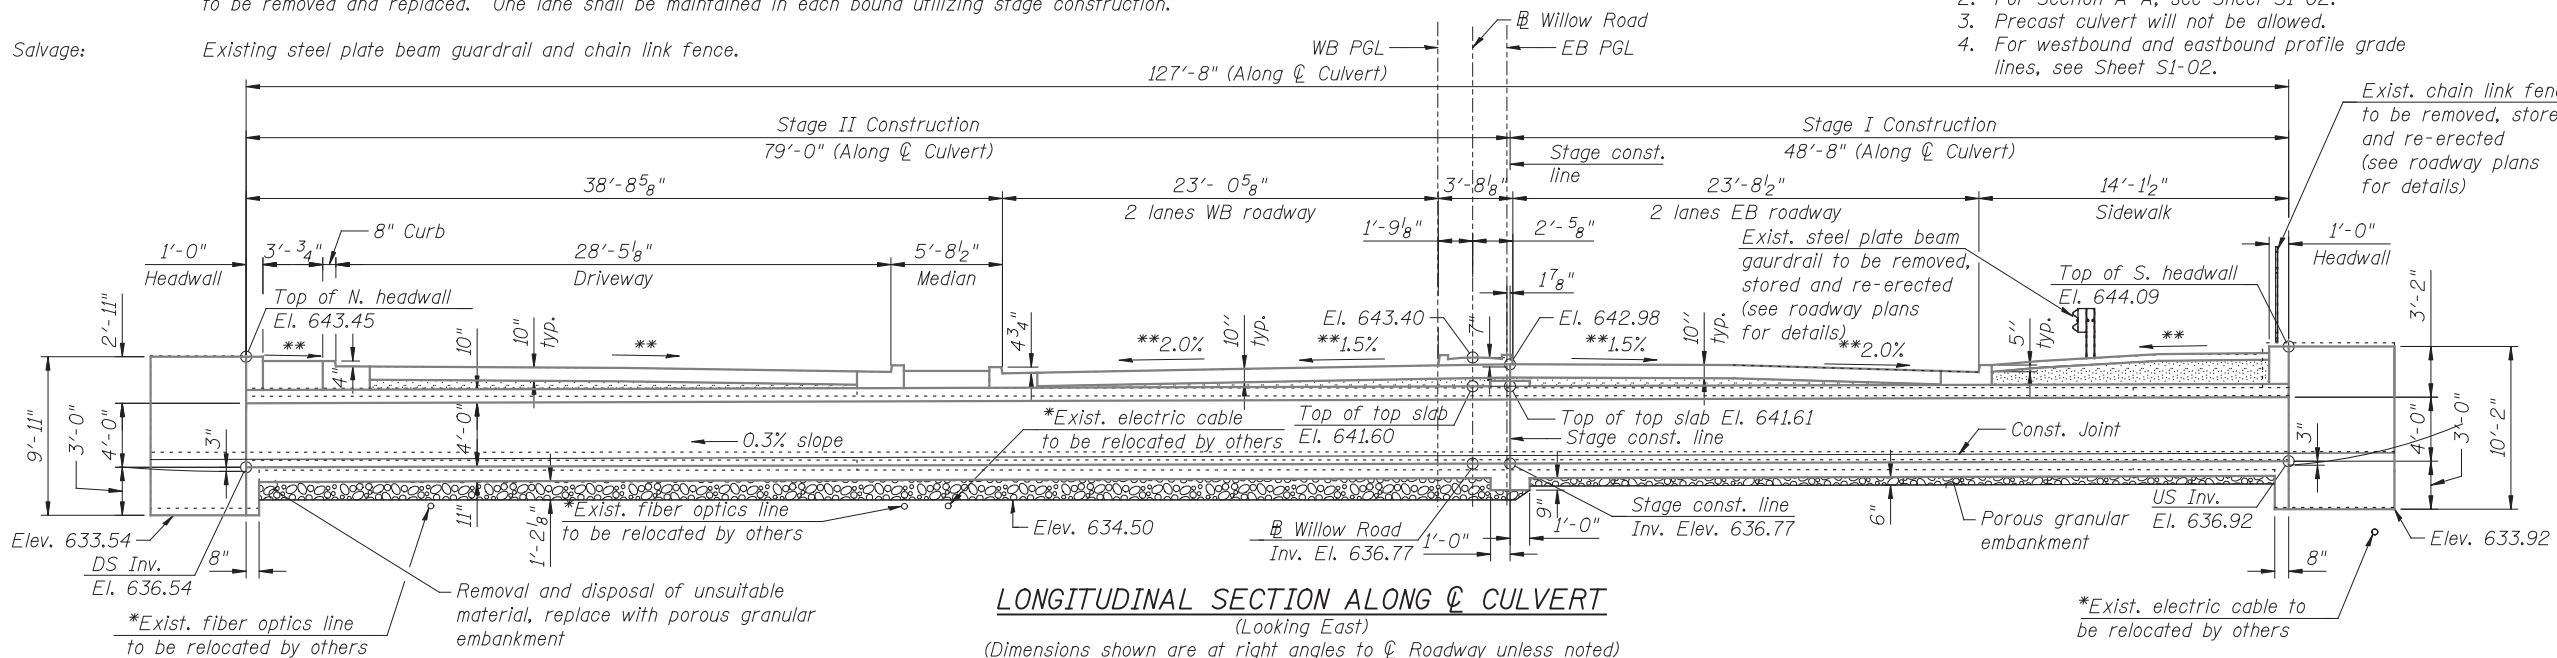
(Looking East)  
(Dimensions shown are at right angles to Q̄ Roadway unless noted)
