STATE OF ILLINOIS
DEPARTMENT OF TRANSPORTATION

REPAIR PROCEDURES FOR BEAM 8 SPAN 3

REPAIR DETAILS
FAI 172 OVER BN RR
SN 001-0051

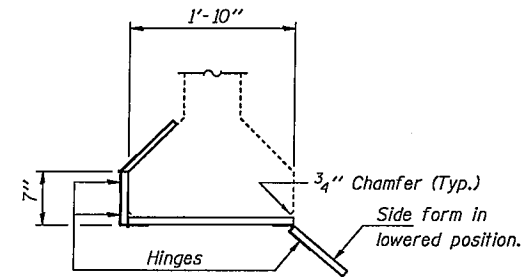
SUGGESTED FORM DETAIL

6. Preloading, if specified, and forms shall be kept in place for 3 days after completion of concrete repair or until the repair material has reached an ultimate strength of 5,000 psi. Timing of form removal shall be modified as necessary to meet curing requirements as specified by the manufacturer.

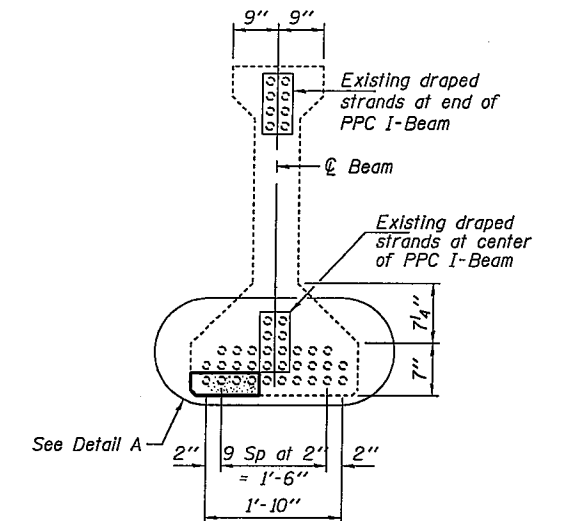
**SECTION A-A
PATCHING DETAIL**
Beam 8, Span 3

2. Using the same tools, remove the existing concrete to sound concrete, as described above, along the edges of the damaged area to a depth of 1" min. to 1 1/2" max. The edges shall be saw cut 3/4" deep. The entire area of existing concrete against which new concrete will be placed and any exposed portions of the prestressing strands shall be sandblasted. The concrete shall be sandblasted to expose clean, well bonded aggregate.

3. Power driven pins as shown in Detail A shall be placed at 9" alternate centers along damaged length of beam at locations shown in Detail A. Place 1" x 1" x 18 gauge welded wire fabric in repair areas and attach it to the pins or strands with wire ties. The clearance between the finished surface of the new concrete and the welded wire fabric shall be 1" minimum. All beams involved in this work shall be rebuilt to their original dimensions.

5. The repair shall be made using a material from the "Approved List of Non-Shrink Grouts" maintained by the Bureau of Materials and Physical Research. The repair material chosen shall be appropriate for the thickness of repair to be made. Coarse aggregate with maximum size of 3/8" shall be added with the amount as specified by the manufacturer. Place the lower form on the bottom of the beam and compact by vibrating (or other approved methods) the mix into the voids. After accessible voids have been filled and compacted, the side form shall be raised into position and the remaining voids filled and compacted. The sloping upper surface shall be finished to the configuration of the existing PPCI-Beam flange.
