STRUCTURE REPAIR PLAN AT FLOOR BEAMS
(Span 6)

STRUCTURE REPAIR DETAILS
SPAN 6
VACHEL LINDSAY BRIDGE REHABILITATION
LONG BAY DRIVE OVER LAKE SPRINGFIELD
SPRINGFIELD, ILLINOIS

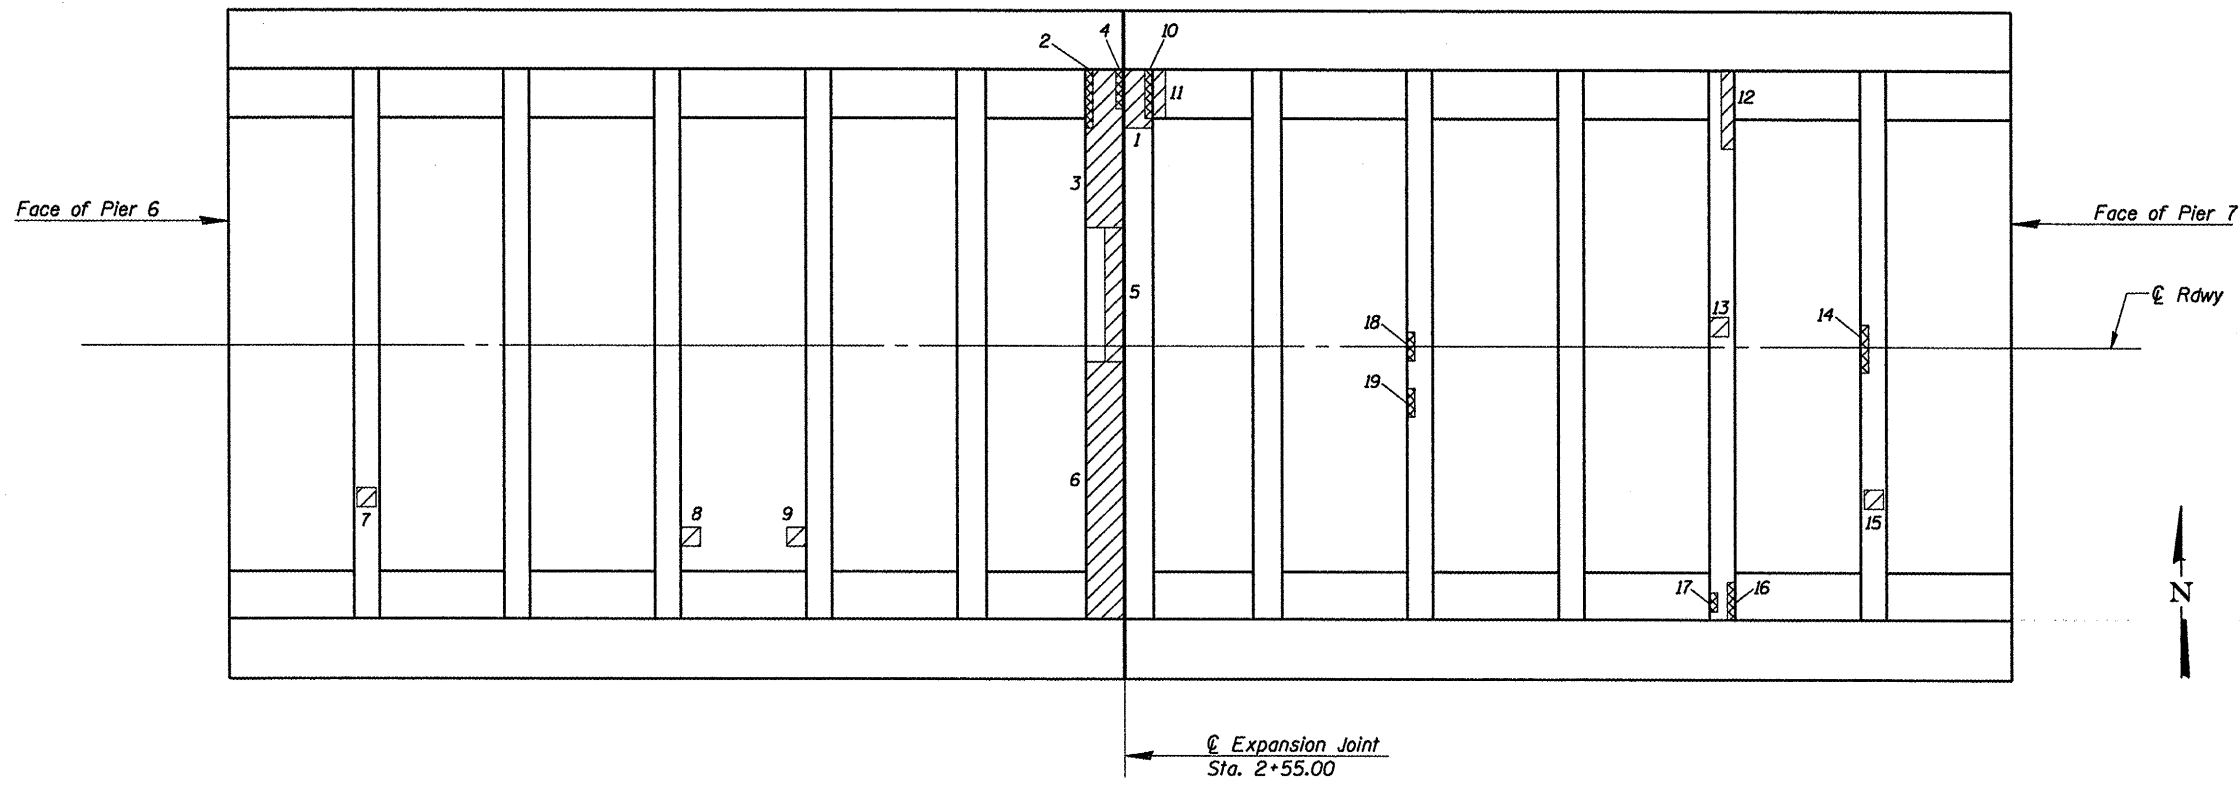
- Indicates Area of Horizontal Structural Repair
- Indicates Area of Vertical Structural Repair
