Structural Repair of Concrete (Depth Equal to or Less than 5'')

WINGWALL REMOVAL & REPAIRS STRUCTURE NO. 016-1149	II
0111001011E 110.010-1143	
SHEET NO. S36 OF 50 SHEETS

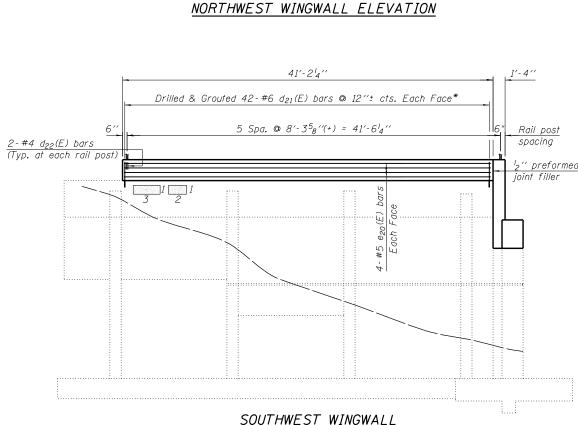
ELEVATION

Drilled & Grouted 4-#6 d₂₁(E) bars @ 11" cts.

2-#4 d₂₂(E) bars (Typ. at each rail post)

Each Face*

Rail post

spacing

l₂'' preformed joint filler
