LIN ENGINEERING, LTD.
260 N. Chestnut
Chicago, Illinois 60623
Phone: (312) 462-1819 Fax: (312) 462-8708
Designed By: STD Checked By: MTH Drawn By: JMD
Date: 01/05 File: 0470048.DGN

ILLINOIS DEPARTMENT OF TRANSPORTATION
CROSS SECTION
F.A.P. 326 (IL RTE. 47)
OVER FOX RIVER
SECTION (108,109)RS-4
KENDALL COUNTY
S.N. 047-0048

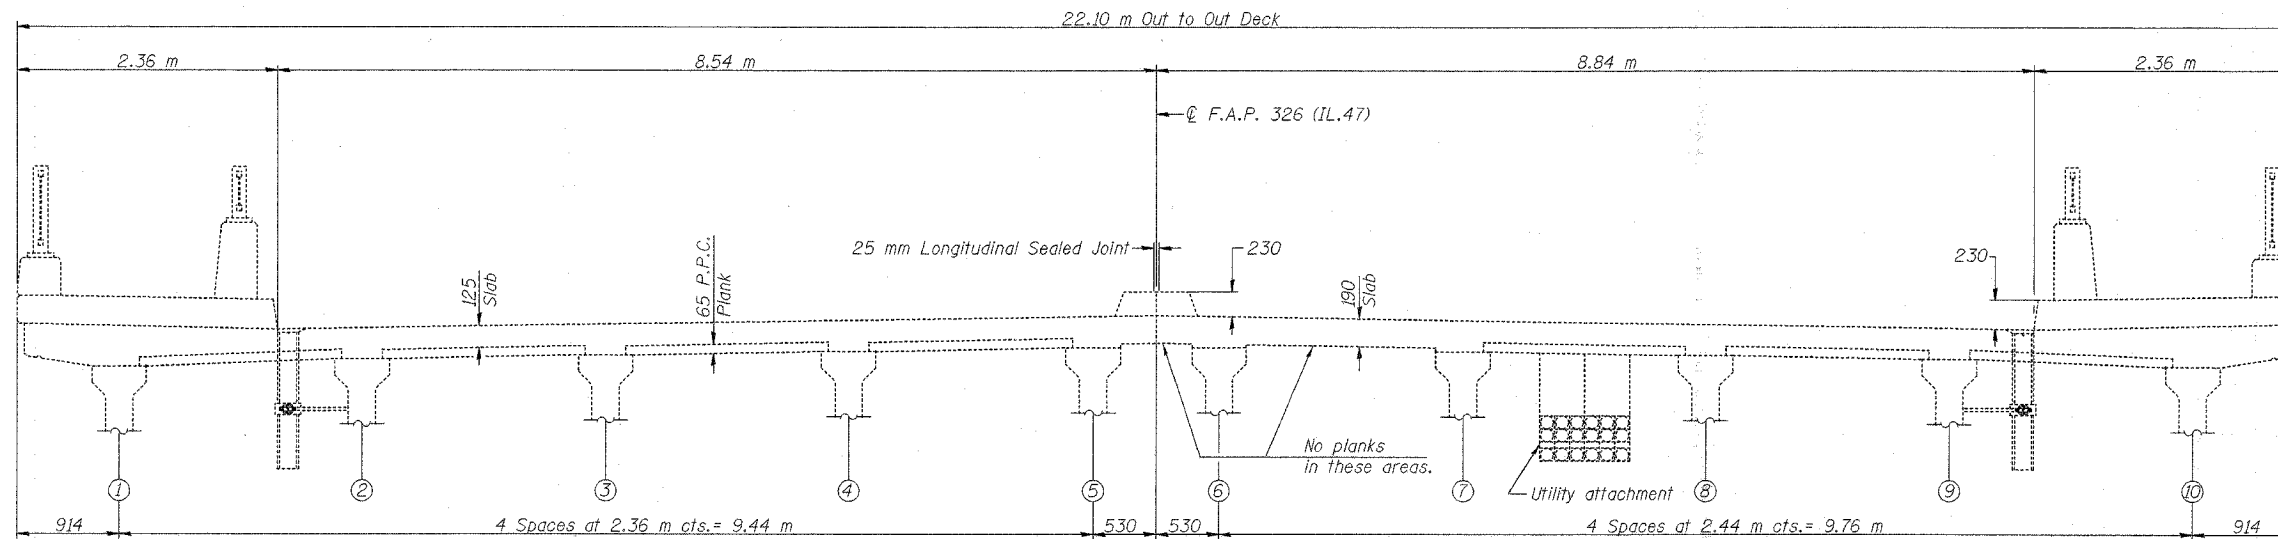
CROSS SECTION
(Looking North)

Note: All deck slab repair in the deck area over the planks shall be paid for as Deck Slab Repair (Full Depth). However, the removal of the existing concrete shall only be to the existing P.P.C. plank. This area shall then be cleaned and the plank inspected for deterioration. If deterioration is found, the entire plank shall be removed and replaced with a full depth patched area with proper reinforcement detailed, as approved by the Engineer. This work will be paid for as Deck Slab Repair (Full Depth, Type II). The Contractor shall take all necessary precautions to protect the P.P.C. planks from getting damaged during deck slab repair. Should the planks be damaged, the entire plank area shall be removed and replaced with proper reinforcement detailed as approved by the Engineer, at the expense of the Contractor.
