QUINCY REGIONAL AIRPORT
BALDWIN FIELD
ADAMS COUNTY, ILLINOIS

REHABILITATE
RUNWAY 18-36

CONSTRUCTION
PLAN

STA 159+40 TO STA 176+20

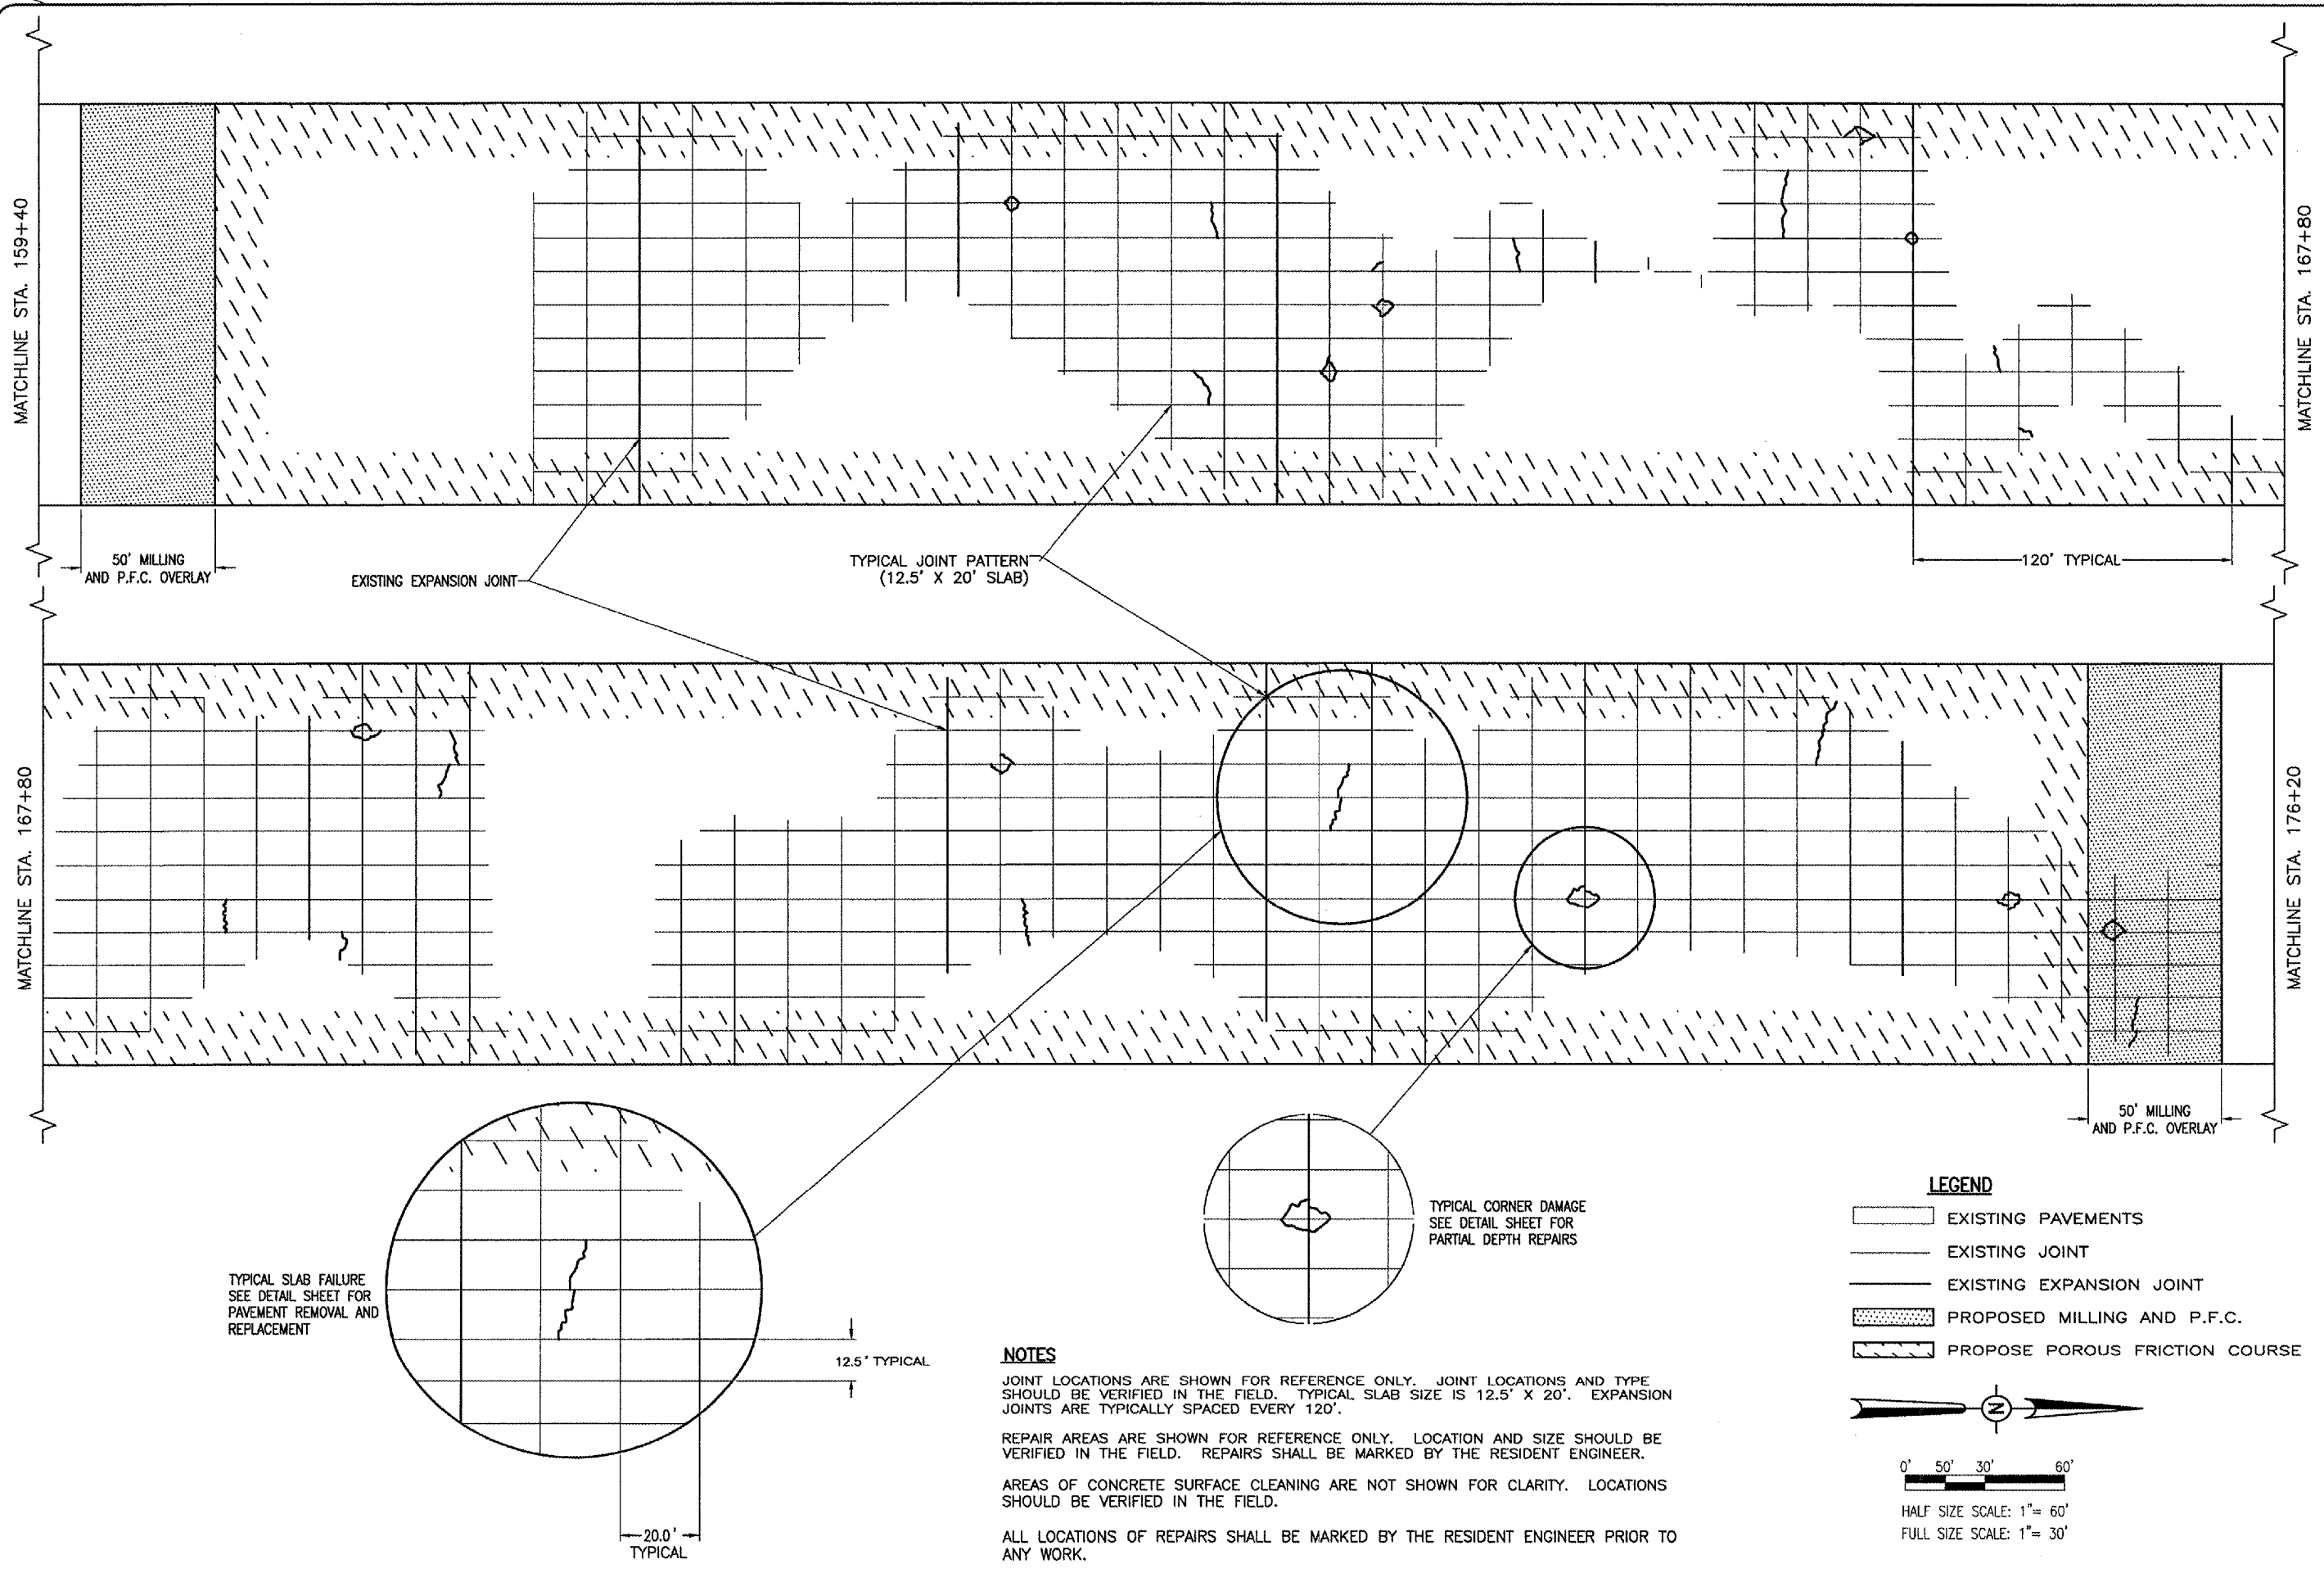
TYPICAL SLAB FAILURE
SEE DETAIL SHEET FOR
PAVEMENT REMOVAL AND
REPLACEMENT

20.0'
TYPICAL

12.5' TYPICAL

TYPICAL CORNER DAMAGE
SEE DETAIL SHEET FOR
PARTIAL DEPTH REPAIRS
