LASALLE STATE OF ILLINOIS **★** 76-09263-00-BR DEPARTMENT OF TRANSPORTATION LASALLE COUNTY MENDOTA MERIDEN ADAMS NORTHVILLE PLANS FOR PROPOSED TROY GROVE OPHIR FREEDOM SERENA ROAD IMPROVEMENT DIMMICK WALTHAM SECTION 76-09263-00-BR EARL TWP OT TAWA UTICA PROJECT NO. SRS - 0005(60) PLANS EDEN FARM RIDGE RAPIDS PROFILE HOR VERMILLION PROFILE VERT X-SECTIONS HOR HOPE OTTER-X-SECTIONS VERT I"= CREEK DETAILS C93 - 127 - 76OSAGE R.3E. GROVE -IMPROVEMENT PROPOSED PRECAST, PRESTRESSED CONCRETE DECK BEAM BRIDGE, CLOSED TIMBER ABUTMENTS, PILE BENT PIER, 2 SPANS @ 31'-6 34", SKEWED 45° LT FWD., STA. 2+77 EARLVILLE" 36N THESE PLANS WERE PREPARED STATE OF ILLINOIS UNDER MY SUPERVISION DEPARTMENT OF TRANSPORTATION WILLIAM JOHN KEITH, I.R.P.E. 62-29664 DISTRICT ENGINEER 3-30-, 1927 ENGINEER OF LOCAL ROADS AND STREETS APPROVED BY 33 <u>3-30</u>, 19 77 INDIAN at the EUGENE E. STEVENSON COUNTY SUPERINTENDENT OF HIGHWAYS R.3 E DEPARTMENT OF TRANSPORTATION FEDERAL HIGHWAY ADMINISTRATION APPROVED: GROSS LENGTH: FT.= DIVISION ADMINISTRATOR DATE EQUATIONS: OMISSIONS: NET LENGTH: FT.=

TOWNSHIP IMPROVEMENT LA SALLE COUNTY EARL ROAD DISTRICT E. 1250TH ROAD STRUCTURE NO. 050-3451

PILE REPAIR STRUCTURE 050-3

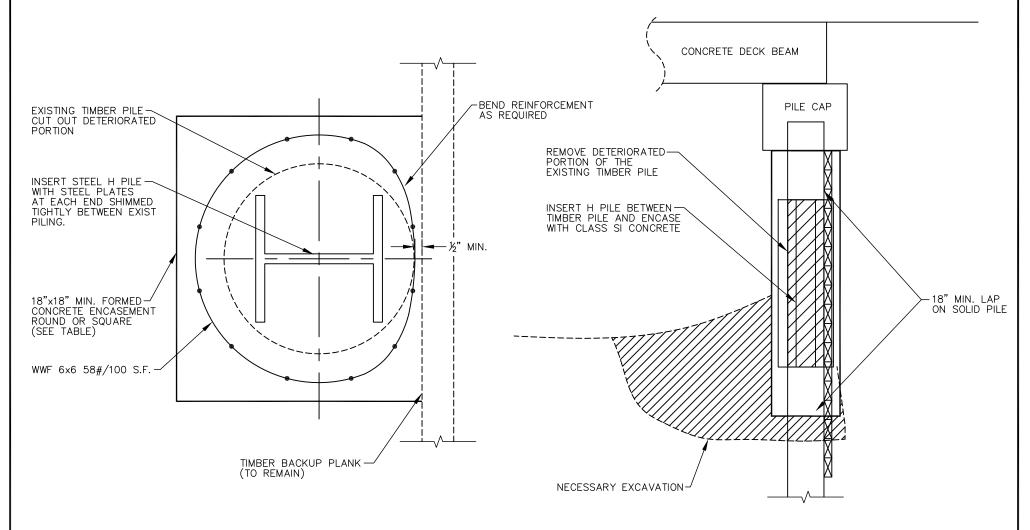
HP 8x36 USE 18" ENCASEMENT HP 10x42 USE 24" ENCASEMENT HP 12x53 USE 24" ENCASEMENT <u>OPTION B</u> ABUTMENT REPAIR DETAIL

PILE #3,7,9 SOUTH ABUTMENT

PILE #21,22 NORTH ABUTMENT

ENCASEMENT TABLE

ABUTMENT OR PIER PILE REPAIR ENCASEMENT A, B OR C MAY BE USED FOR ALL REPAIR CONDITIONS, EXCEPT AS NOTED BELOW.

PIER ENCASEMENT B, PIER PILE SLEEVE DETAIL, OR A MODIFIED VERSION OF OPTION A WITH ENCASEMENT & STIRRUPS CENTERED ABOUT THE PILE MAY BE USED.

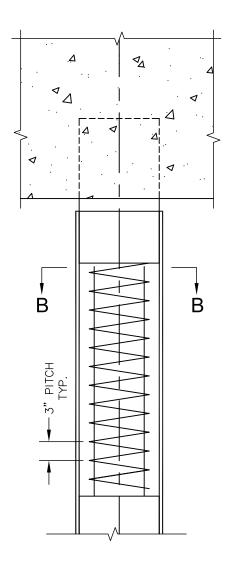
SECTION B-B

CLASS SI CONCRETE (3500 PSI) SHALL BE USED.

REINFORCEMENT BARS SHALL BE INCIDENTAL TO THE COST OF EACH PILE REPAIR AND SHALL CONFORM TO AASHTO ASTM A706 GRADE 60.

THE STEEL PILE ENCASEMENTS SHALL FIT SNUG OVER THE TIMBER PILE AND SHALL REMAIN IN PLACE.

- +	\prod	
PLACE BACKER ROD AS REQUIRED			//	
AT BOTTOM OF STEEL JACKET PRIOR TO CONCRETE PLACEMENT			/	
REPLACE PORTION OF TIMBER—PILE WITH REBAR CAGE SEE				
STEEL SLEEVE REINFORCEMENT DETAIL			9 OR .250	
SEAL GAPS IN SLEEVE IF > 1/2" OPEN	IING /	WALL	THICKNES	
MIN 2"x2"x¾" ANGLE FULL LEN WITH 3"x½" DIA. A307 GALVANI BOLTS @ 12" CTS	GTH —			
BOLTS @ 12" CTS	<u>LLU</u>
