EXISTING END DIAPHRAGM D AND D1

COVER PLATE REPAIR DETAILS

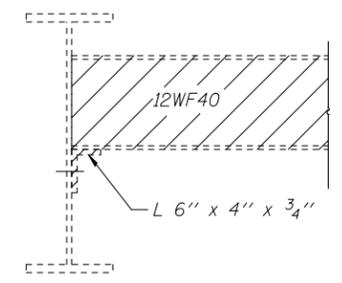
(Showing Removal)
Remove existing diaphragms and support angles at abutments and Pier 4 only. Cost included with Structural Steel Removal.

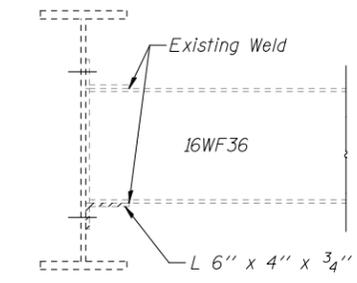
EXISTING INTERIOR DIAPHRAGM D3

(Showing Removal)
Remove existing lower support angles only. Grind welds smooth. Cost included with Structural Steel Removal.

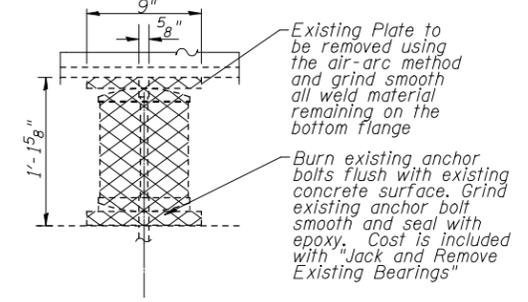
EXISTING BEARING REMOVAL DETAIL
(Abuts & Pier 4)

Jacking Loads (per beam)	Abut.
R D Steel Only	(K) 6
Min. Jack Capacity, Steel Only	(K) 12

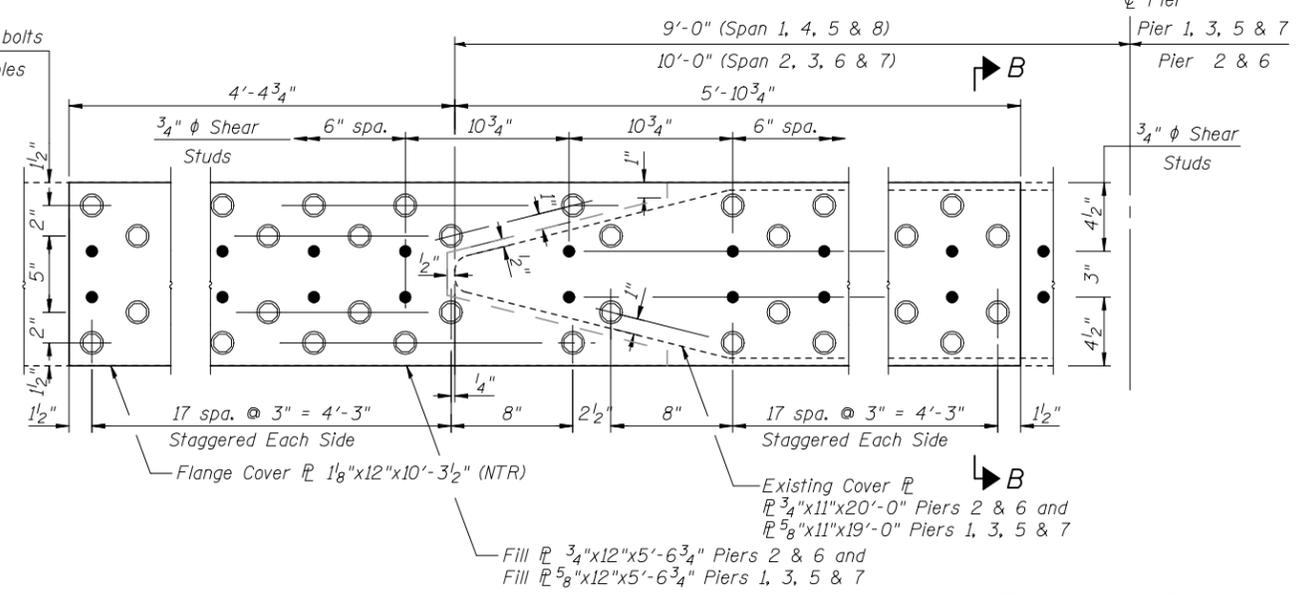
Note: One fill plate and one flange cover plate required at each end of each top flange existing cover plate.
