GEOTECHNICAL REPORT

IL-15 OVER RICHLAND CREEK
FAP 103 (IL-15), SECTION 27-1BR-1
ABUTMENT RETAINING WALLS
WORK ORDER NO. 61
ST. CLAIR COUNTY, ILLINOIS
PTB 168-023

GEOTECHNICAL REPORT
IL-15 OVER RICHLAND CREEK
FAP 103 (IL-15), SECTION 27-1BR-1
ST. CLAIR COUNTY, ILLINOIS

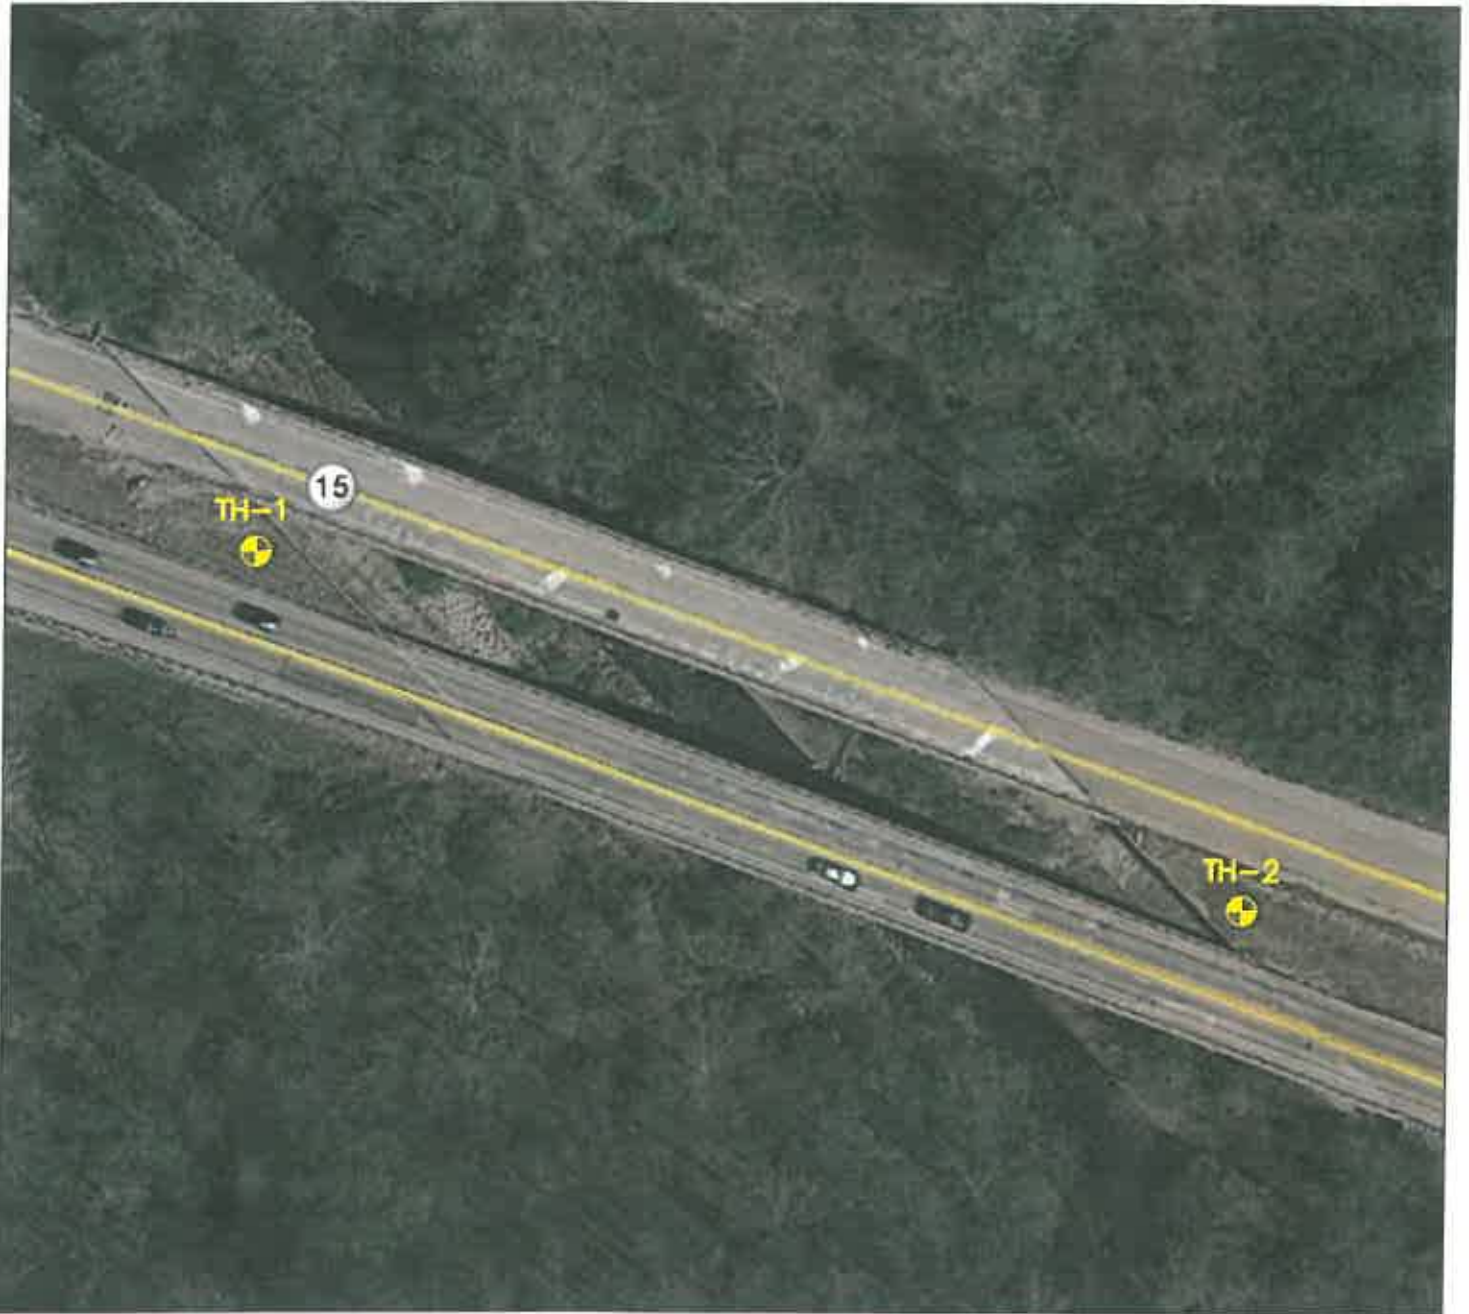
SITE AND BORING LOCATION PLAN IL ROUTE 15 OVER RICHLAND CREEK RETAINING WALLS ST. CLAIR COUNTY, ILLINOIS		
Drawn By: ACE	Checked By: JAS	
Project No.: 20175035.00	Date: 8/9/17	Figure 2

On July 11 and 12, 2017, TSi conducted a subsurface exploration at the site, consisting of two soil test borings, designated as Borings TH-1 and TH-2. TH-1 was drilled near the westbound abutment retaining wall and TH-2 was drilled near the eastbound abutment retaining wall. The boring locations were selected by and staked in the field by TSi prior to drilling. The boring locations were not surveyed at the time of this report. The ground surface elevations at the boring locations were estimated by TSi based on existing plans provided by Farnsworth. The logs from this exploration are included in Appendix B. The approximate locations of the borings are shown on Figure 2 in Appendix A. The approximate ground surface elevation at each boring is stated on the appropriate Log of Boring in Appendix B. Some of the borings were offset due to access restrictions.

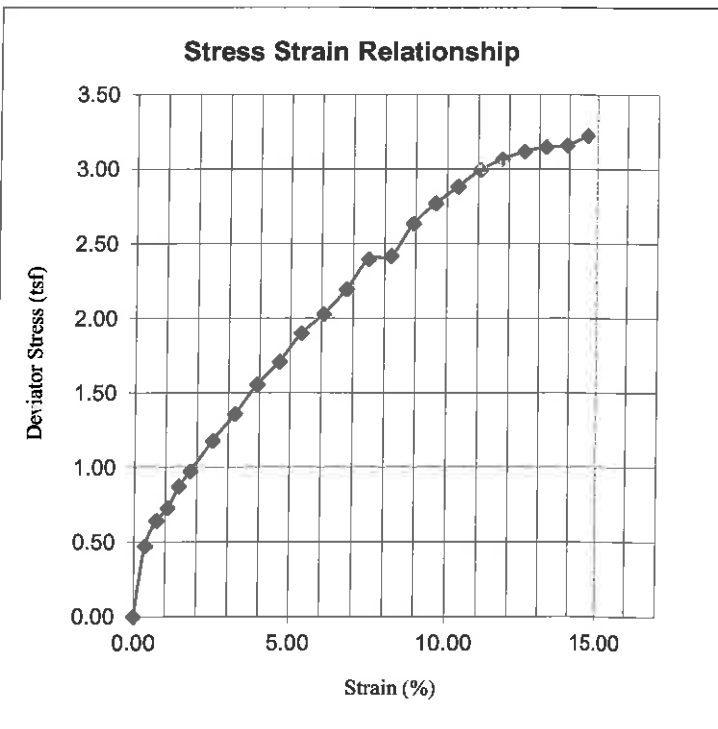
Unconsolidated-Undrained Triaxial Compression Test - Q-test

Project Name IL 15 over Richland Creek Tested By AdJ 7-18-17
 Project No. 20175035.00 Checked By _____
 Boring No. TH-2 Sample No. ST-8-2 Depth 18.5-19.0

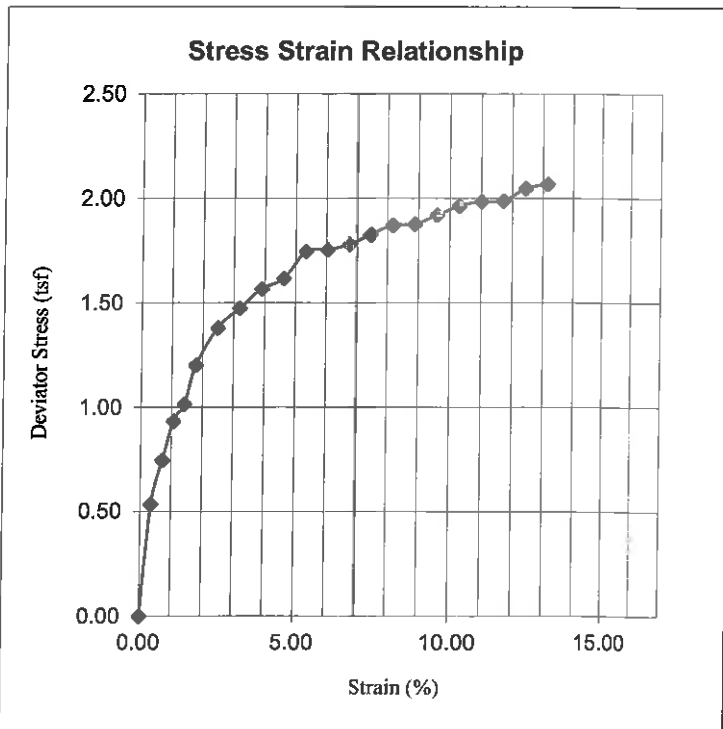
Unconsolidated-Undrained Triaxial Compression Test - Q-test

Project Name Il 15 over Richland Creek Tested By AdJ 7-19-17
 Project No. 20175035.00 Checked By _____
 Boring No. TH-2 Sample No. ST-10-3 Depth 24.0-24.5
 Soil Description Gray, lean CLAY (CL)
