**PROPOSED
HIGHWAY PLANS**

FAS ROUTE 944 (U.S. 60/62)
SECTION (138D-BR) P-1
ALEXANDER COUNTY, ILLINOIS
MISSISSIPPI COUNTY, MISSOURI
C-99-002-06

IMPROVEMENT LOCATION
STRUCTURE 002-0005
PAINT STRUCTURAL STEEL
AT SPECIFIED LOCATIONS

BRIDGE NO. 1
 STRUCTURE 002-0005
 FOR INFORMATION ONLY

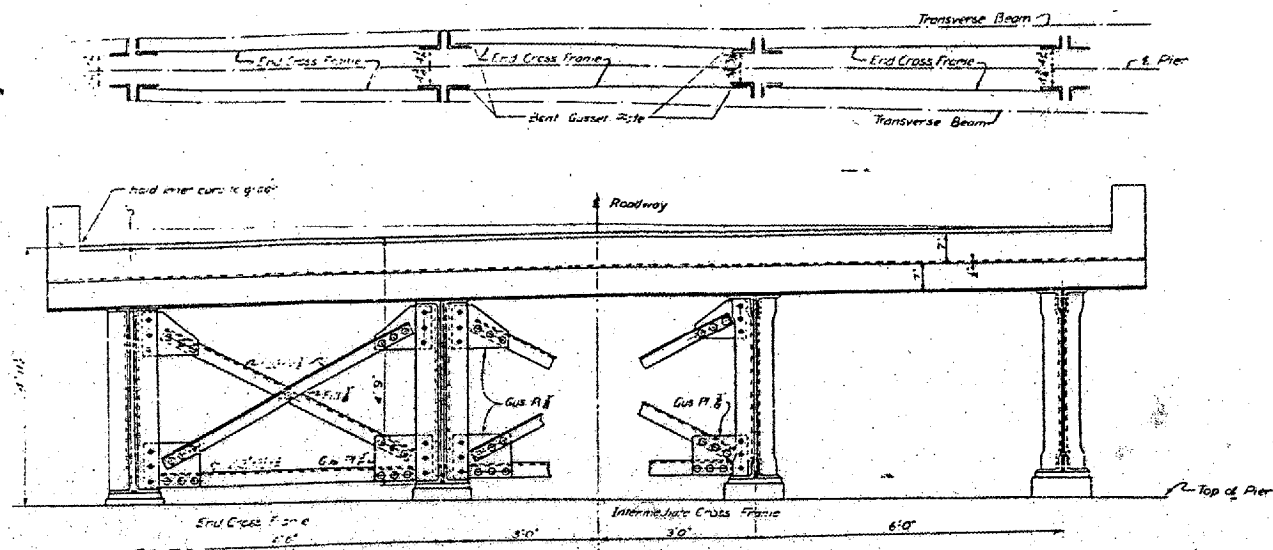
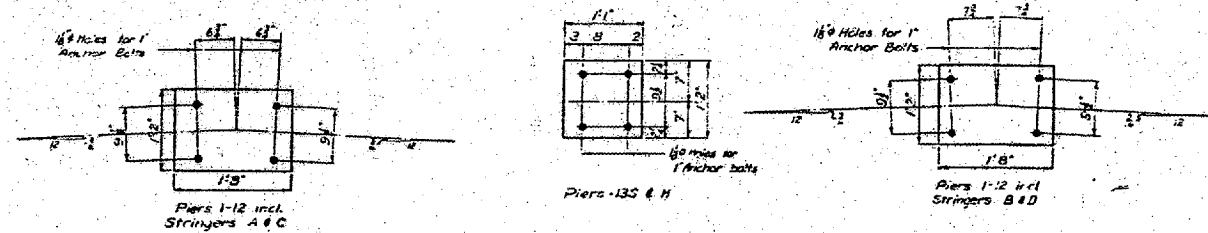
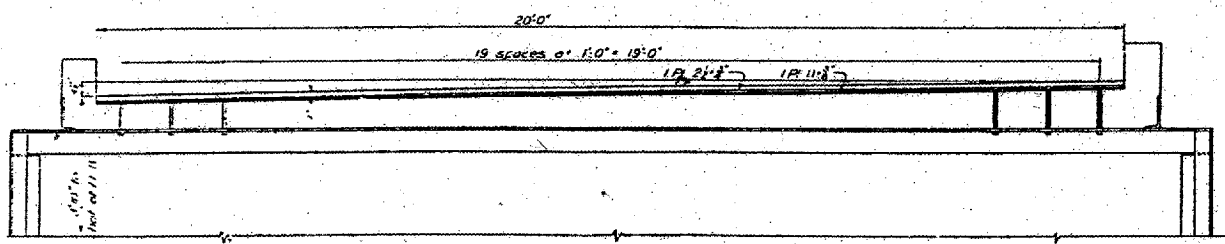
THE CAIRO BRIDGE AND TERMINAL COMPANY
 MISSISSIPPI RIVER BRIDGE AT CAIRO, ILLINOIS
 MISSOURI APPROACH DETAILS
 SCALE 1"=10'
 WADDELL & PARDEE'S ENGINEERS
 NEW YORK CITY
 AUGUST 19, 1927
 SHEET NO. 22

SECTIONS AT PIERS H-125, INC.

The transition from the curved roadway surface to the flat super-elevated surface of the Mass. approach will occur in the end panel of the Mass. bridge (0+02). Sealed fits as given below will be placed under the transverse beams of stringers C and D. Adjustments not provided for by these fits will be made in the thickness of the slab.

SECTION AT END FLOOR BEAM - PIER H

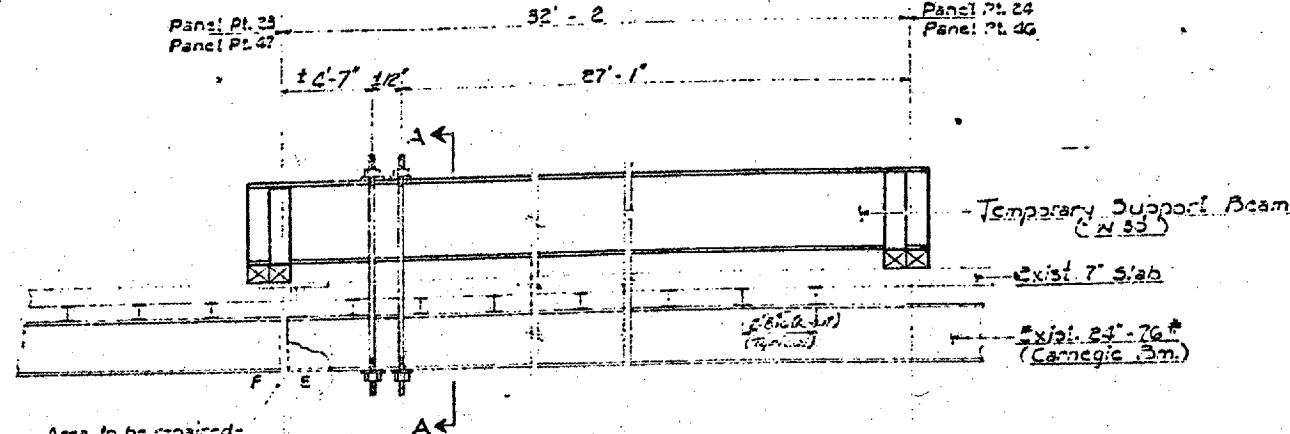
TEMPORARY SUPPORT

Area to be repaired:
Saddle detail not
shown.

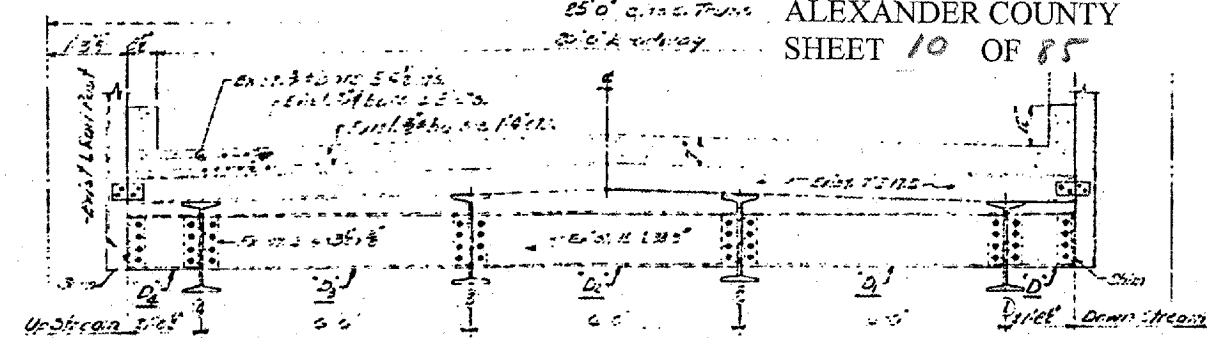
CROSS SECTION
(Looking North)

NOTE: For location of diaphragms see sheet No. 1 and for size TABLE 1.

Ball plate shall be 3/8" x 6" x 6" and shall be welded to the diaphragm at locations as indicated by the E's.

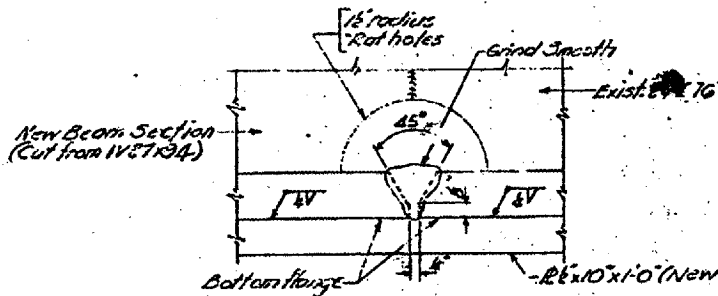
DETAIL A

Welding shall be in accordance with the Specifications for Welded Highway and Railway Bridge, D.2.0-63, AWS

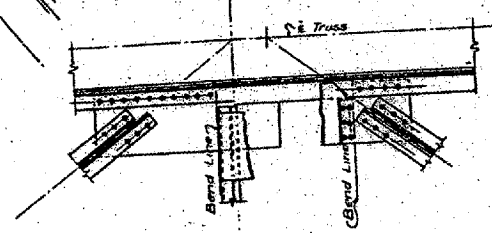
PORTALS AT U40, L40, U42, L42, U44, L44

Note: Details not shown are similar to those in portal at U16, except for the 12, 13 and the plates in the diagonals and vertical and horizontal struts. Use S.L. 24-31-2 (6) and Te. Ph. 15-3 (10).

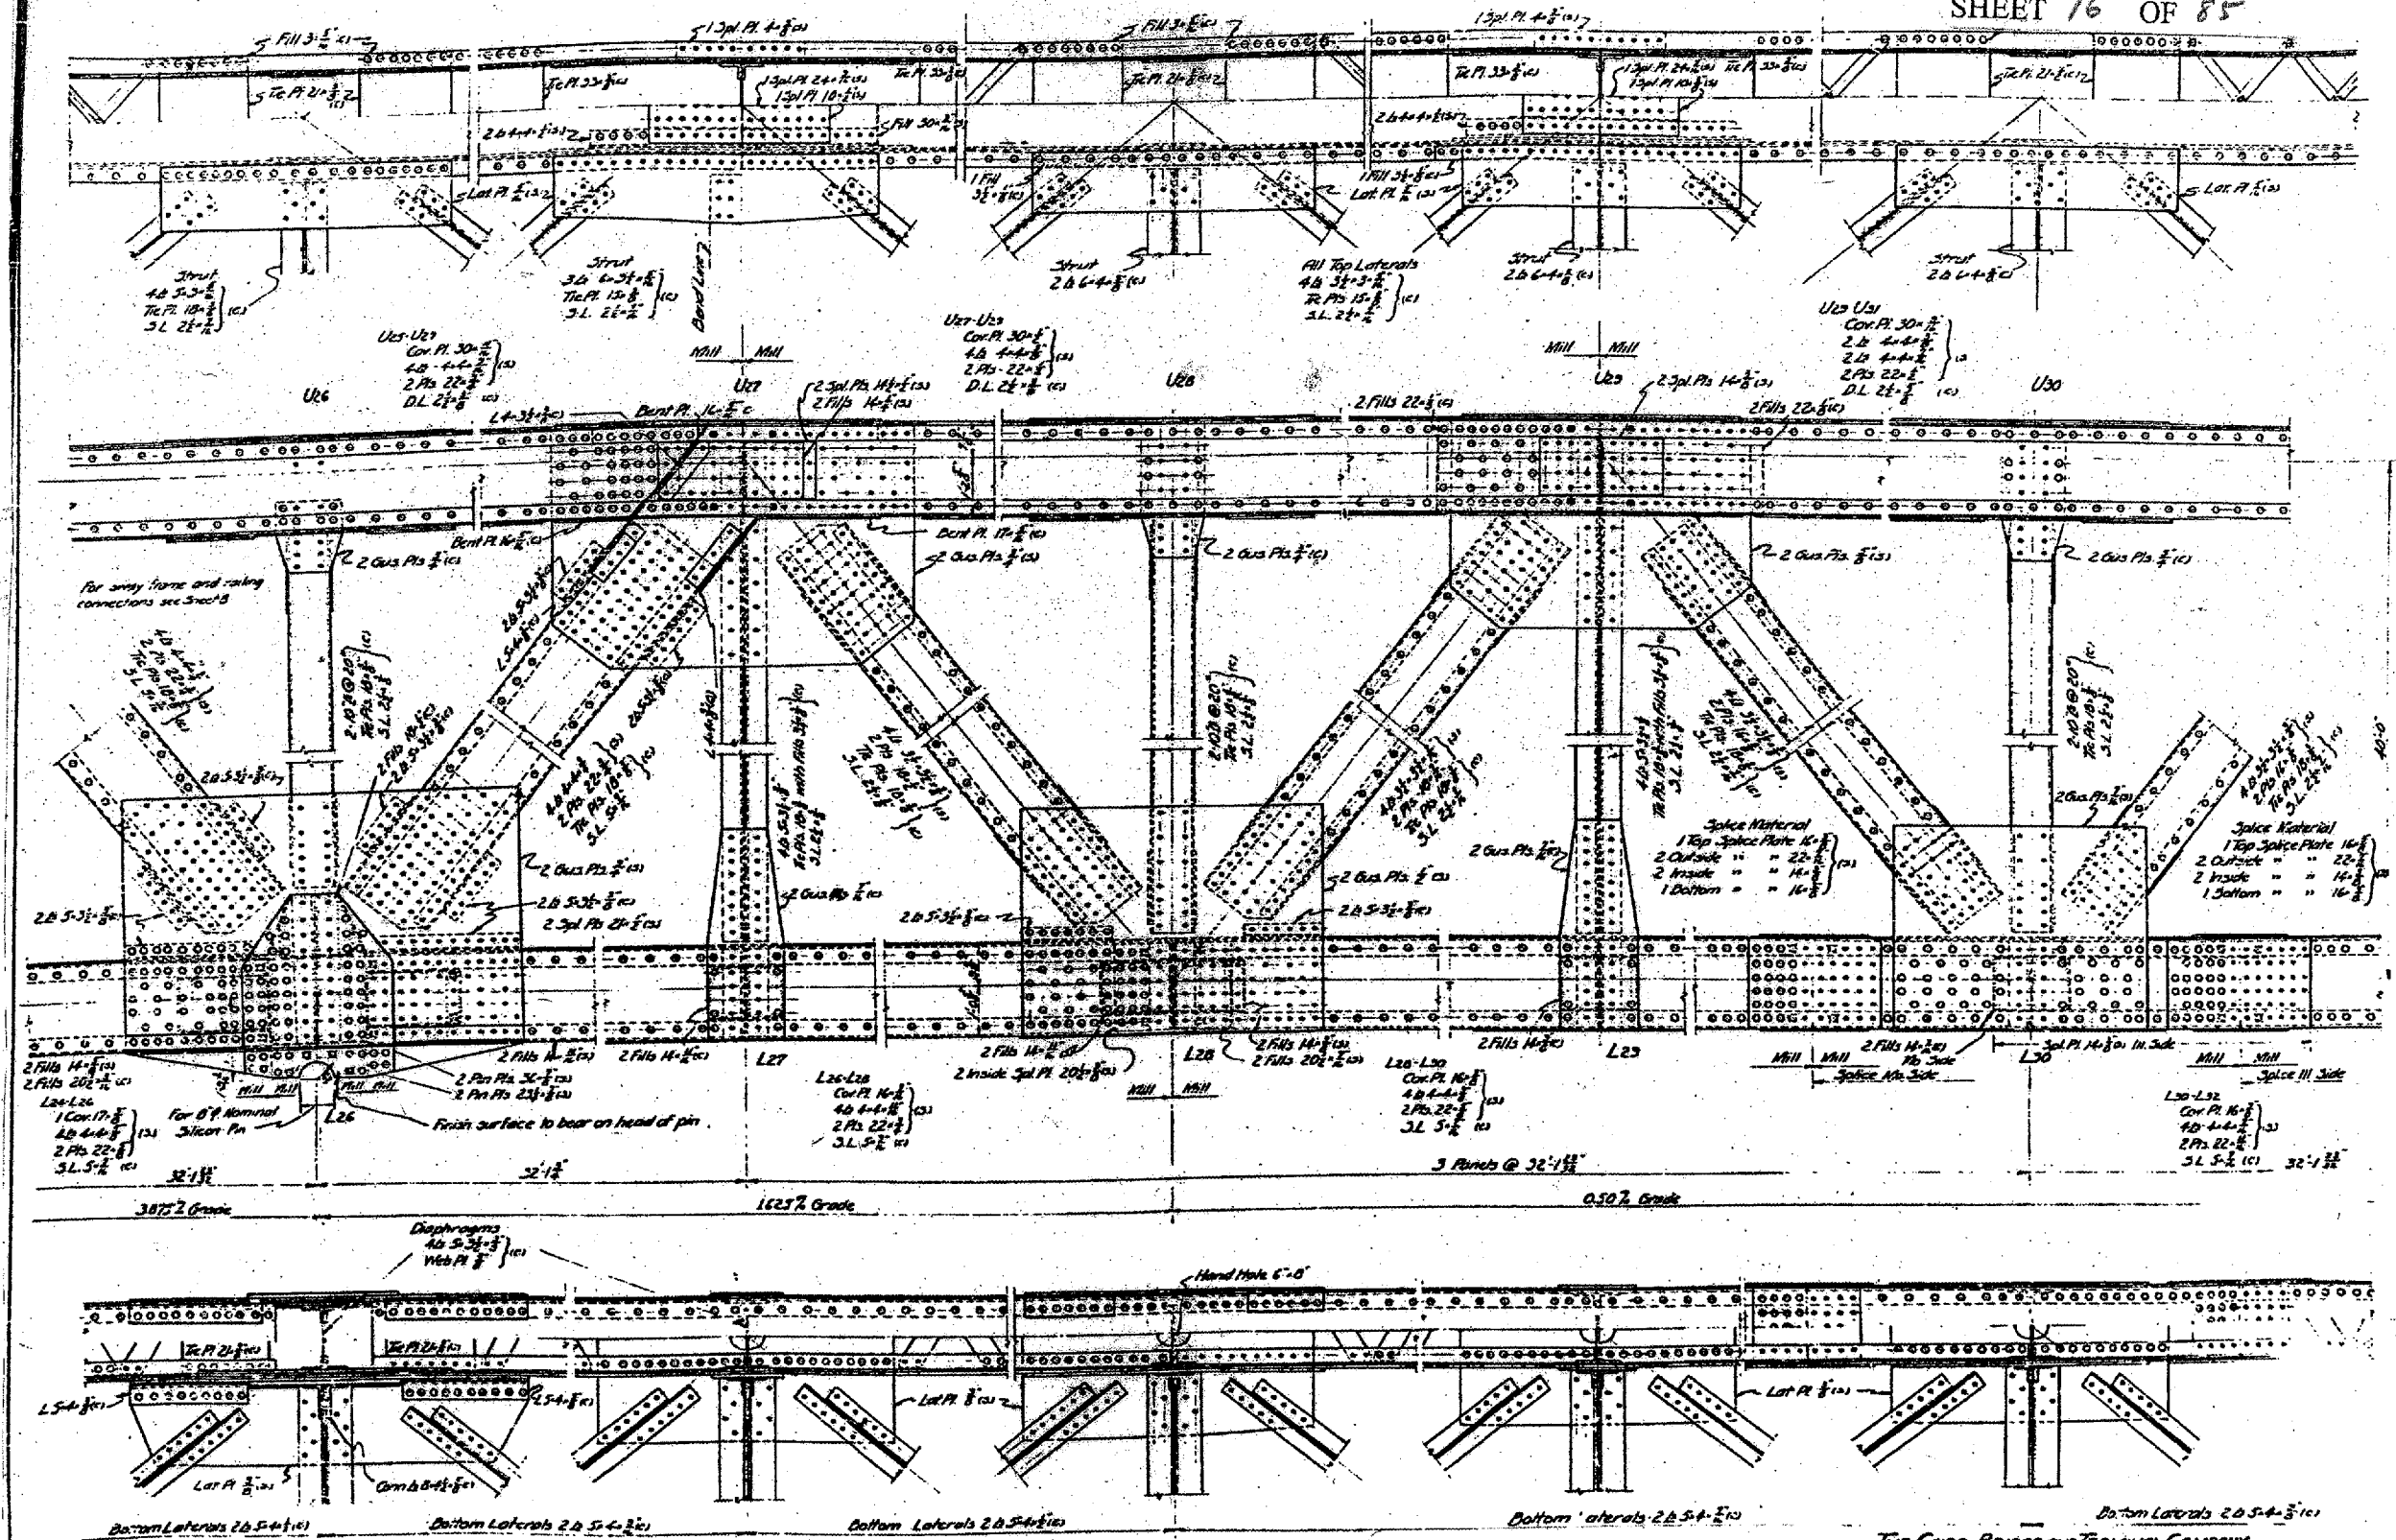
THE CAIRO BRIDGE AND TERMINAL COMPANY
 MISSISSIPPI RIVER BRIDGE AT CAIRO, ILLINOIS
 450 FOOT ANCHOR ARM
 Scale 3/4" = 1'
 WADDELL AND HARDESTY CONSULTING ENGINEERS
 NEW YORK CITY JULY 26, 1927

BRIDGE NO. 1
 STRUCTURE 002-0005
 FOR INFORMATION ONLY

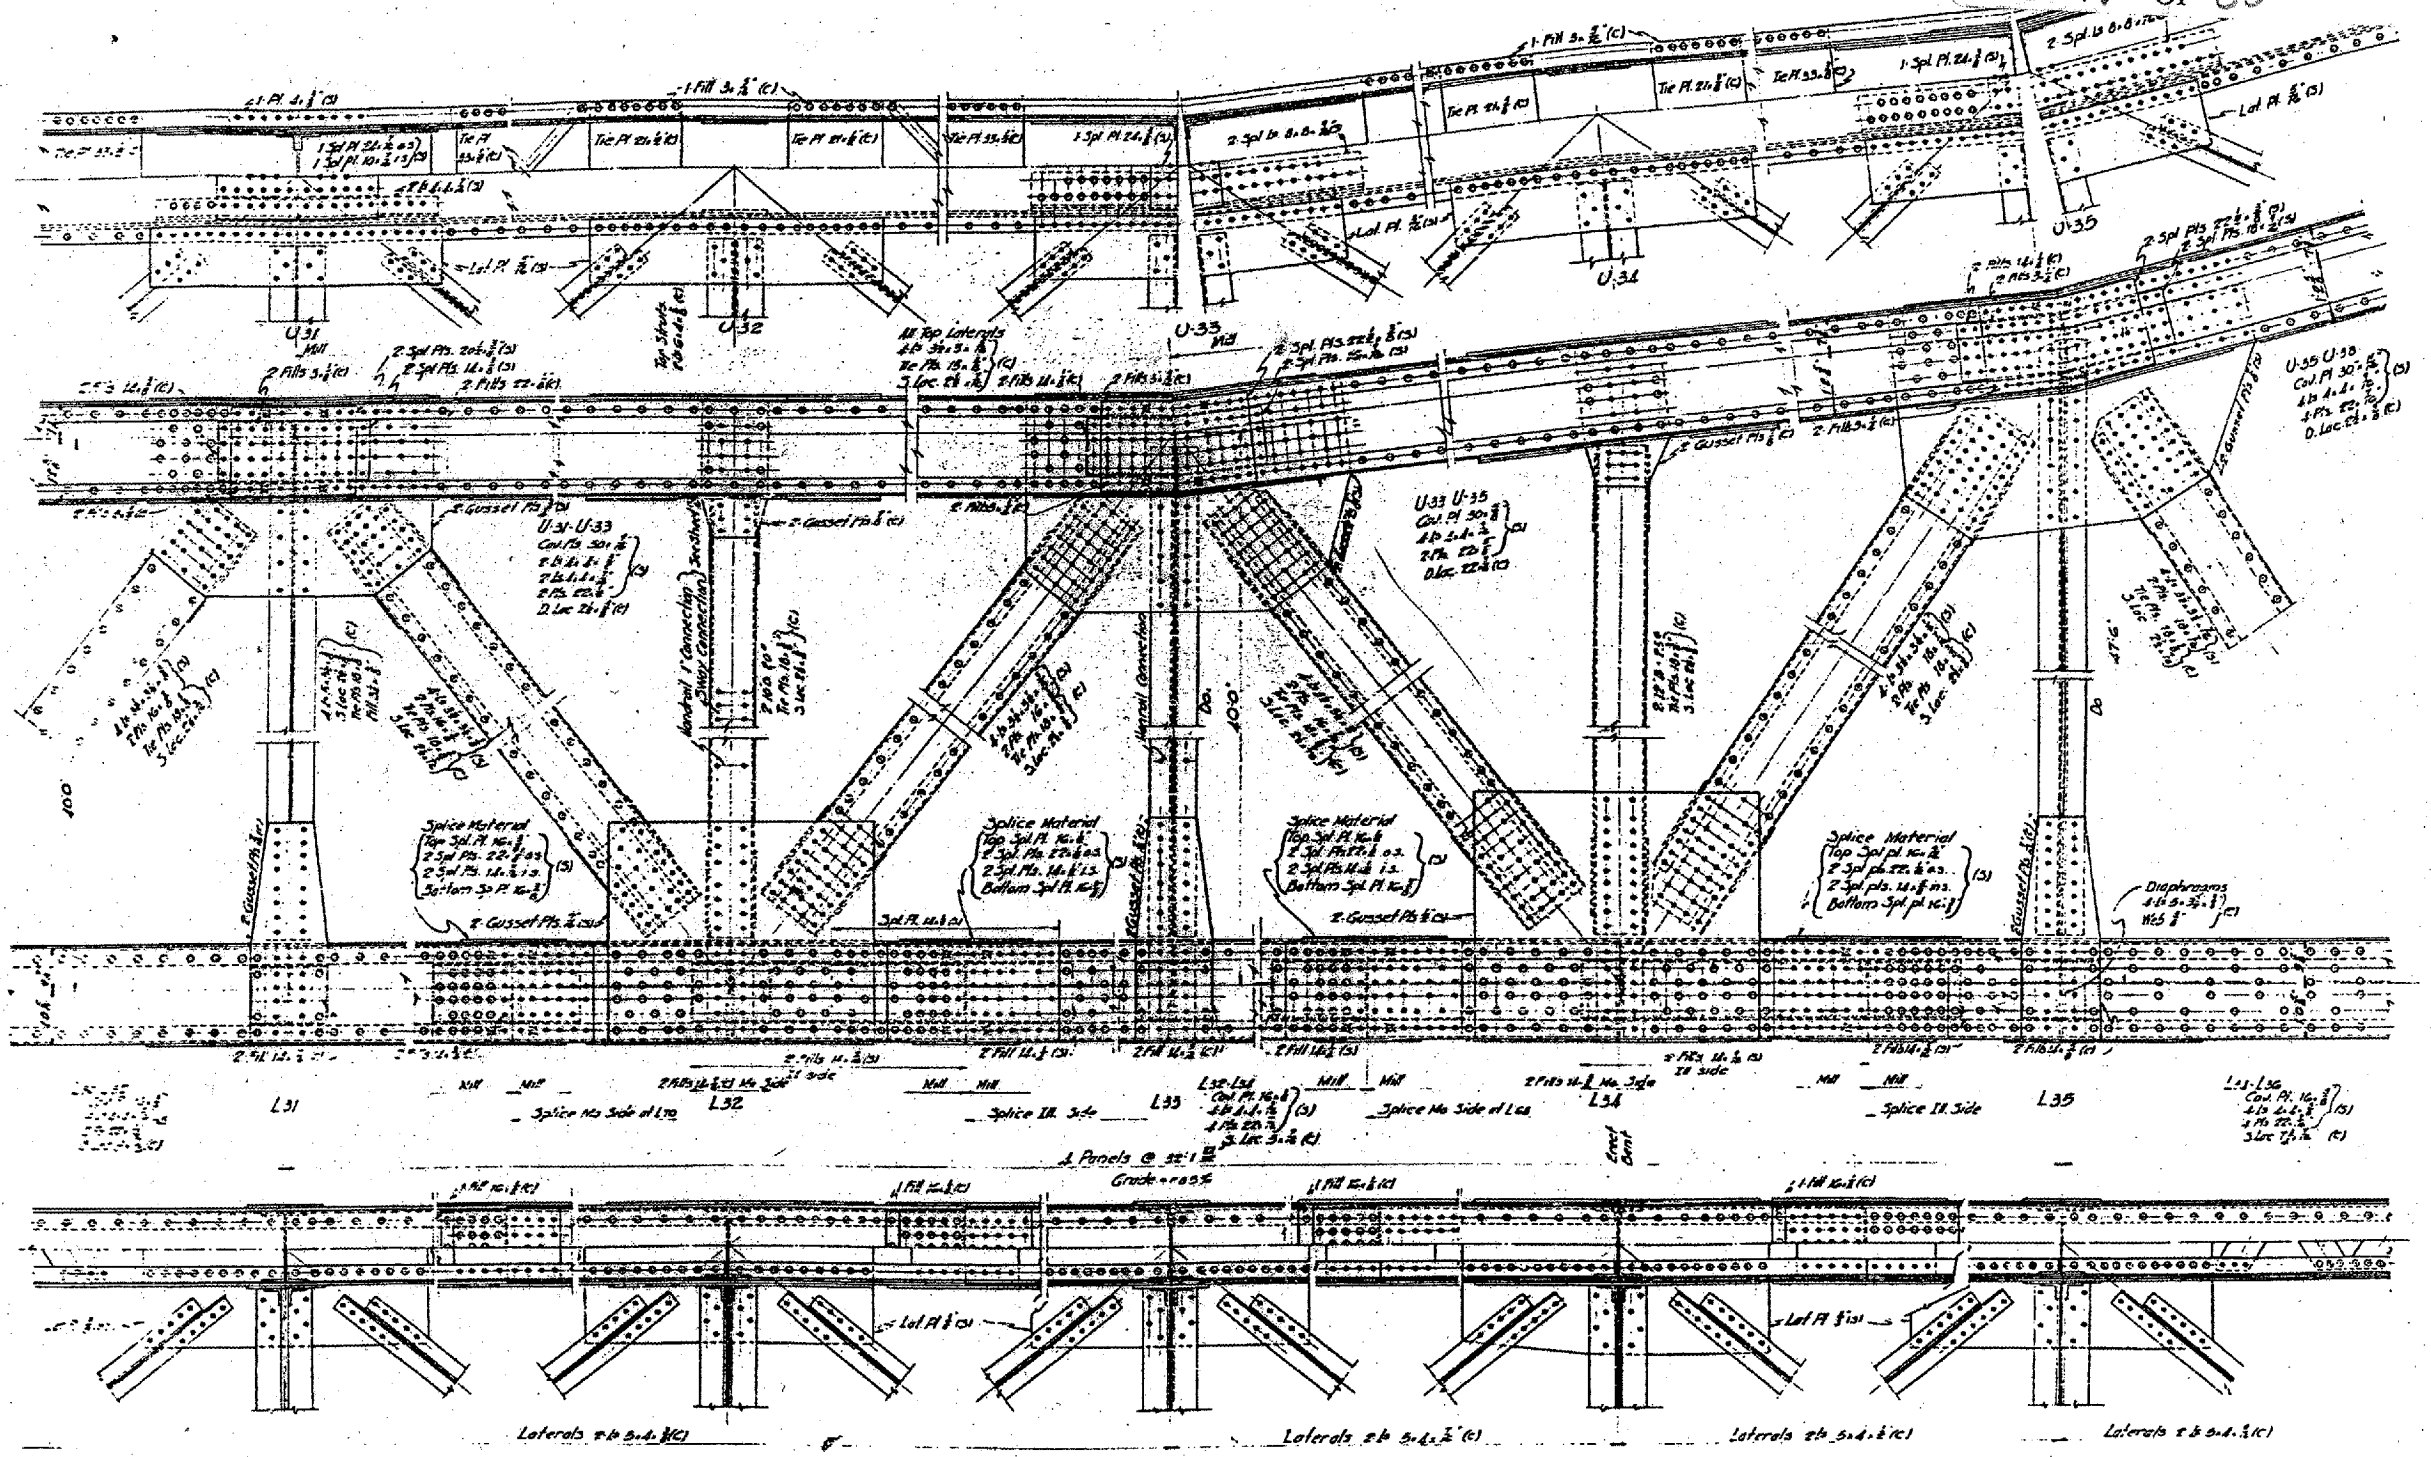
THE CAIRO BRIDGE AND TERMINAL COMPANY
 MISSISSIPPI RIVER BRIDGE AT CAIRO, ILLINOIS
 — 450' ANCHOR ARM —

BRIDGE NO. 1
 STRUCTURE 002-0005
 FOR INFORMATION ONLY

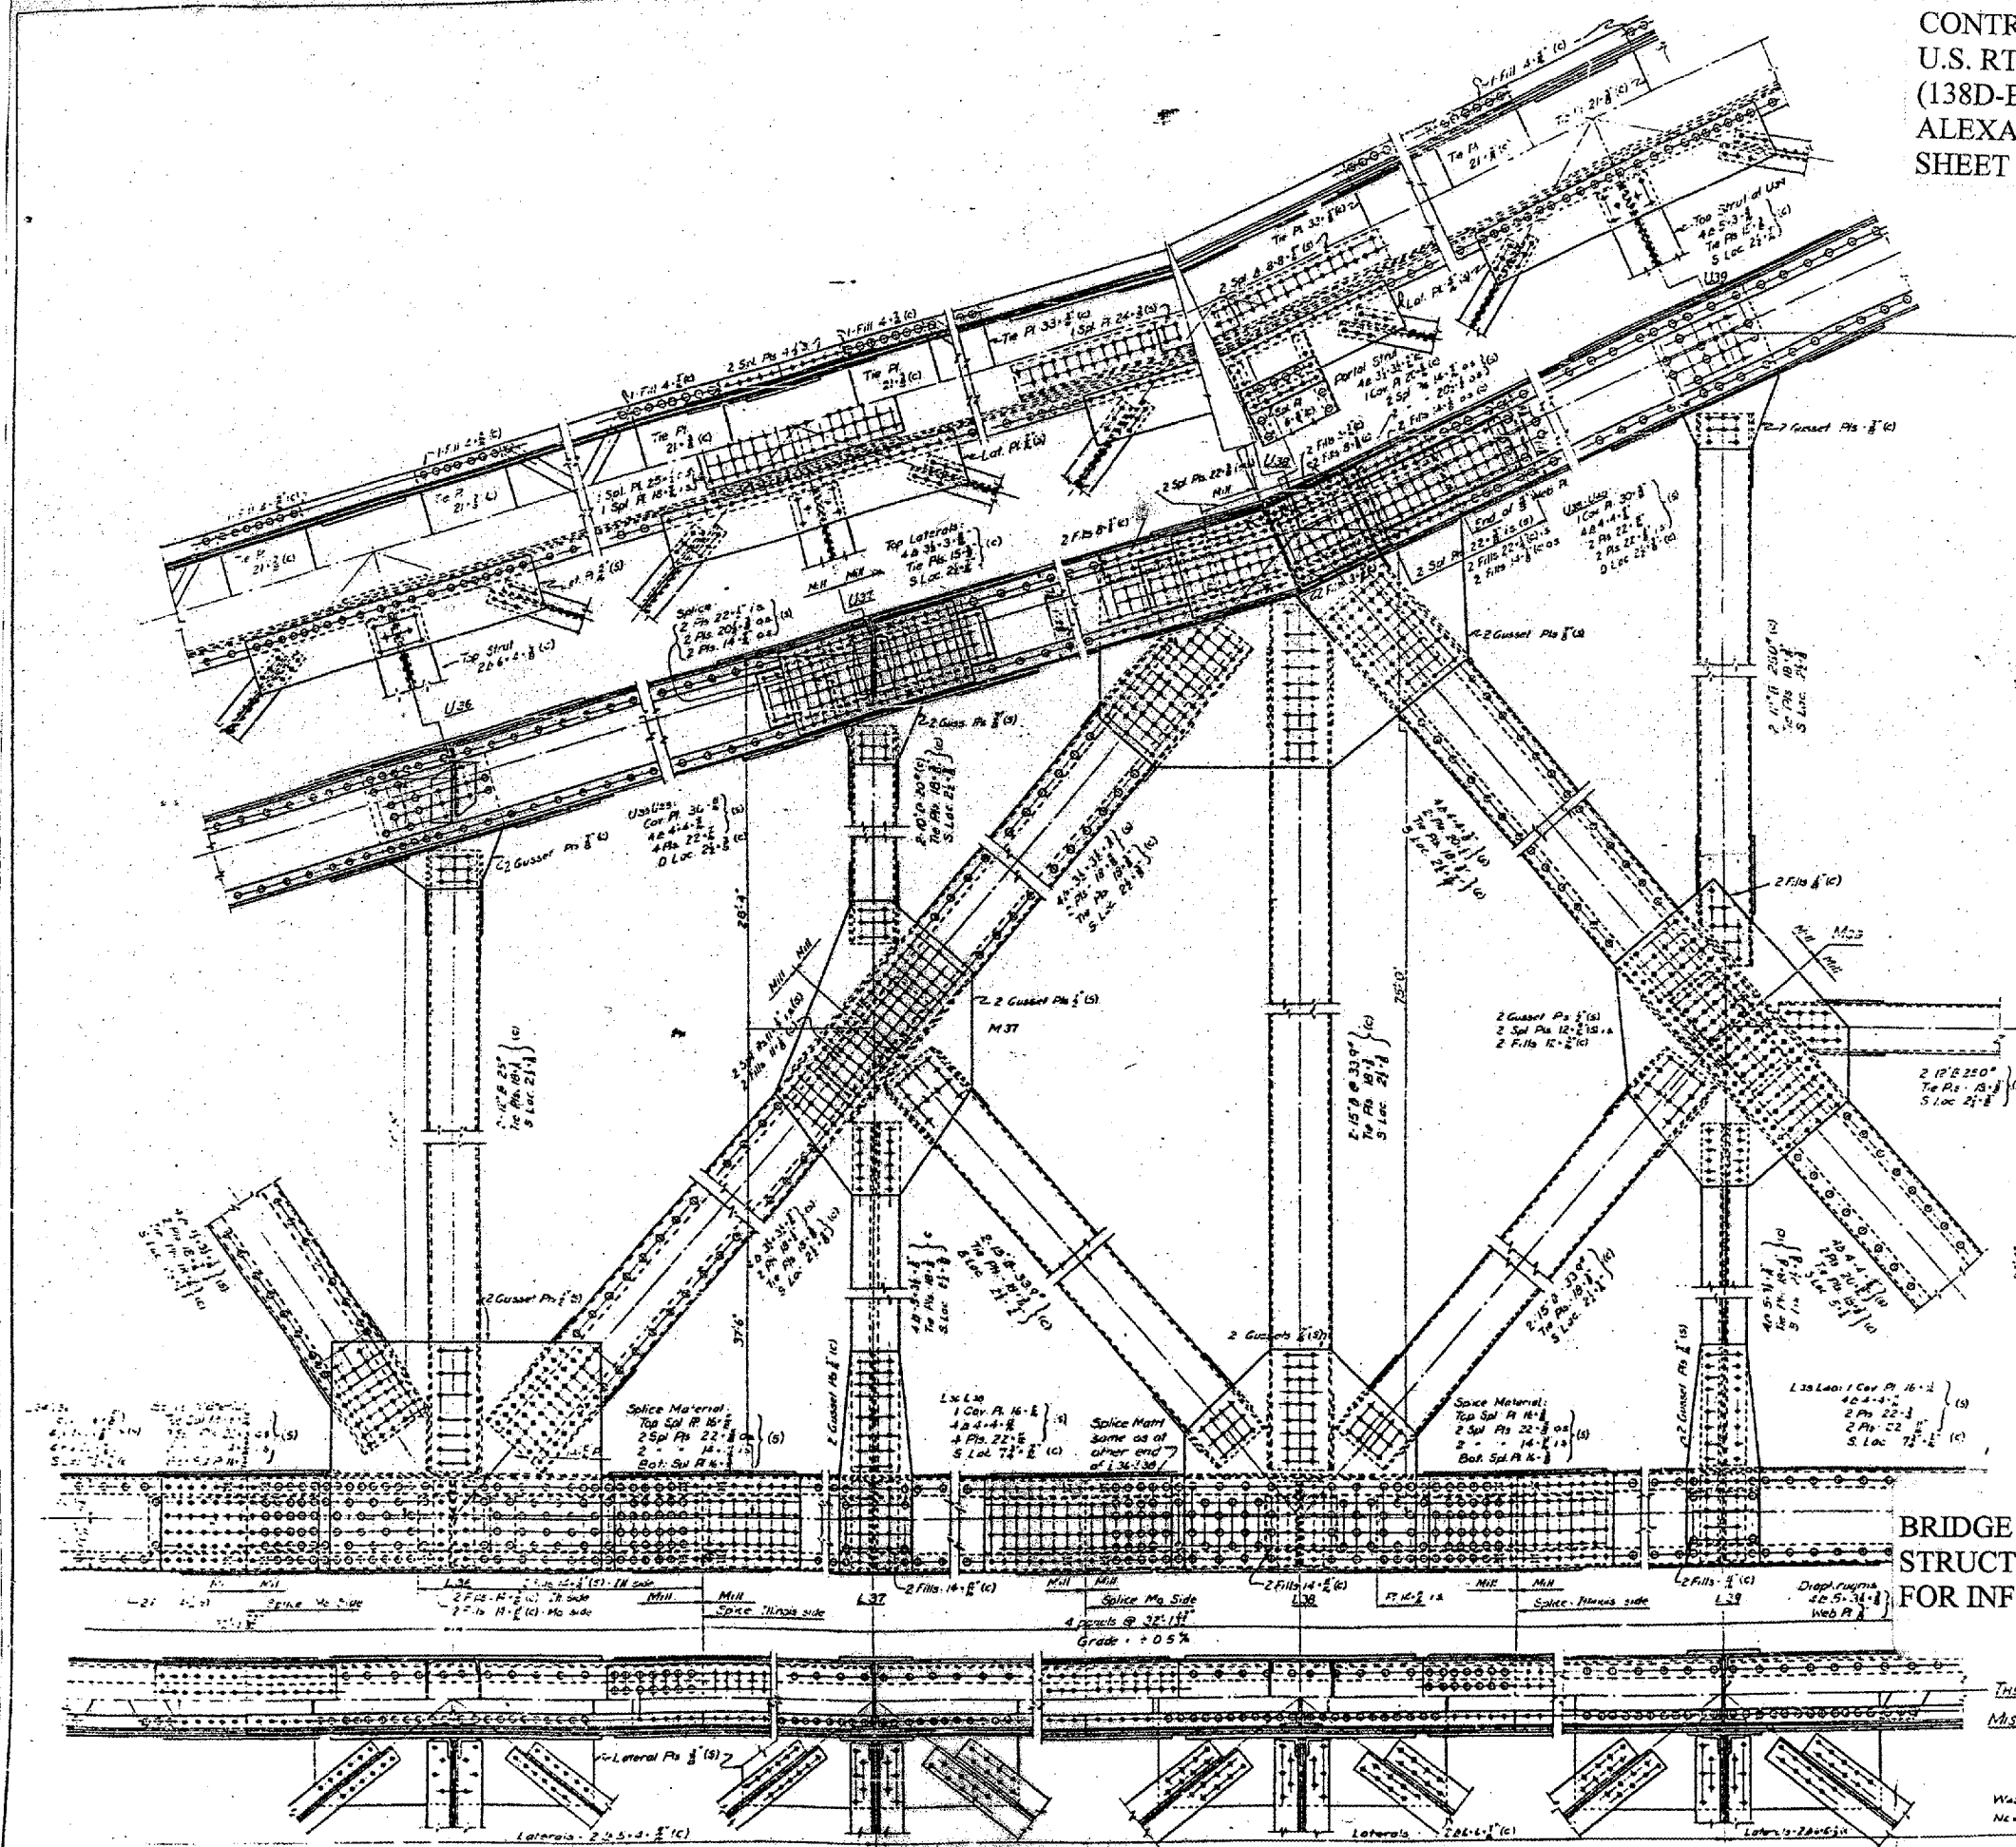
THE CAIRO BRIDGE AND TERMINAL COMPANY
 MISSISSIPPI RIVER BRIDGE AT CAIRO, ILLINOIS

— 450' ANCHOR ARM —

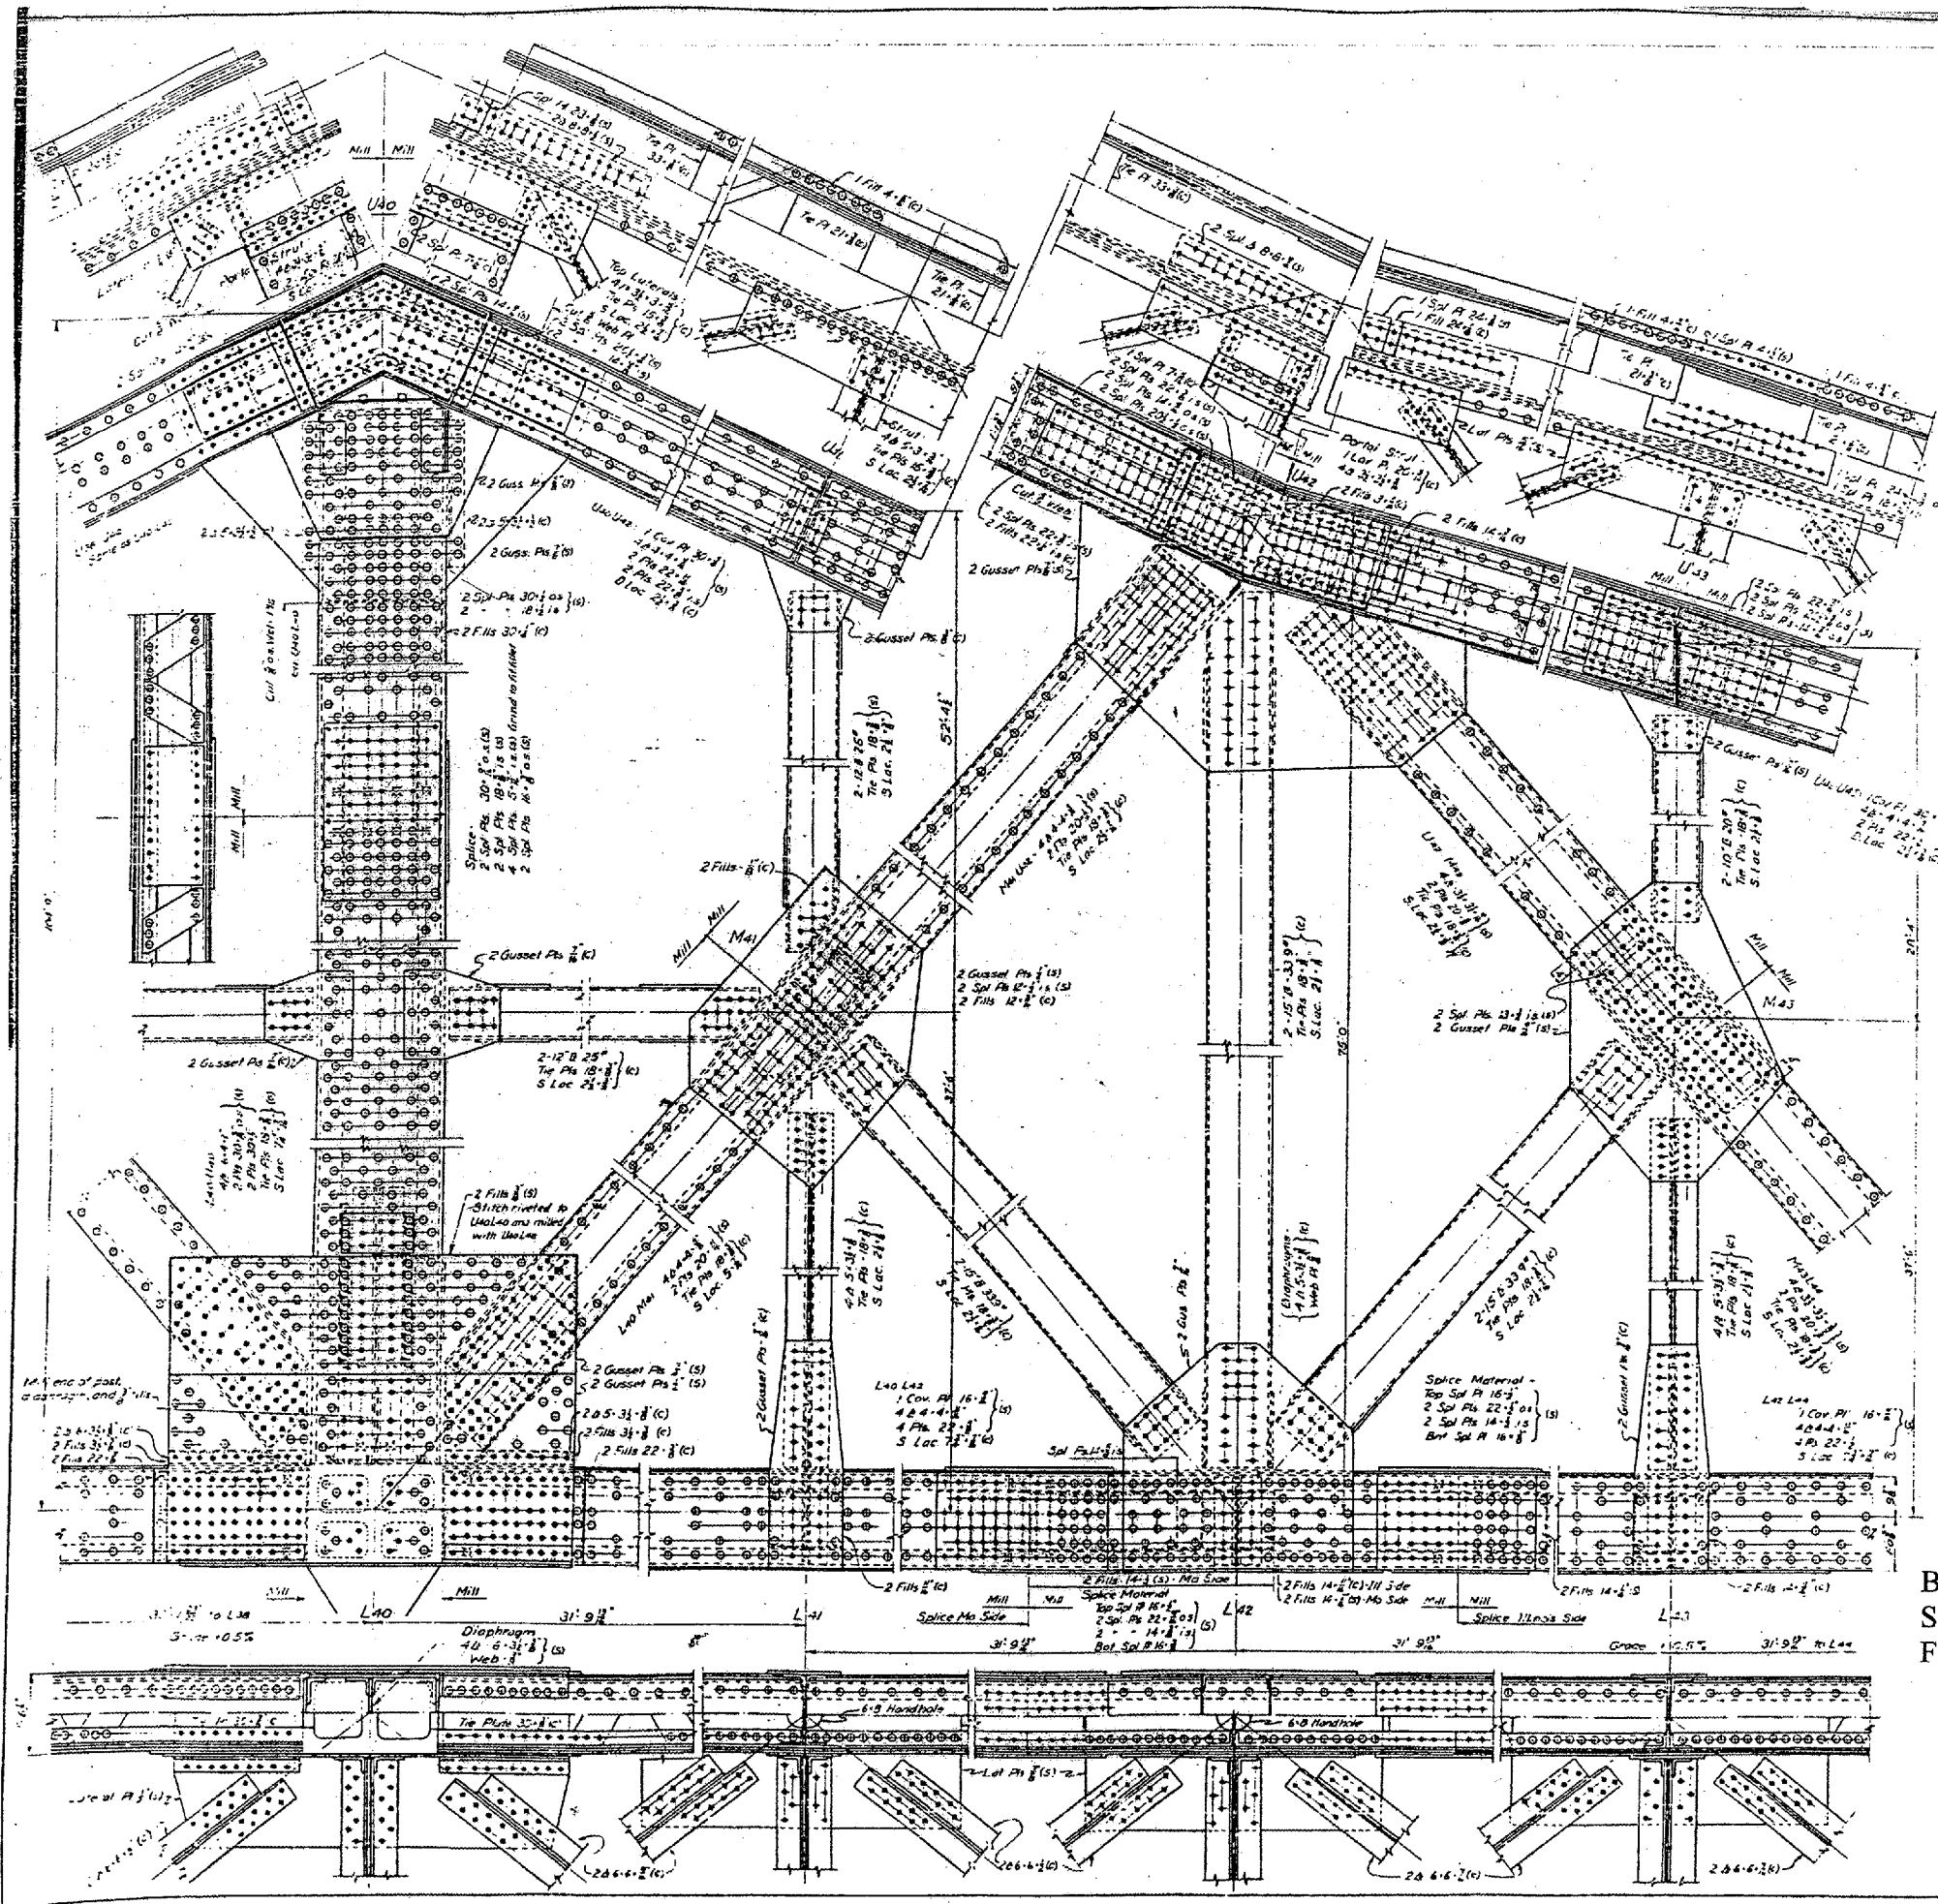
THE CHIRO BRIDGE AND TERMINAL COMPANY
 MISSISSIPPI RIVER BRIDGE AT CHIRO, ILLINOIS

— 700 FT. CHANNEL SPAN TRUSSE —

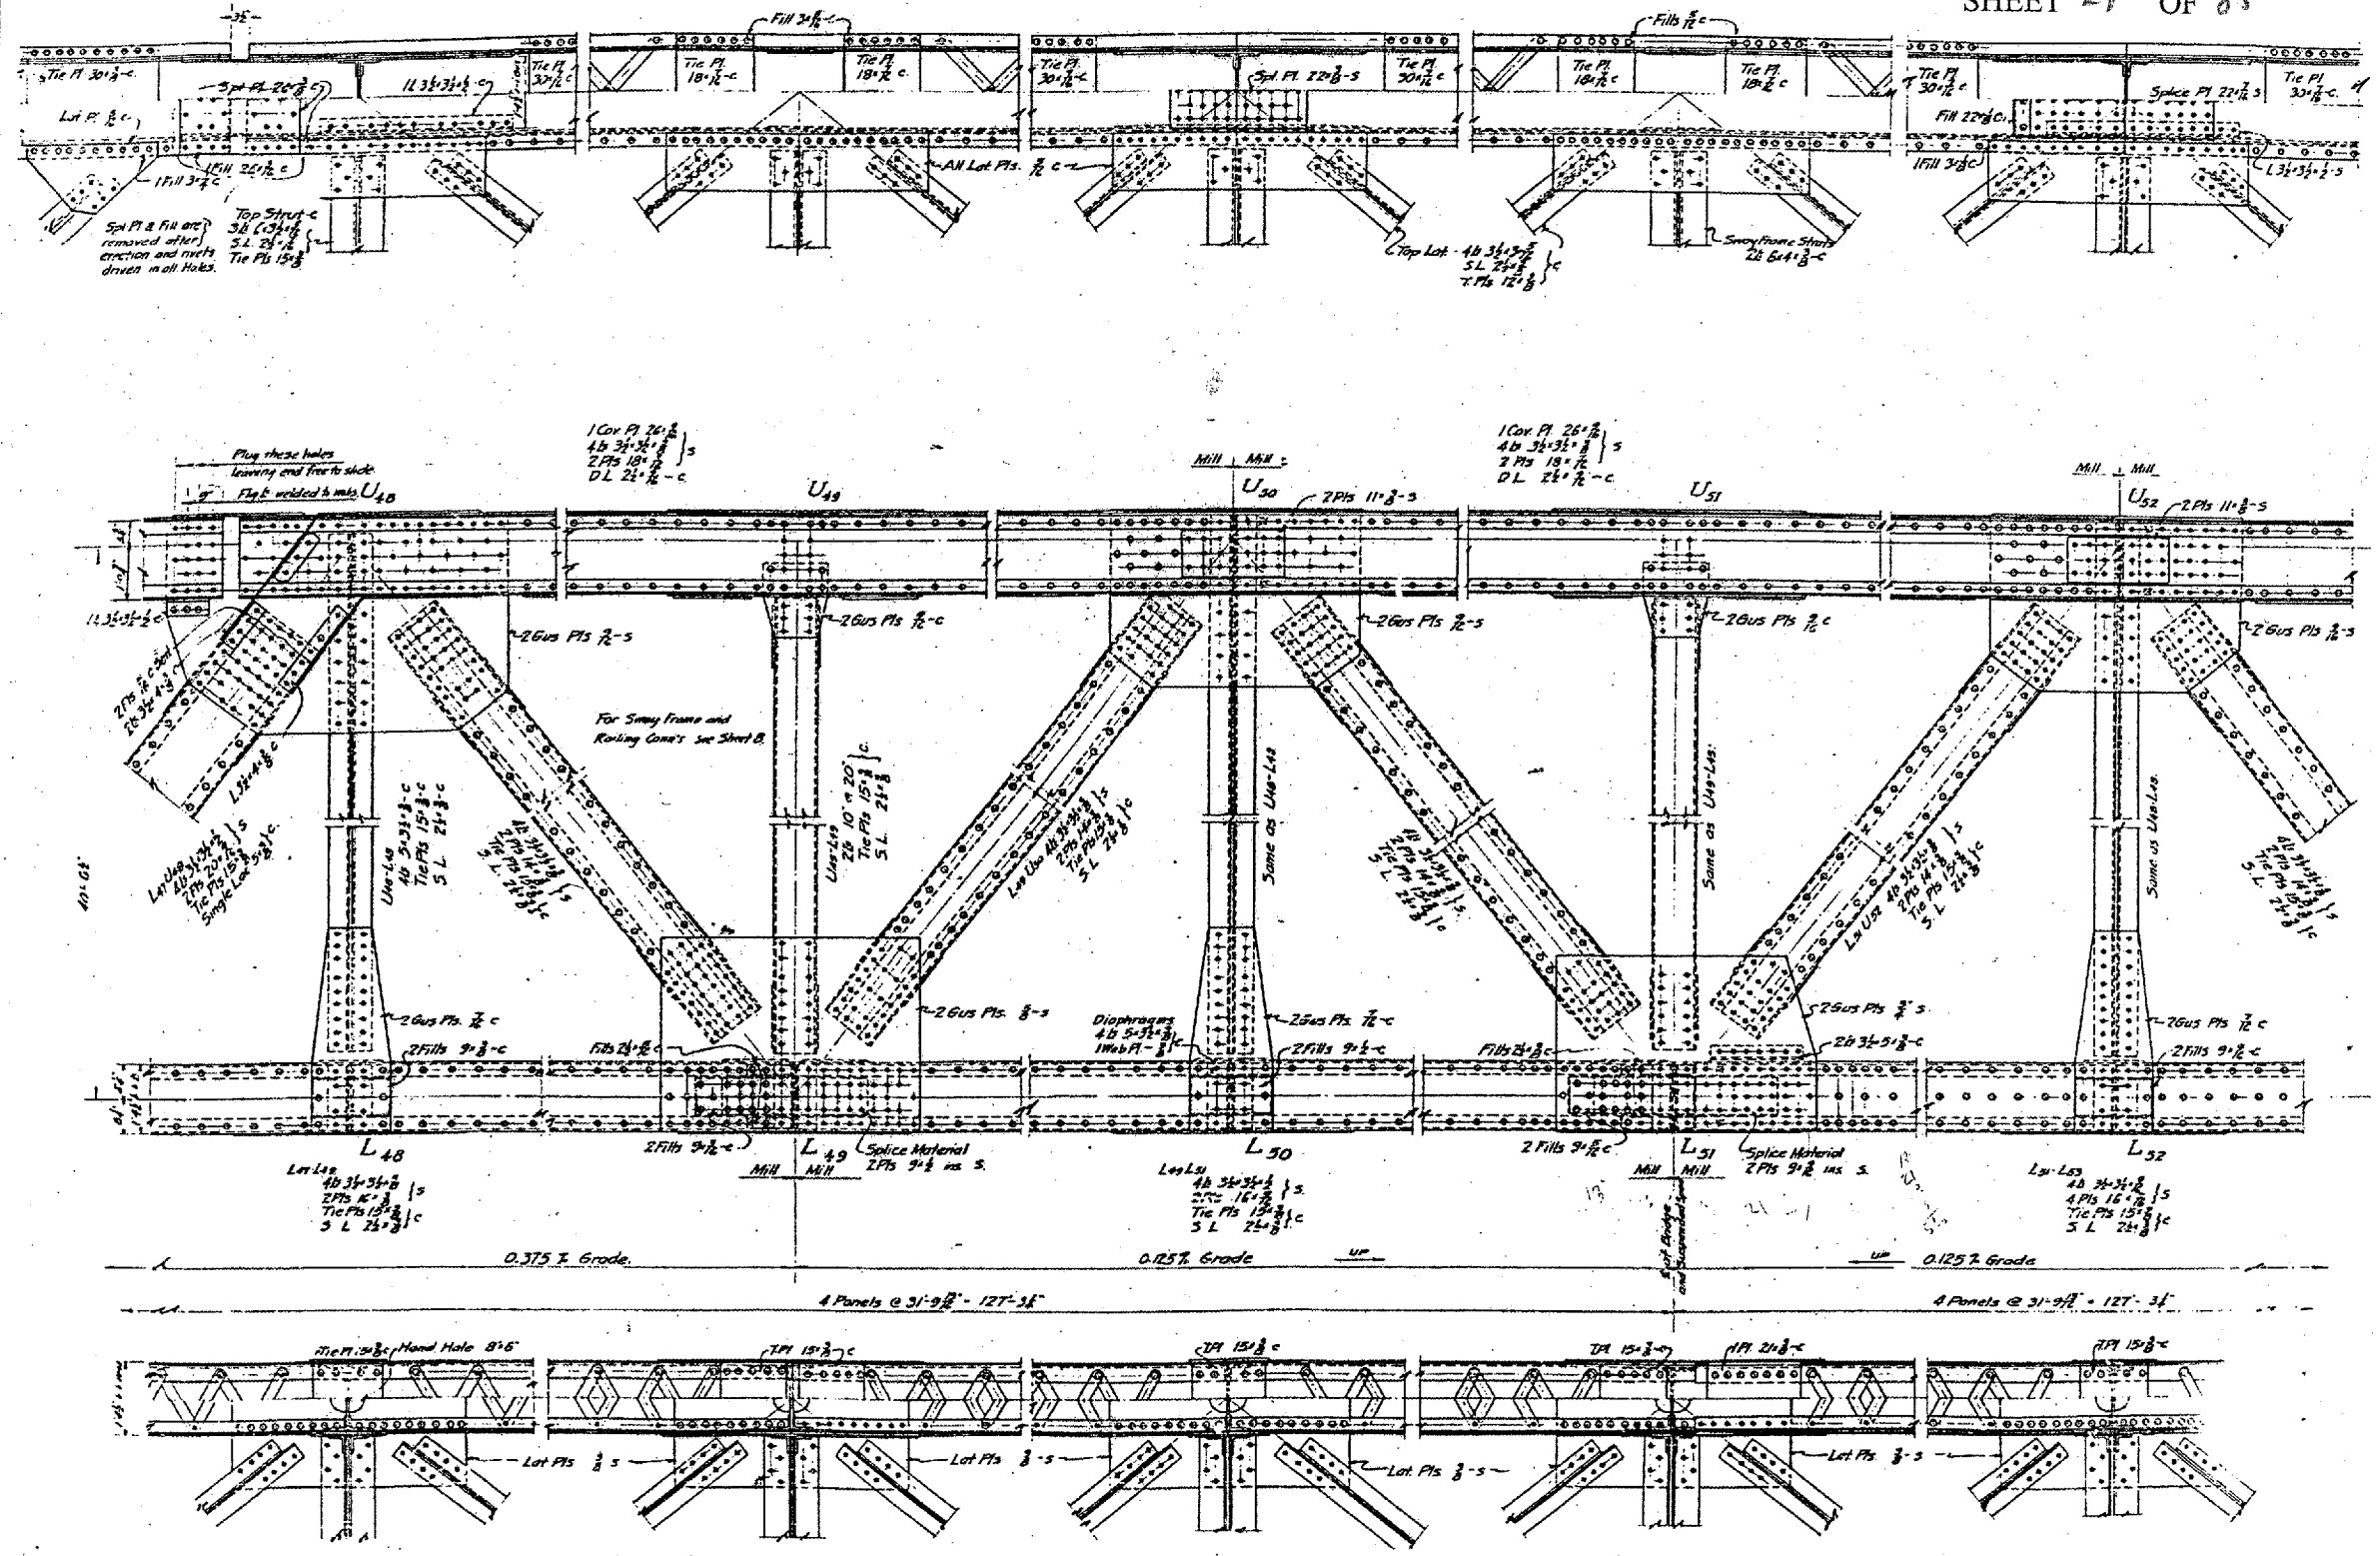
THE CAIRO BRIDGE AND TERMINAL COMPANY
 MISSISSIPPI RIVER BRIDGE AT CAIRO, ILLINOIS
 254 FT 6 1/2 IN SUSPENDED SPAN
 SCALE 3/4" = 1'-0"
 WADDELL AND HARDESTY CONSULTING ENGINEERS
 NEW YORK CITY AUGUST 16, 1927

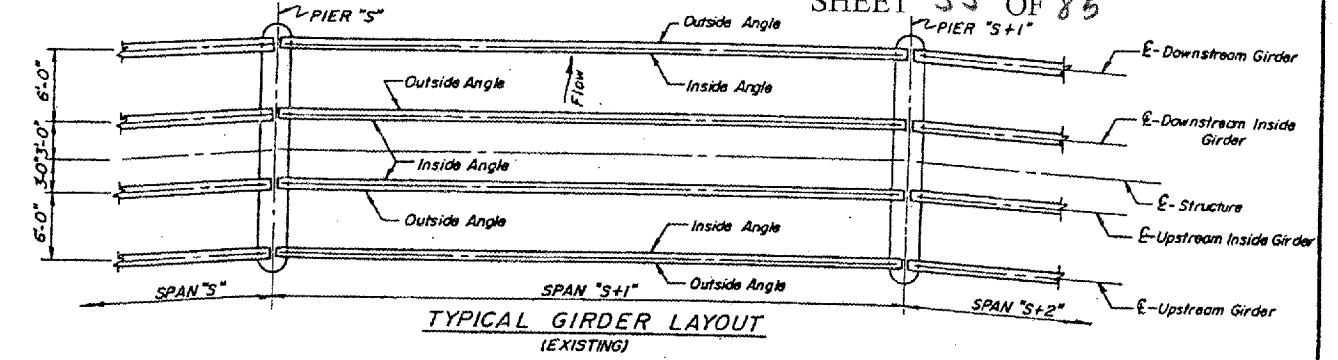
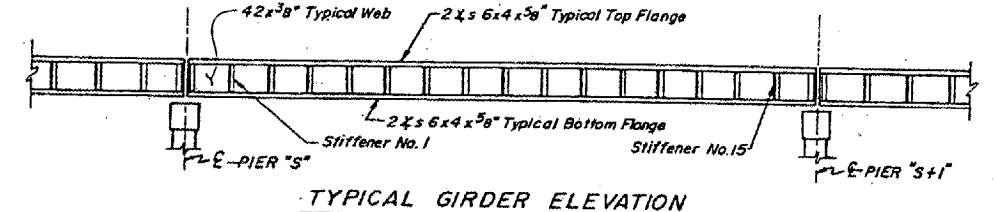
Note: All Stiffeners Are Numbered From The North End Of The Girders

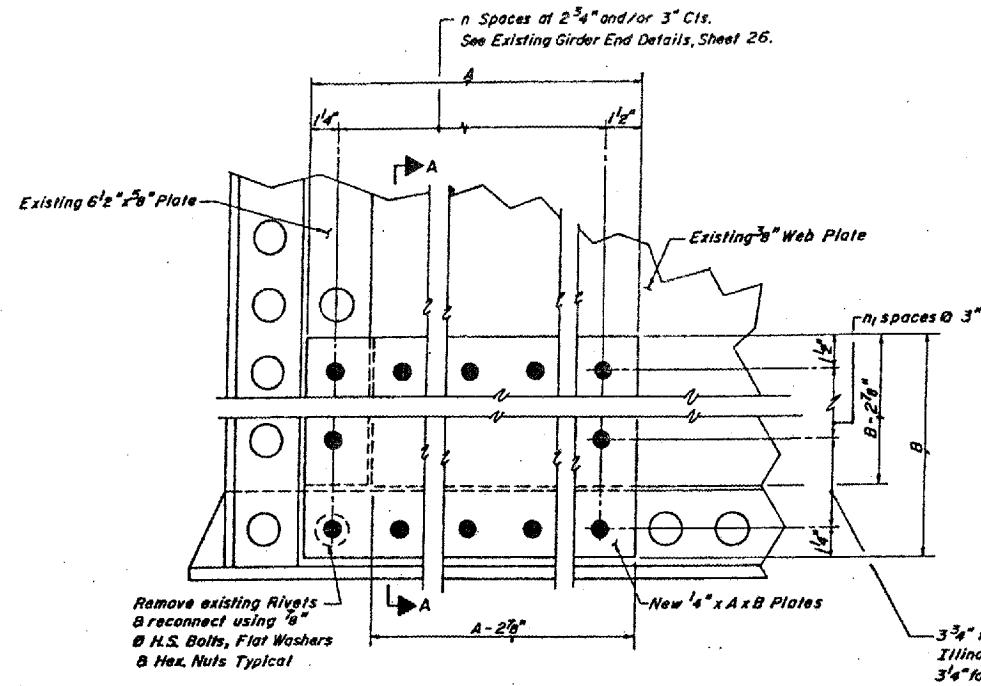
GIRDER WEB REPAIR TYPE "A"
DETAIL "1"
