**PROPOSED
HIGHWAY PLANS**

FAS ROUTE 944 (U.S. 60/62)
SECTION (138D-BR) P-1
ALEXANDER COUNTY, ILLINOIS
MISSISSIPPI COUNTY, MISSOURI
C-99-002-06

IMPROVEMENT LOCATION
STRUCTURE 002-0005
PAINT STRUCTURAL STEEL
AT SPECIFIED LOCATIONS

BRIDGE NO. 1
 STRUCTURE 002-0005
 FOR INFORMATION ONLY

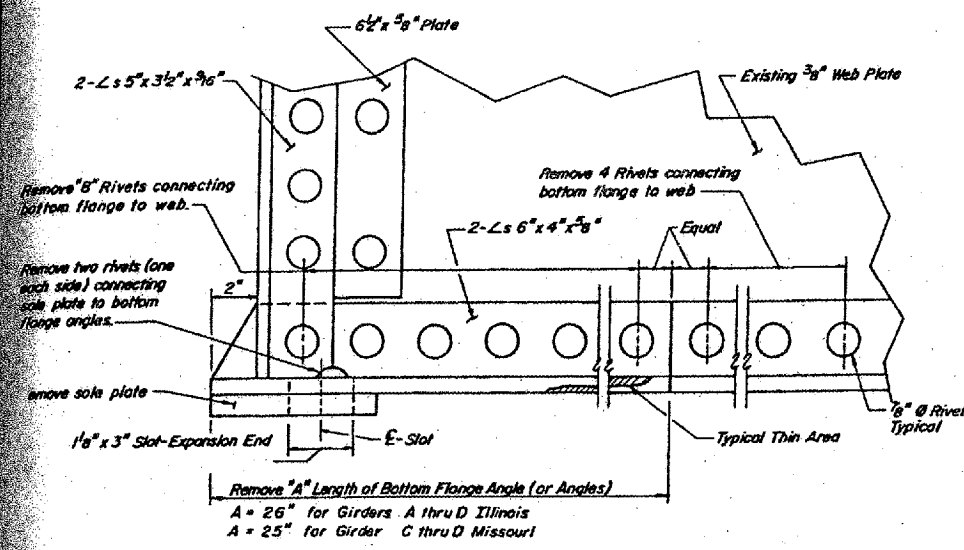
ELEVATION
EXISTING

GIRDER EXPANSION END FLANGE REMOVAL AND REPLACEMENT DETAILS "3" & "4"

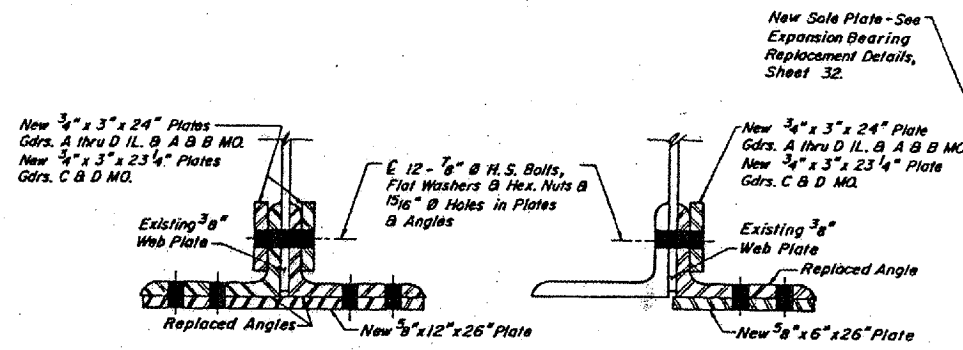
DETAIL-3
(BOTH SIDES)

DETAIL-4
(ONE SIDE)

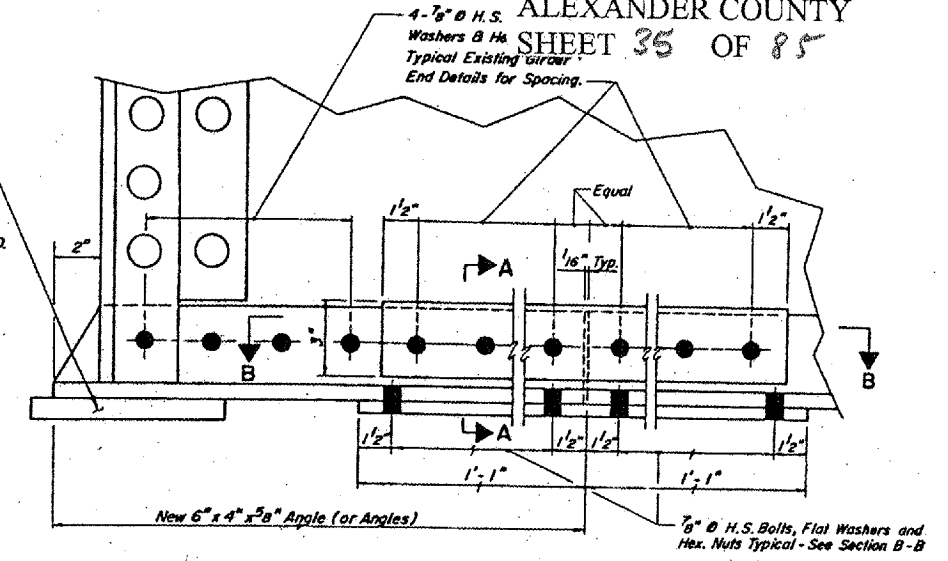
ELEVATION
REPAIRED

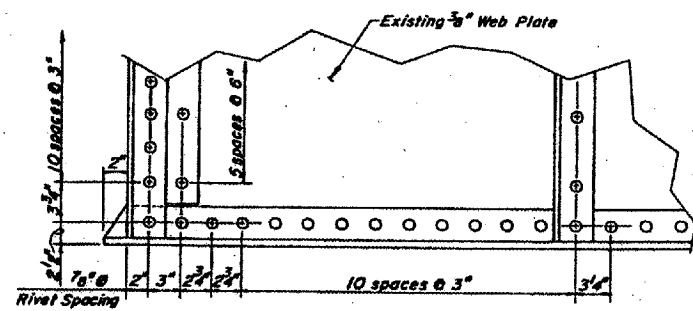
GIRDERS A-D ILL., A & B MO.

EXISTING GIRDERS - END DETAILS

New 3/4"x3"x24" Splice Plates:
Gdrs. A-D IL, Gdrs. A & B Mo.
New 3/4"x3"x23 1/4" Splice Plates:
Gdrs. C & D Mo.

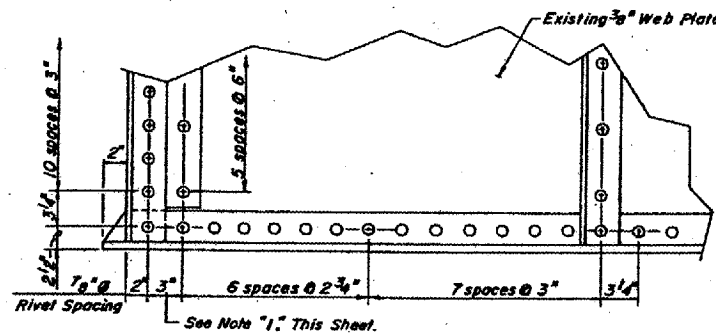
GIRDERS C & B MO.

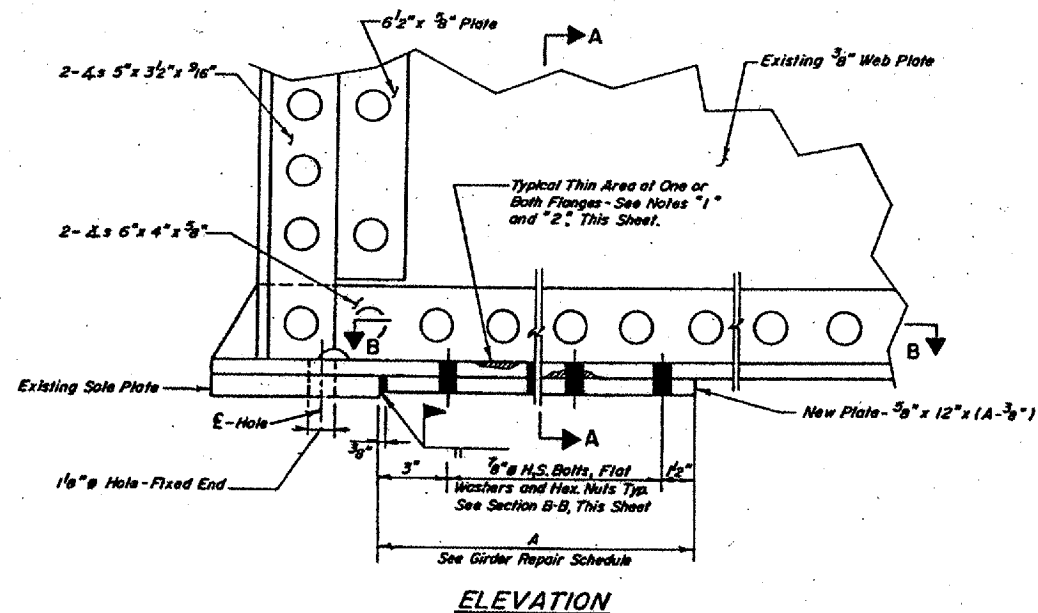
GIRDER FIXED END FLANGE REPAIR - DETAIL "6"

- NOTES:
- Contractor to clean the vicinity of the thin area and remove all rust, foreign material and all old paint down to the bare metal.
 - Filler plates of 3/8" minimum thickness shall be used at locations where connection bolts pass thru thin area of existing members.

Outside bottom flange angle has 1/8" to 3/8" loss at top between stiffener #1 and the end. For repair, see detail (27)	Outside bott. flange angle has 1/8" to 1/4" loss btwn. stiff. 4-5, 8-9 & 13-15, 1/8" to 1/4" loss btwn. stiff. 6-7 at top. See Note "3", This Sheet.	Inside top flange angle has 3/16" loss at top between stiffener #1 and the end. See Note "3", This Sheet.	Outside bott. flange angle has 1/8" loss at top between stiffener #1 and the end. See Note "3", This Sheet.								
14 N	14 N TO 13 N	Sole plate and inside bott. flange angle have pack rust in between them at Pier 13 N. See Note "2", This Sheet.	Sole plate and outside bott. flange angle have pack rust in between them at Pier 13 N. See Note "2", This Sheet.	Sole plate and inside bott. flange angle have pack rust in between them at Pier 13 N. See Note "2", This Sheet.	Sole plate and outside bott. flange angle have pack rust in between them at Pier 13 N. See Note "2", This Sheet.	Upstream - Inside Girder: A = 28 1/2" for Detail "6" N = 4	12 N	12 N TO 11 N	Sole plate and outside bott. flange angle have pack rust in between them at Pier 12 N. See Note "1", This Sheet.	Sole plate and outside bott. flange angle have pack rust in between them at Pier 12 N. See Note "1", This Sheet.	Sole plate and outside bott. flange angle have pack rust in between them at Pier 12 N. See Note "1", This Sheet.	Sole plate and outside bott. flange angle have pack rust in between them at Pier 12 N. See Note "1", This Sheet.

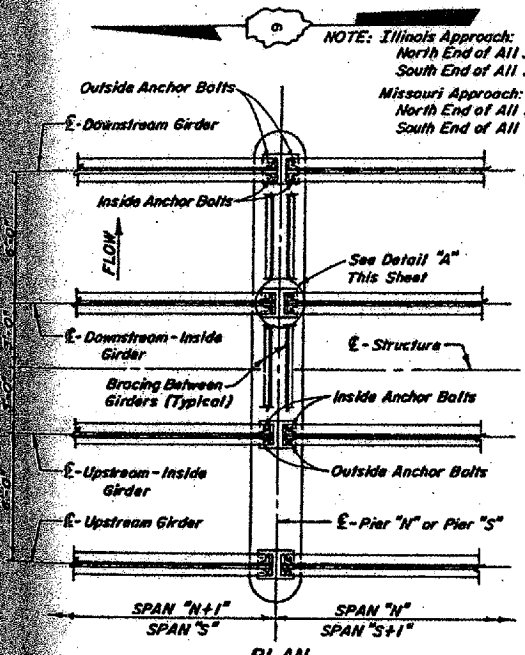
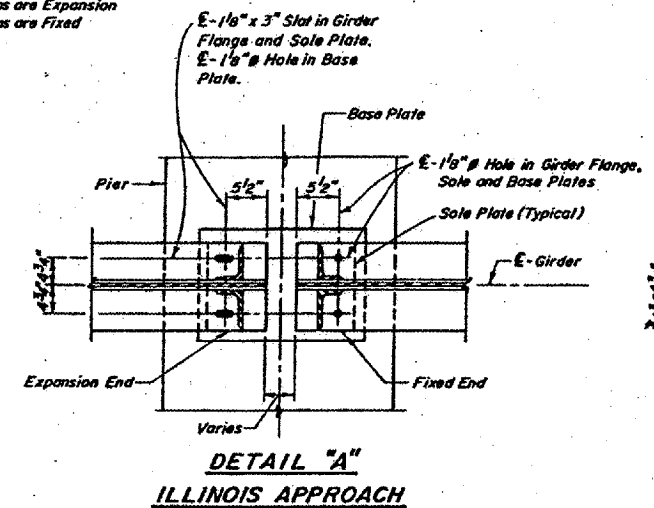
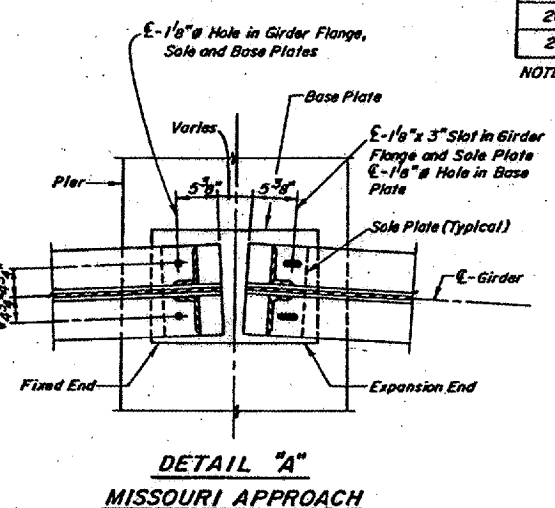
BASE PLATE DETAILS

MISSOURI APPROACH SOLE AND BASE PLATE DETAILS (EXISTING)

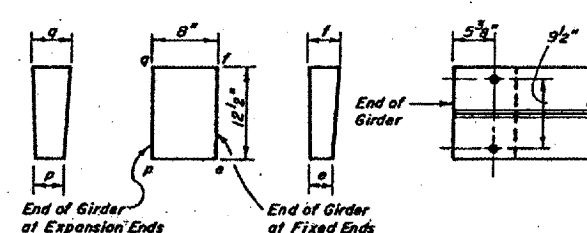
SOLE PLATE DETAILS

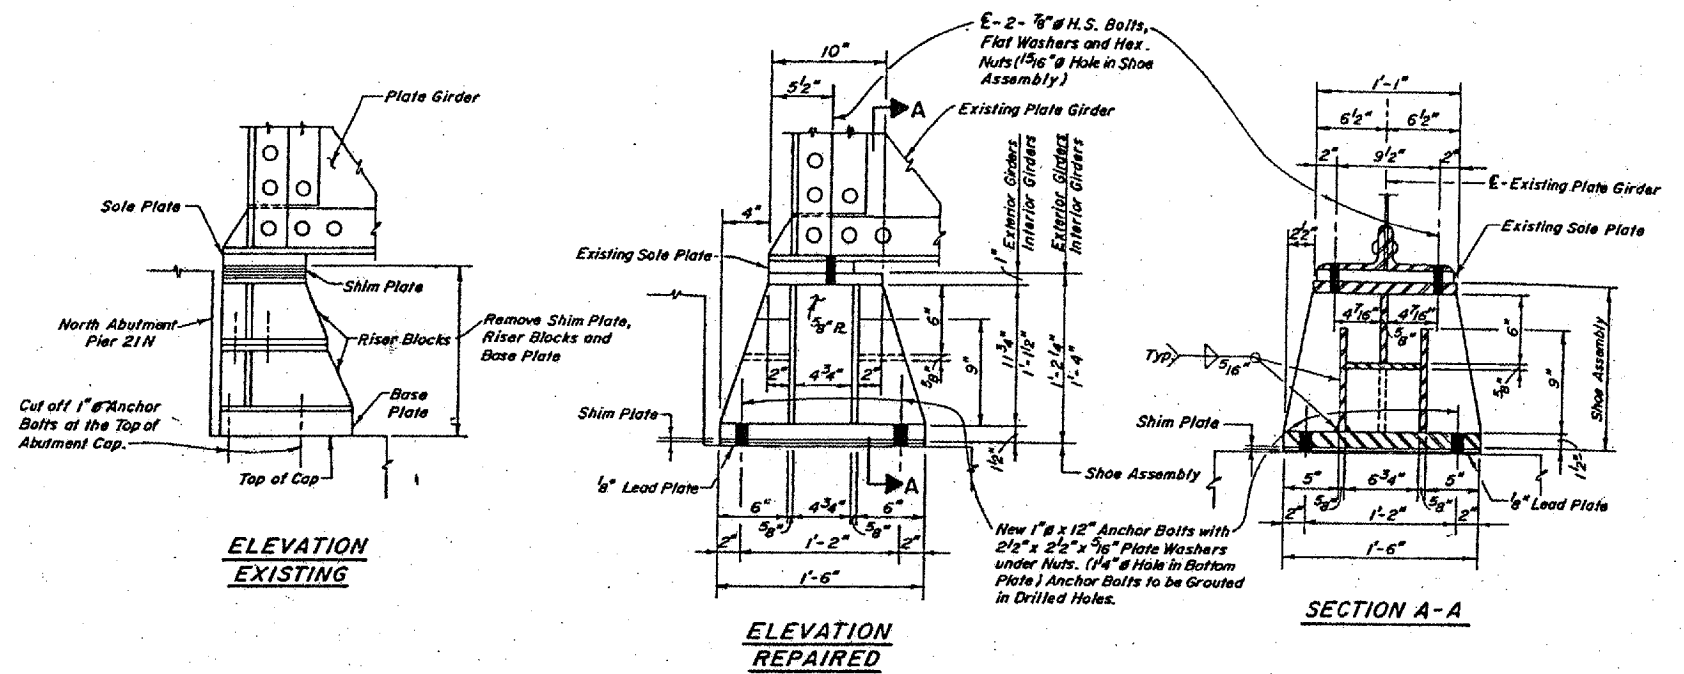
ELEVATION
EXISTING

ELEVATION
REPAIRED

ANCHOR BOLT REPLACEMENT DETAILS "7" AND "8"
(AT FIXED BEARING)

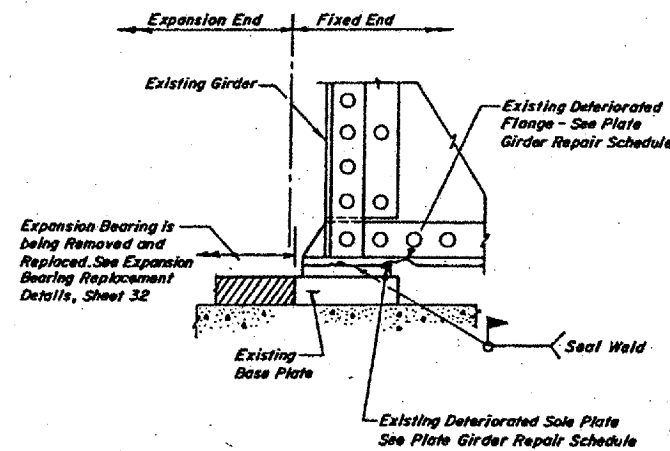
ELEVATION
FIXED BEARING REPAIR DETAILS

- NOTES:
- Clean girder end and remove all rust, foreign material and old paint down to the bare metal. Seal bearing using Fixed Bearing Repair Detail, Sheet 31.
 - Clean girder end and remove all rust, foreign material and old paint down to the bare metal. Expansion bearing is being replaced. See Bearing Repair Schedule, Sheets 28-30 and Expansion Bearing Replacement Details, Sheet 32.
 - Clean and remove all rust, foreign material and old paint down to the bare metal. Cost incidental to "Cleaning and Painting."
 - Clean girder end and remove all rust, foreign material and old paint down to the bare metal. Abutment bearing is being replaced. See Bearing Repair Schedule, Sheets 28-30 and Abutment Bearing Replacement Details, Sheet 31.

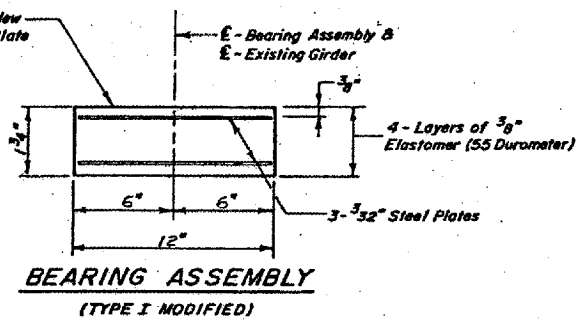
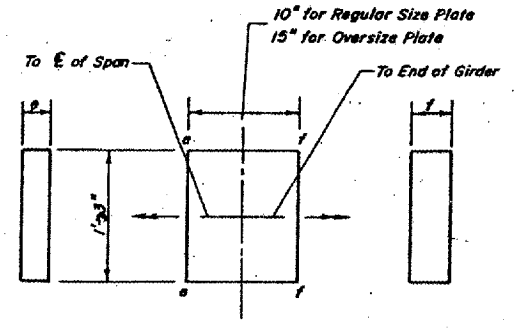
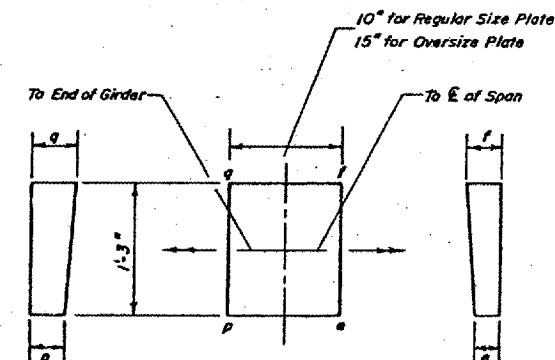
Note that of the total 84 sole plates listed above, all except 12 sole plates (located at Piers A, 1N and 2N) are of constant thickness.

SOLE PLATE DETAILS (SEE TABLES - THIS SHEET)

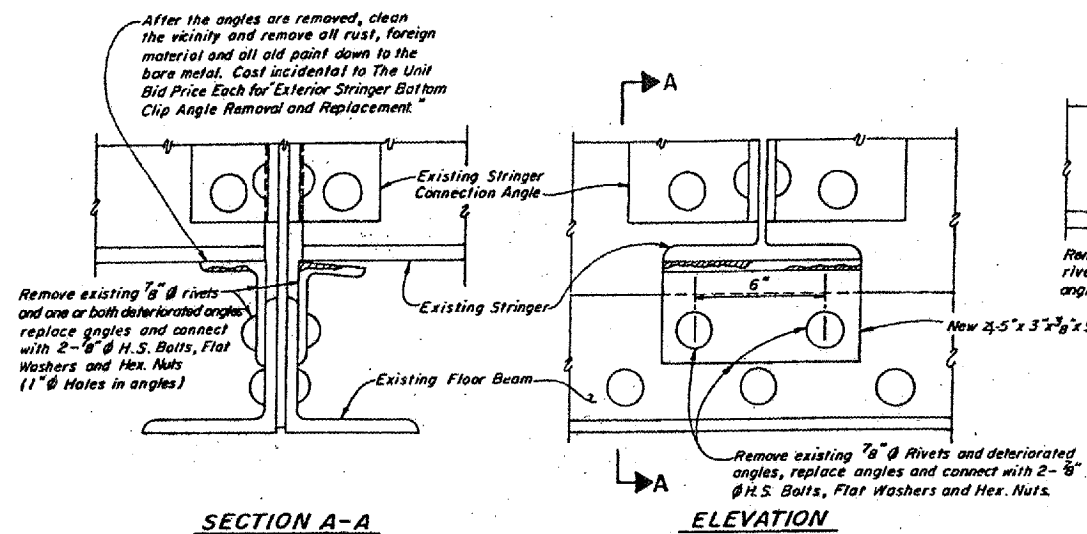
SECTION A-A

ELEVATION

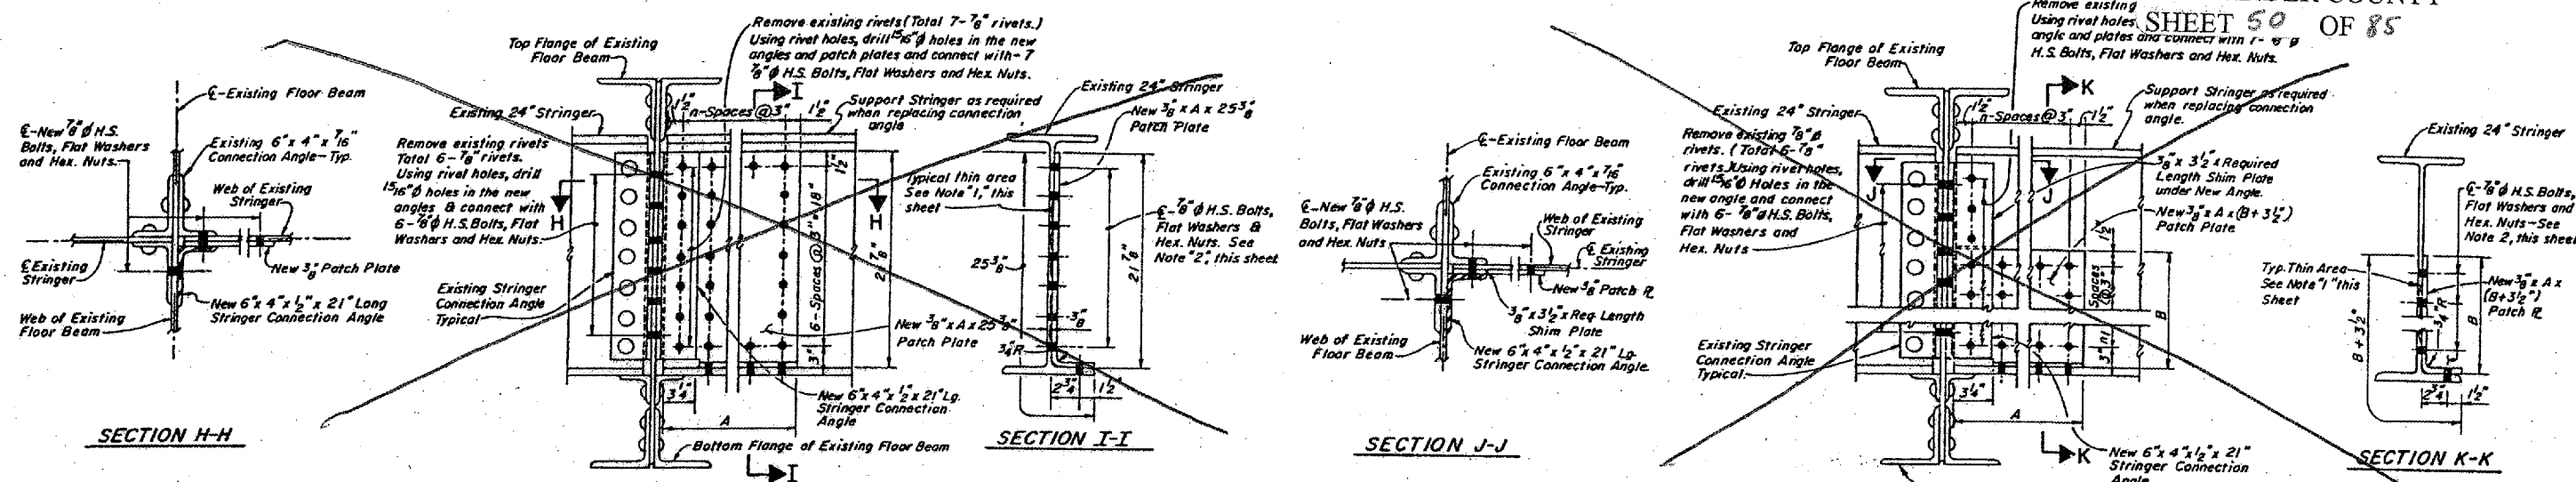
STRINGER FULL DEPTH WEB REPAIR - DETAIL "21"
WEB PLATE ONE SIDE

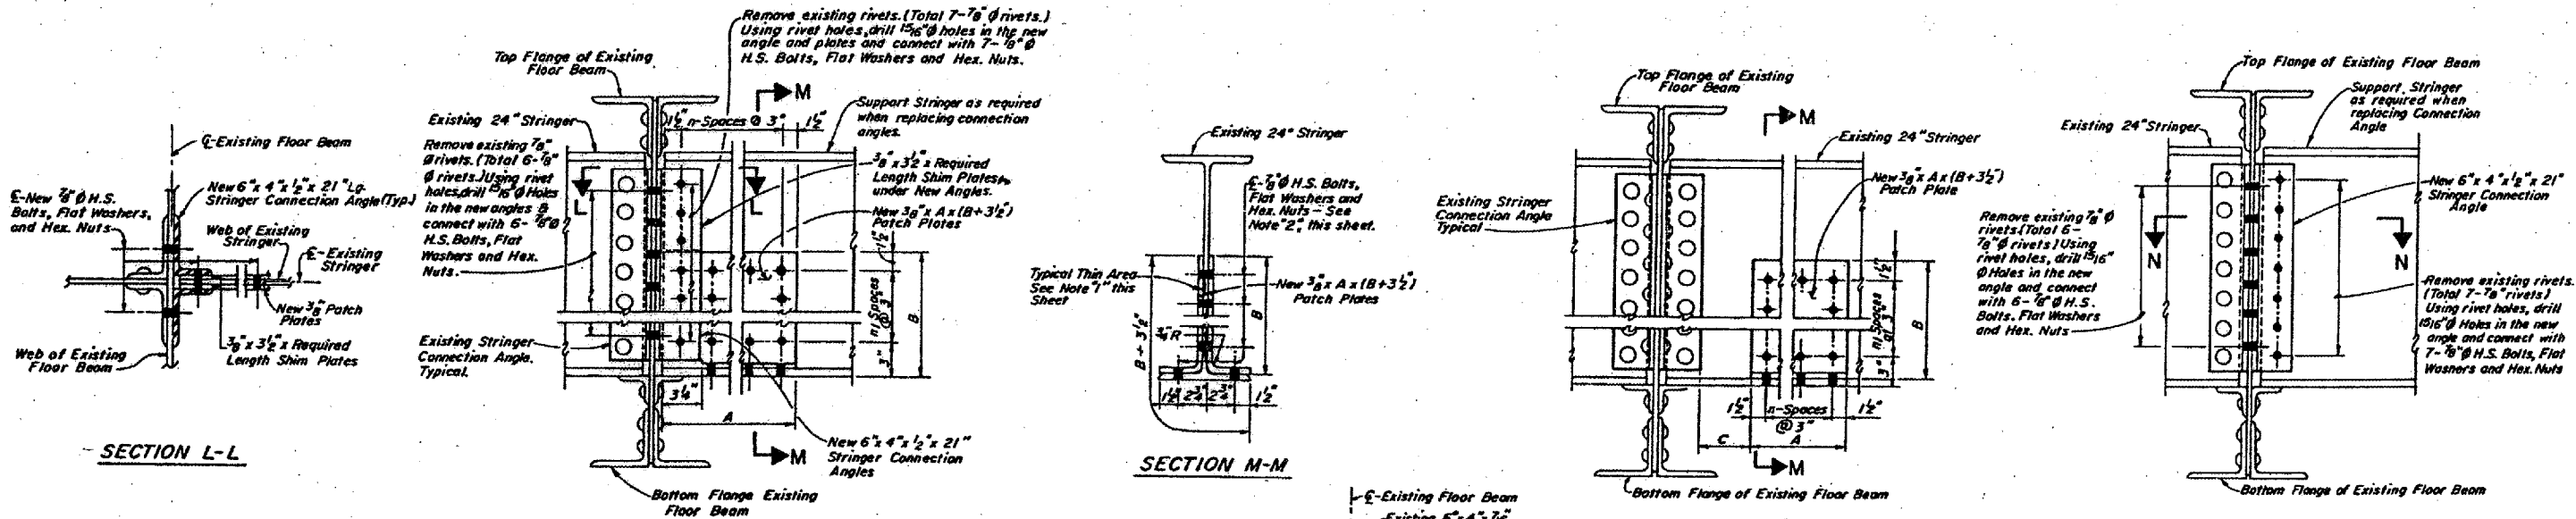
STRINGER PARTIAL DEPTH WEB REPAIR - TYPE "B" - DETAIL "22"
WEB PLATE ONE SIDE

STRINGER PARTIAL DEPTH WEB REPAIR - TYPE "B" - DETAIL "23"
WEB PLATES BOTH SIDES

STRINGER PARTIAL DEPTH WEB REPAIR - TYPE "C" - DETAIL "24"
WEB PLATES BOTH SIDES

STRINGER END CONNECTION REPAIR
DETAIL "25"

97	97	The bottom clip angle is rusted. See detail (15/40) for repair.	The bottom clip angle is rusted. See detail (15/40) for repair.			
97	98	The bottom clip angle is rusted. See detail (15/40) for repair.				
98	98	The bottom clip angle is rusted. See detail (15/40) for repair.	Inside face of the web has a hole near the bottom end, the bottom clip angle is rusted. See detail (15/40) and below for repair.	The bottom clip angle is rusted. See detail (15/40) for repair.	The bottom clip angle is rusted. See detail (15/40) for repair.	
98	98		Outside face of the web has thin area near the top and bottom ends and a hole near the bottom end. See detail (20/40) for repair. Use A=12", n=3			
98	99	The bottom clip angle is rusted. See detail (15/40) for repair.	Inside face of the web has thin area near the bottom end, the bottom clip angle is rusted. See details (15/40) and (22/41) Use A=24", B=9", n=7, n1=2	The bottom clip angle is rusted. See detail (15/40) for repair.	Outside face of the web has thin area near the bottom end, the bottom clip angle is rusted. See detail (15/40) and below for repair.	Inside face of the web has thin area near the bottom end. See detail (23/41) for repair. Use A=54", B=9", n=17, n1=2

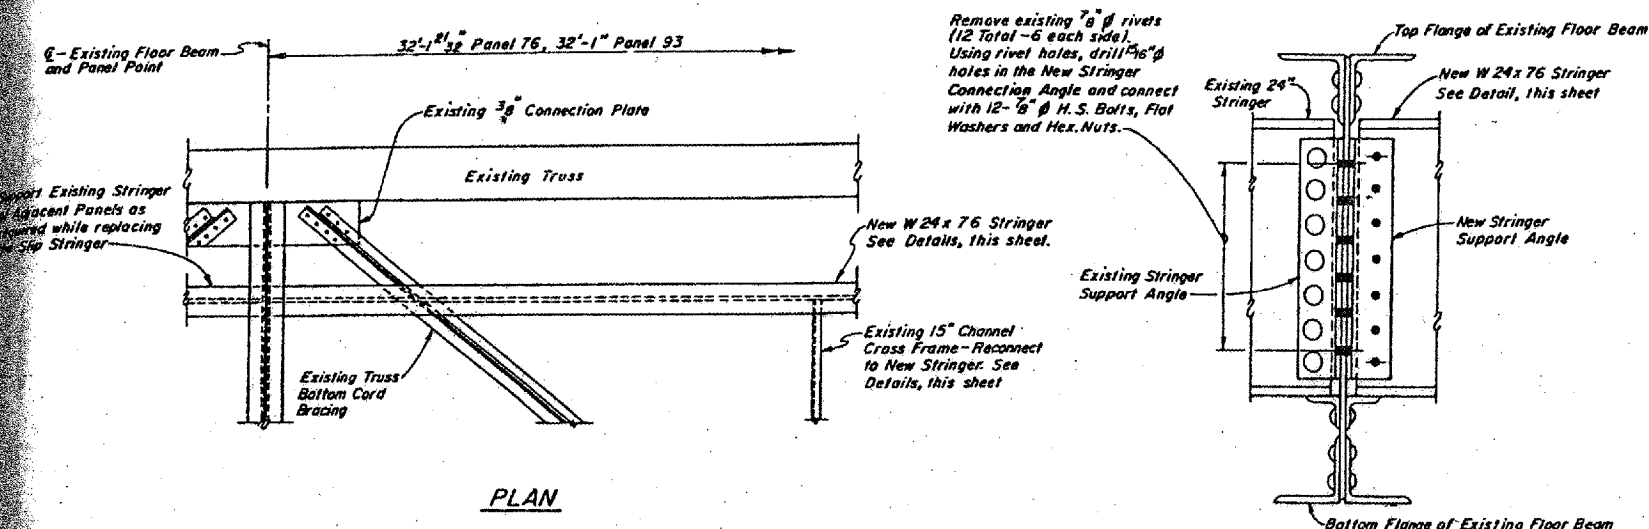
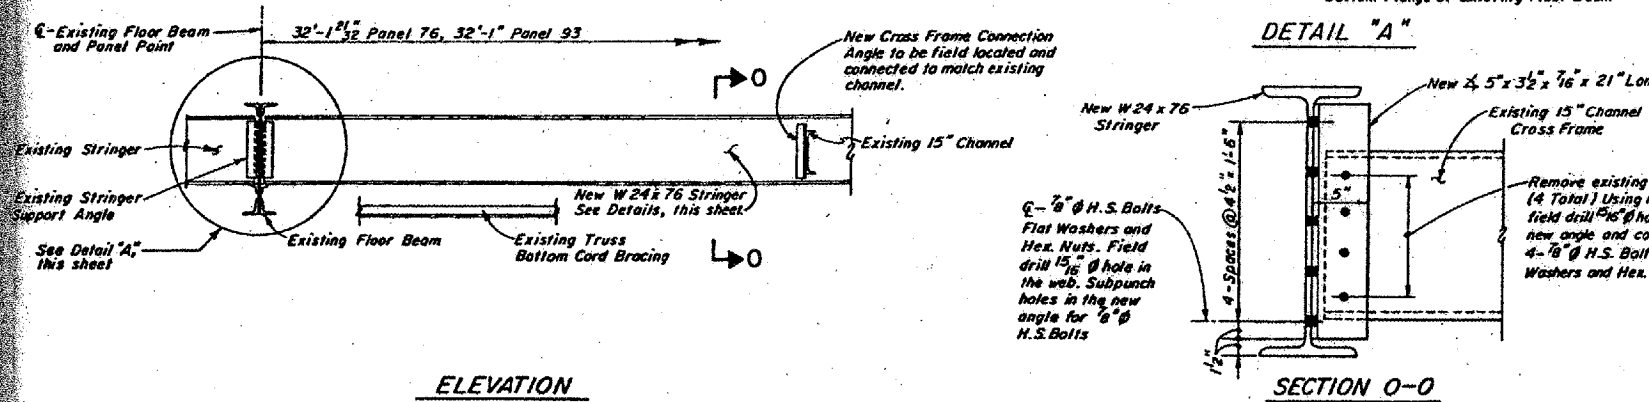
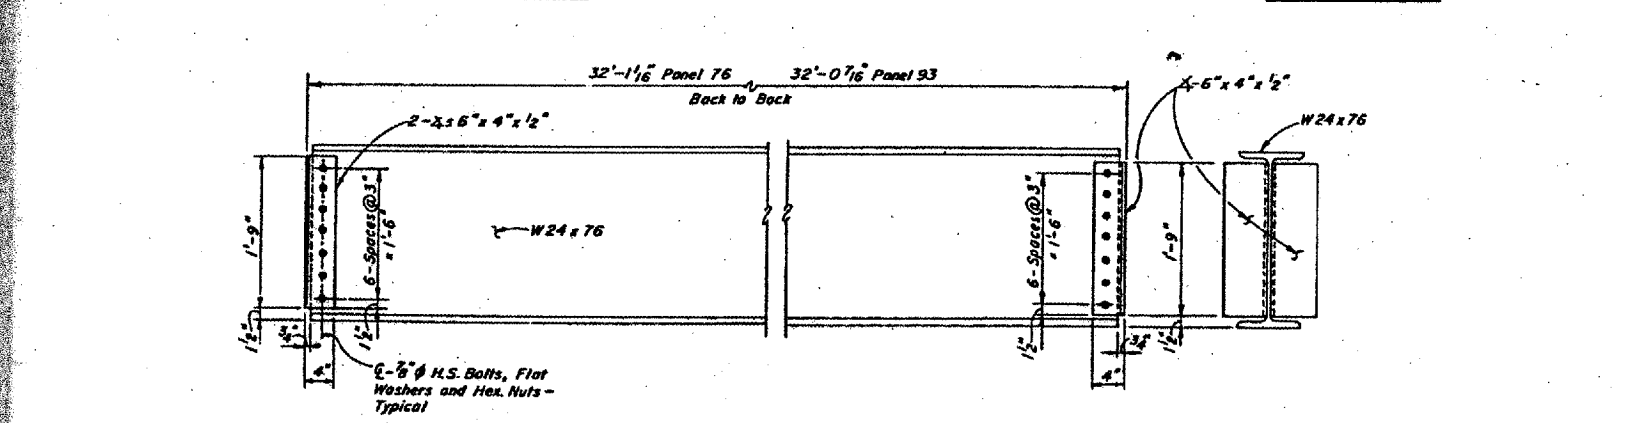
STRINGER REPLACEMENT DETAILS

FULL LENGTH STRINGER REPLACEMENT - DETAIL "26"

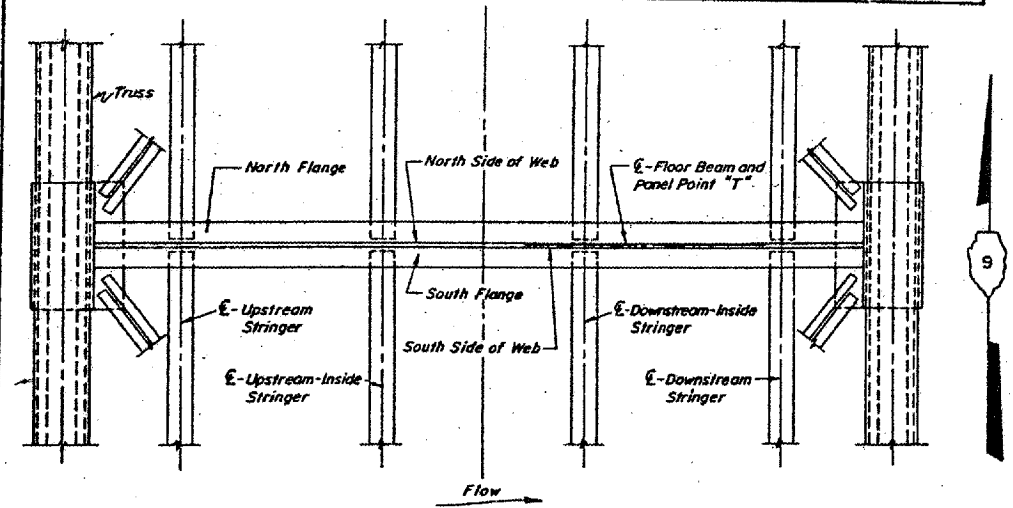
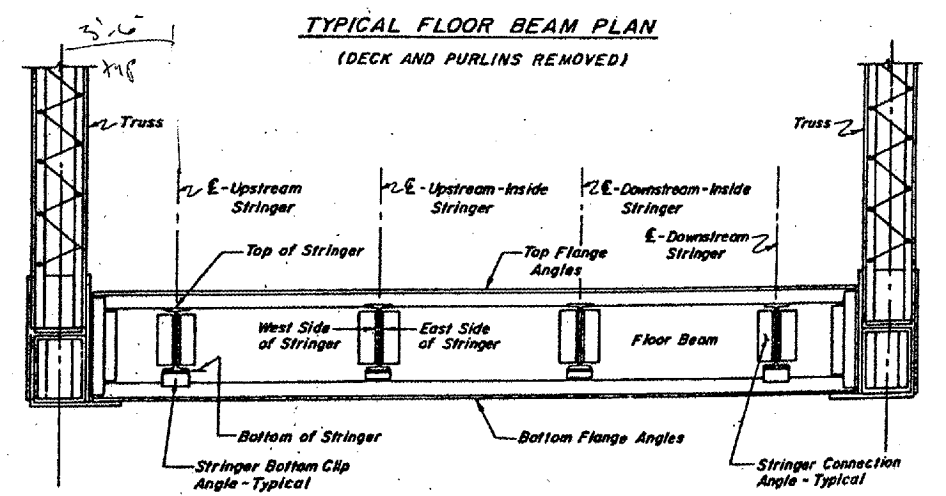
FLOOR BEAM REFERENCE KEY PLAN AND ELEVATION

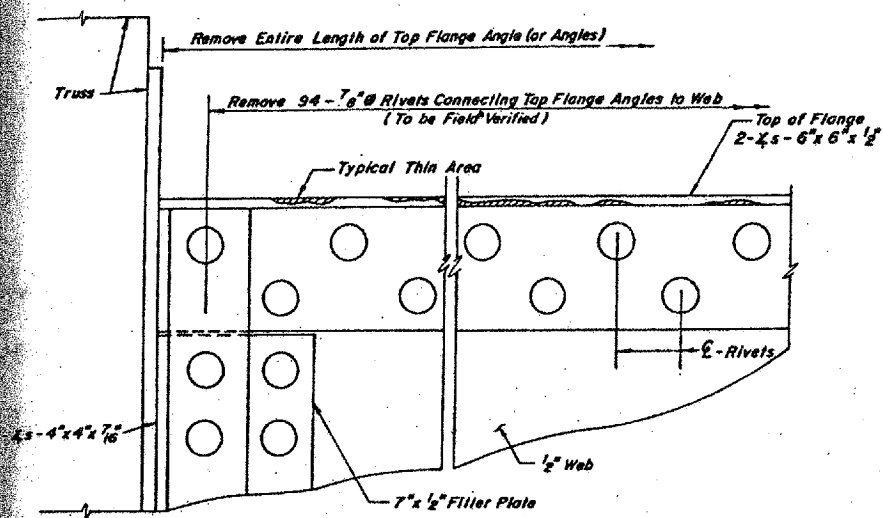
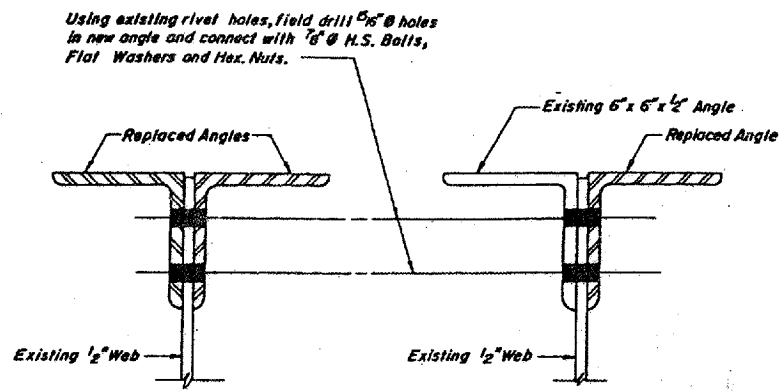
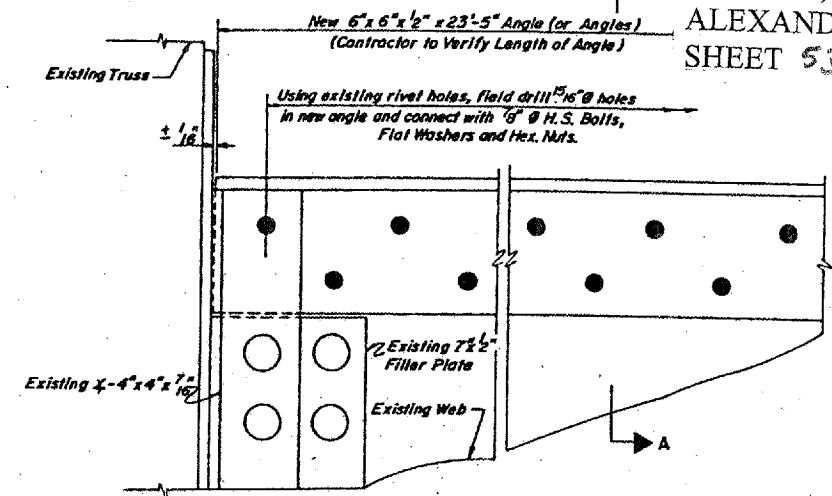
ELEVATION
EXISTING

DETAIL-11
TYPE "B" DETAIL-10
TYPE "A"

SECTION A-A

ELEVATION
REPAIRED

FLOOR BEAM TOP FLANGE REPLACEMENT TYPE "A" & "B" - DETAILS "10" & "11"

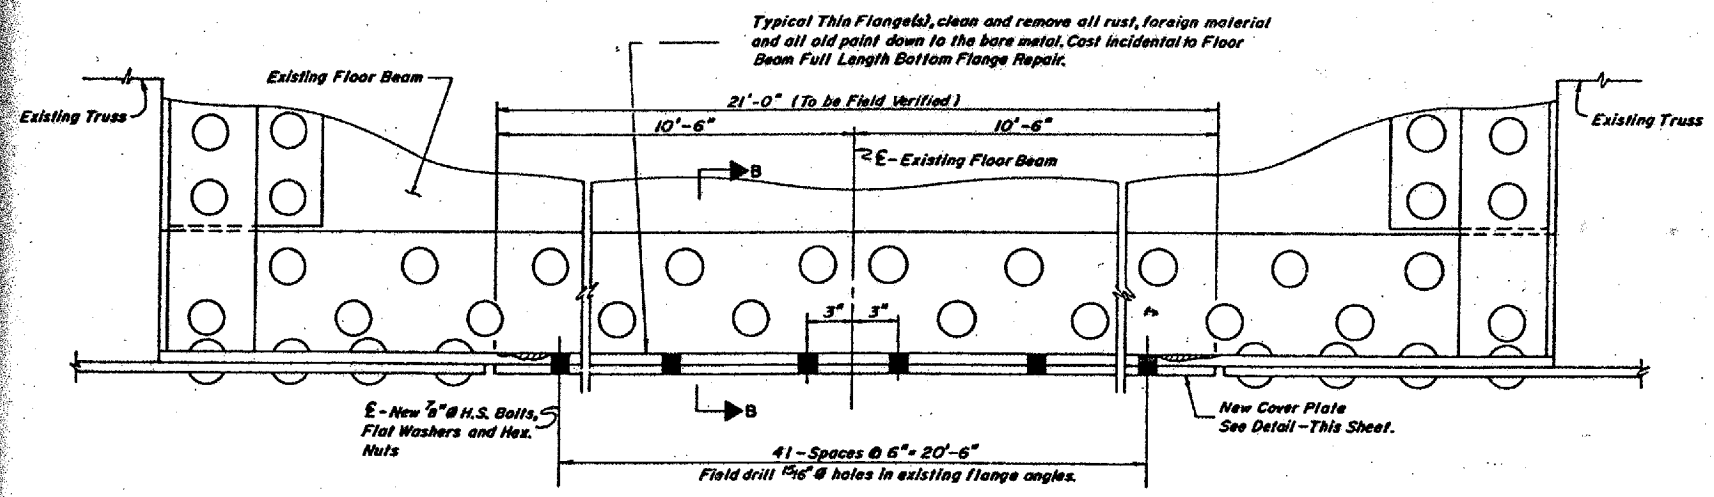
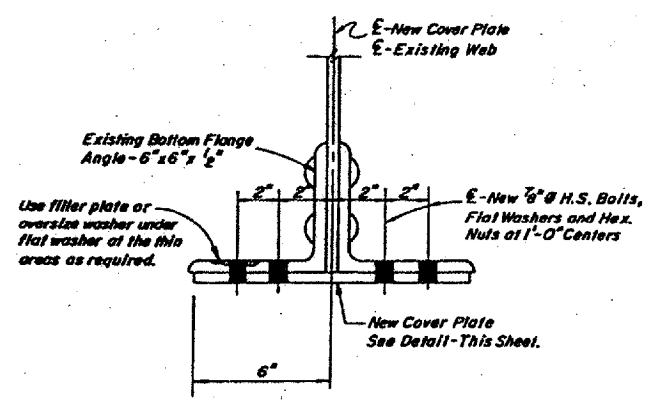
ELEVATION

FLOOR BEAM FULL LENGTH BOTTOM FLANGE REPAIR - DETAIL "13"

SECTION B-B

FLOOR BEAM AT PANEL POINT NO.	DESCRIPTION	REMARKS	FLOOR BEAM AT PANEL POINT NO.	DESCRIPTION	REMARKS	FLOOR BEAM AT PANEL POINT NO.	DESCRIPTION	REMARKS
1	South bottom flange angle has thin area at several locations along the entire length. See detail (13) for repair.	X	30 CONT.	The north side of the web has thin area along the vertical connection angle near the west side of the downstream stringer. See detail (14) for repair.	X	87	North top flange angle has thin areas from 0 to 1' of the upstream & downstream ends. Remove angle - See expansion joint details sheets 71, 84 and 85.	Also, add cover plate to bottom flange. See detail (13) for repair.
3	The south side of the web has thin area at the bottom near the west side of the upstream stringer. See Note "I," This Sheet.		34	The south side of the web has thin area at the top and bottom near the east side of the downstream stringer. See detail (14) for repair.		92	The north side of the web has thin area at the bottom at several locations for entire length. See Note "I," This Sheet.	Also, add cover plate to bottom flange. See detail (13) for repair.

15	The north side of the web has thin area at the top near the east side of the downstream stringer. See above to repair.		55	North bottom flange angle has thin areas at all the stringer locations. See detail (13) for repair.				
21	South bottom flange angle has thin area near mid-span of the floor beam. See detail (13) for repair.		74	The north side of the web has thin area at the top near the upstream stringer. See Note "I," This Sheet.				
	North top flange angle has thin areas from 1' to 6' of upstream & downstream ends. South top flange angle has thin areas from 1' to 6' of upstream & downstream ends. See detail (13) for repair.		76	The north side of the web has thin area at the top near the upstream stringer. See Note "I," This Sheet.				
	South bottom flange angle has thin areas from 1' to 6' of upstream & downstream ends. See detail (13) for repair.		78	The south side of the web has thin area at the bottom near the downstream-inside stringer. See Note "I," This Sheet.

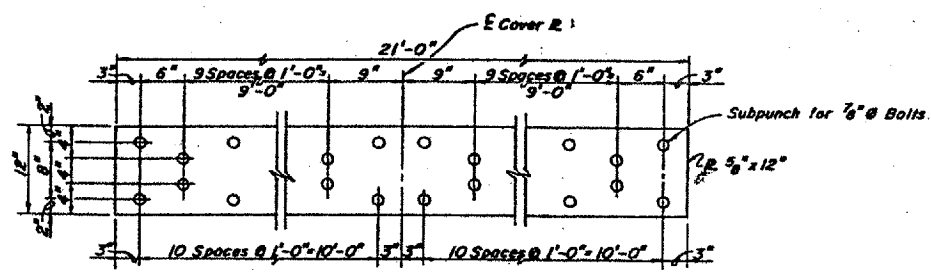
COVER PLATE DETAIL

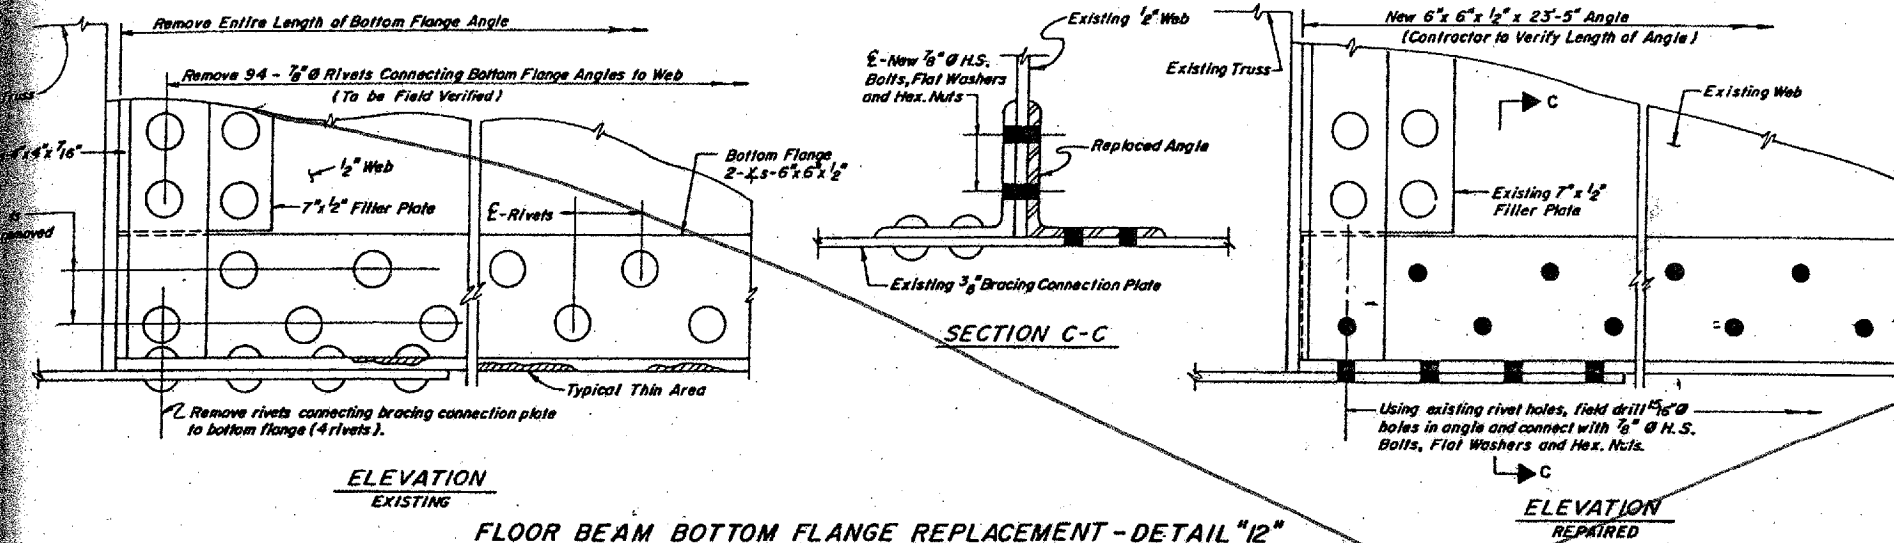
FLOOR BEAM BOTTOM FLANGE REPLACEMENT - DETAIL "12"

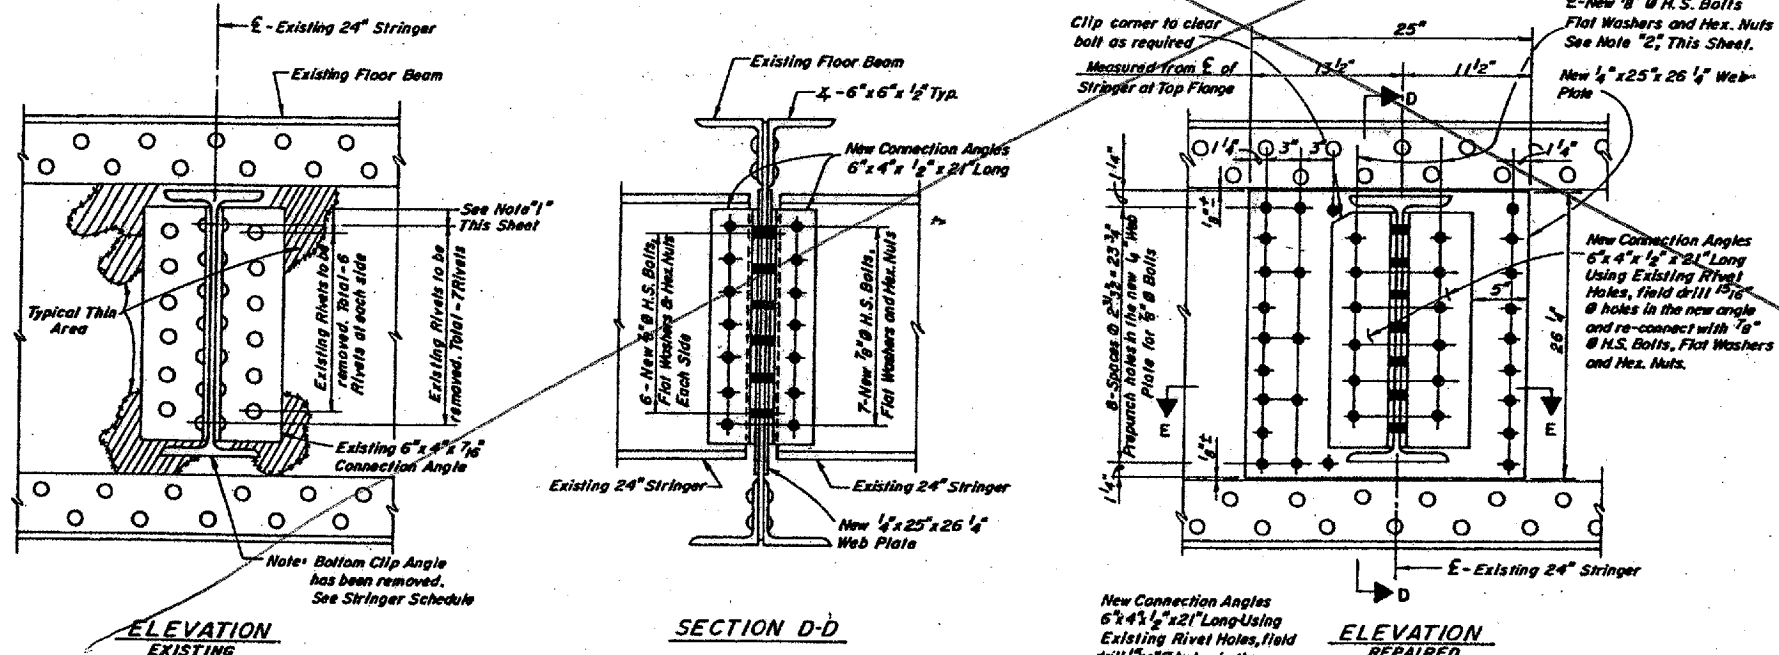
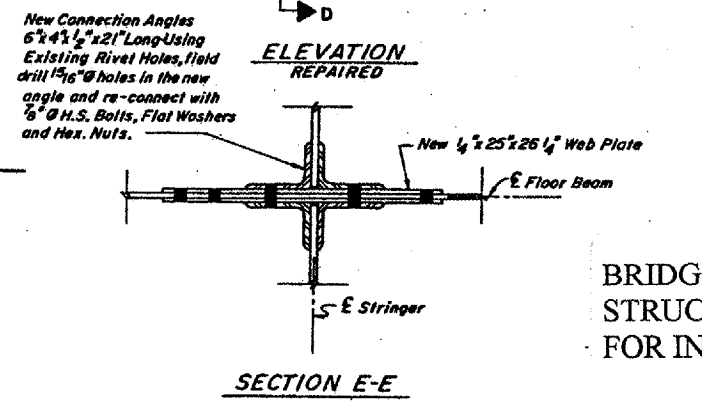
FLOOR BEAM FULL DEPTH WEB REPAIR - DETAIL "14"

- NOTES:
- Support existing stringers at either side of the floor beam and remove the existing 7/8" diameter rivets connecting the stringers to the floor beam and the connection angles to the stringer. Clean the thin area and remove all rust, foreign material and all old paint down to the bare metal. (Cost incidental)
 - Filler plates of 3/8" min. thickness shall be used at locations where connection bolts pass thru thin area of existing members.
 - Work This Sheet with Sheets 43 and 44.

SECTION E-E

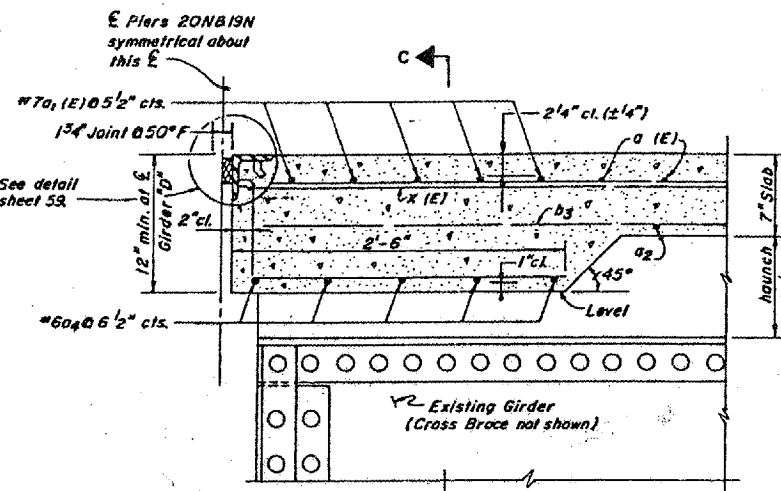
SECTION B-B
(AT PIERS 19N & 20N)

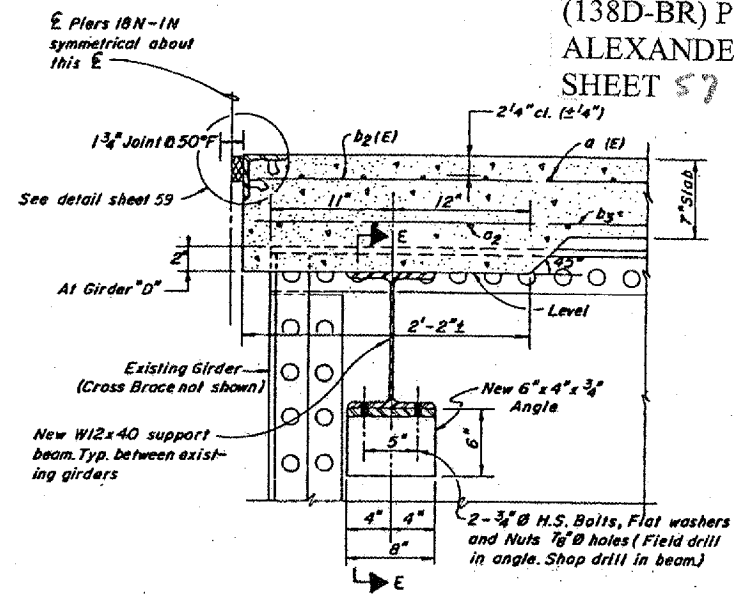
SECTION B-B
(AT PIERS 1N-18N)

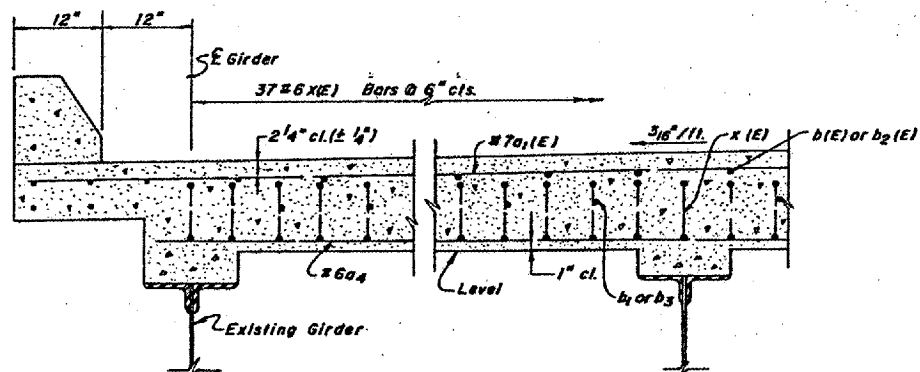
SECTION C-C
PIER SHOWN - ABUT. SIMILAR

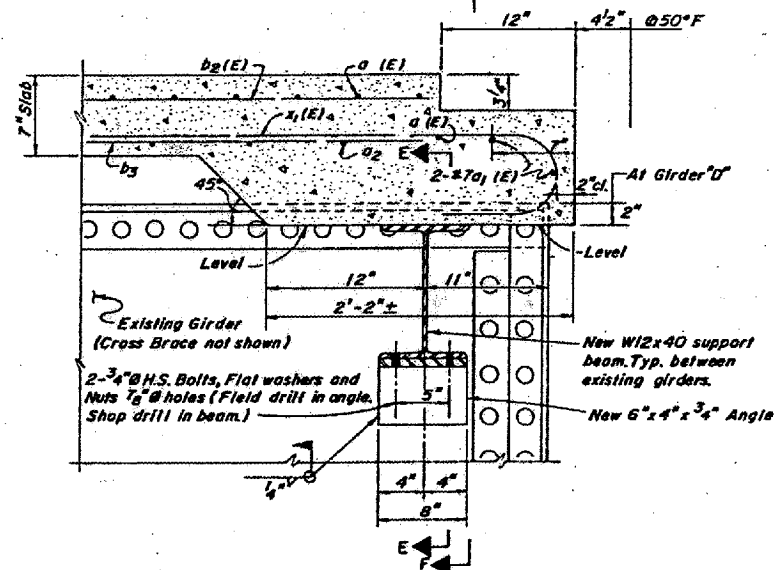
SECTION D-D
TYP SPANS IN-19N

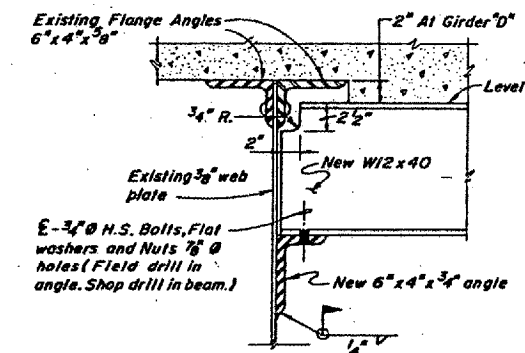
SECTION E-E
(EXTERIOR GIRDERS SHOWN - INTERIOR GIRDERS SIMILAR)

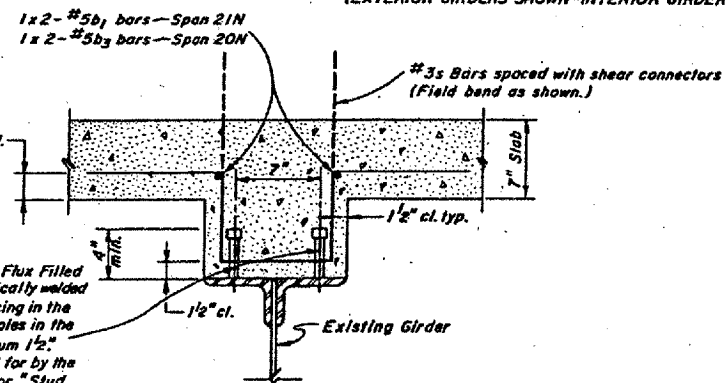
SECTION G-G
TYP SPANS IN-19N

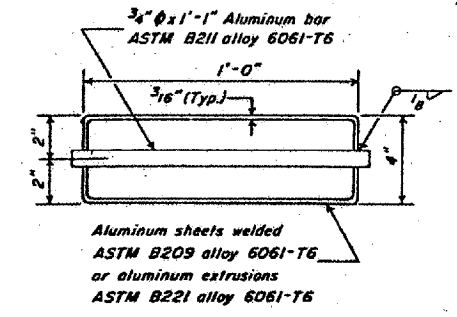
DRAIN DETAIL

The exterior surfaces of the aluminum drains shall be cleaned and given a washcoat pretreatment in accordance with the Steel Struct. Painting Council's Spec. SSPC-SPI & SSPC-PT3 followed by the Basic Lead Silico Chromate Painting specified for structural steel.

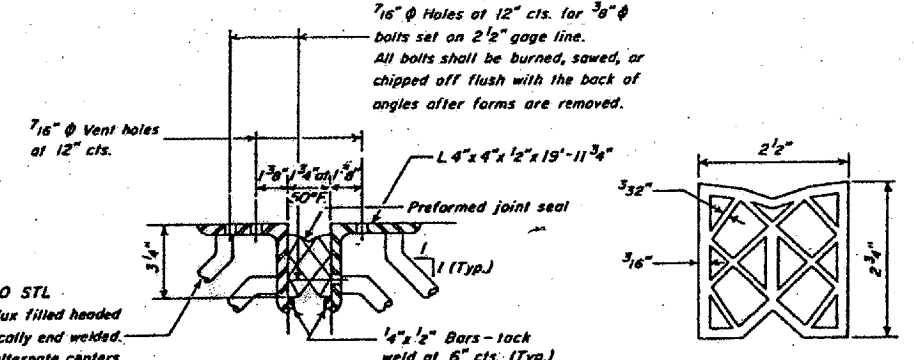
TYPICAL SECTION

PREFORMED JOINT SEAL

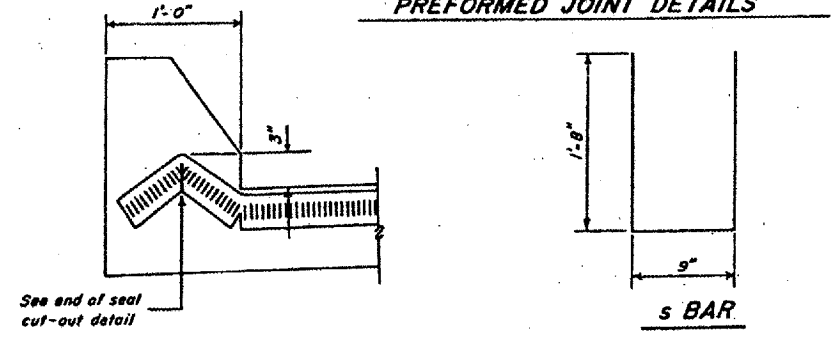
TYPICAL END OF SEAL TREATMENT

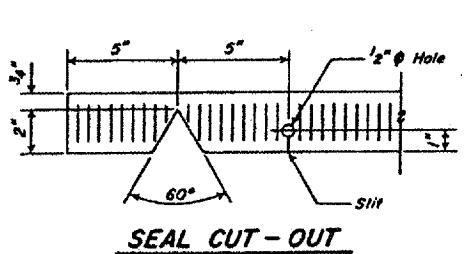
SEAL CUT-OUT
