**PROPOSED
HIGHWAY PLANS**

FAS ROUTE 944 (U.S. 60/62)
SECTION (138D-BR) P-1
ALEXANDER COUNTY, ILLINOIS
MISSISSIPPI COUNTY, MISSOURI
C-99-002-06

IMPROVEMENT LOCATION
STRUCTURE 002-0005
PAINT STRUCTURAL STEEL
AT SPECIFIED LOCATIONS

BRIDGE NO. 1
 STRUCTURE 002-0005
 FOR INFORMATION ONLY

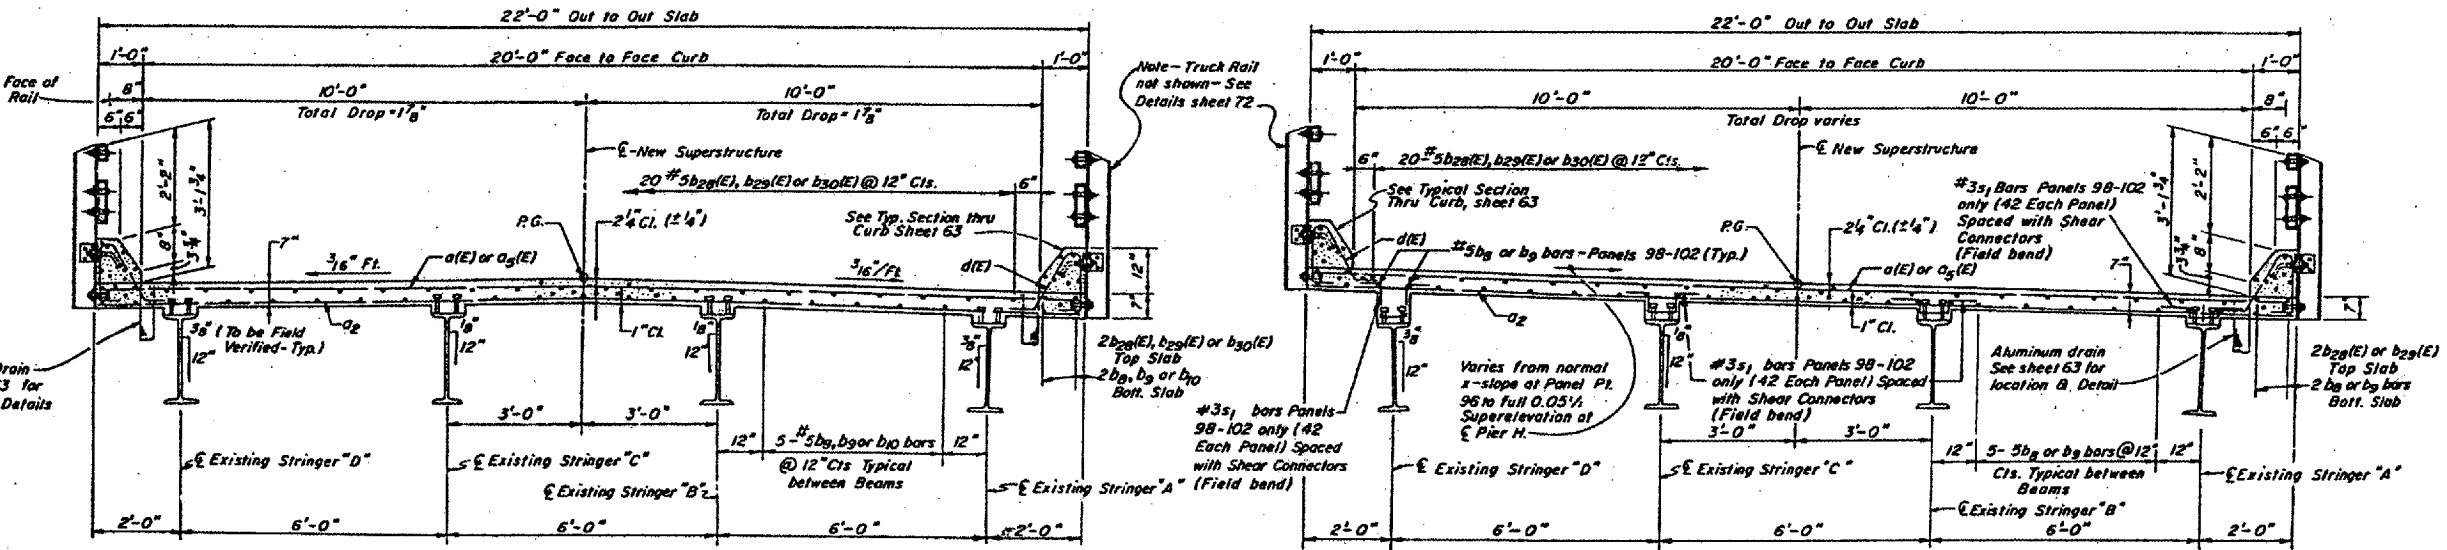
PLAN PANELS 36 THRU 51

PANELS 36 THRU 40 PANELS 41 THRU 46 PANEL 47 (TYPE II PANEL) PANEL 48 (TYPE I PANEL) PANELS 49 THRU 51 (TYPE III PANEL)

SECTION THRU NEW DECK TYPICAL PANELS 1-96 (LOOKING AHEAD)

SECTION THRU NEW DECK TYPICAL PANELS 97-102 (LOOKING AHEAD)

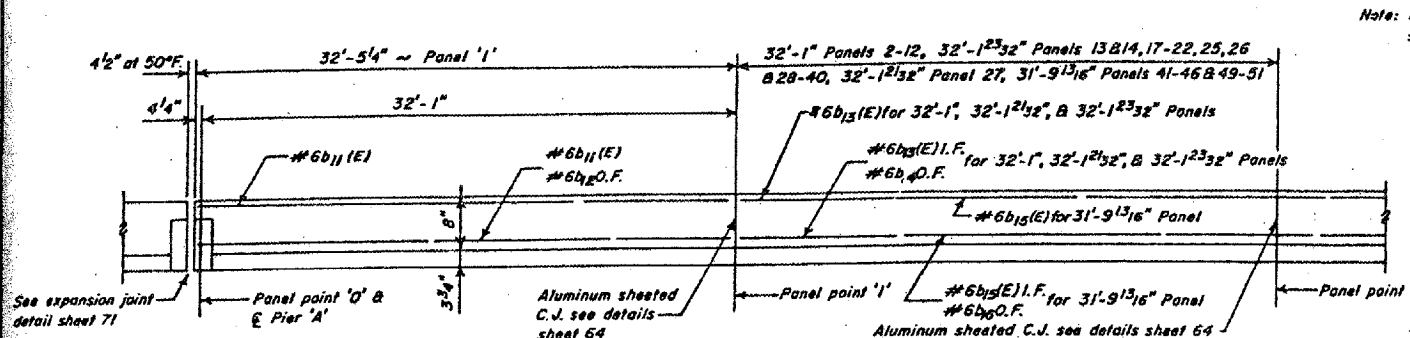
AT TYPICAL PIER PANEL
(TYPE I PANEL)

PARTIAL INSIDE ELEVATION OF CURB
(Curb elevation is symmetrical about panel point '51')

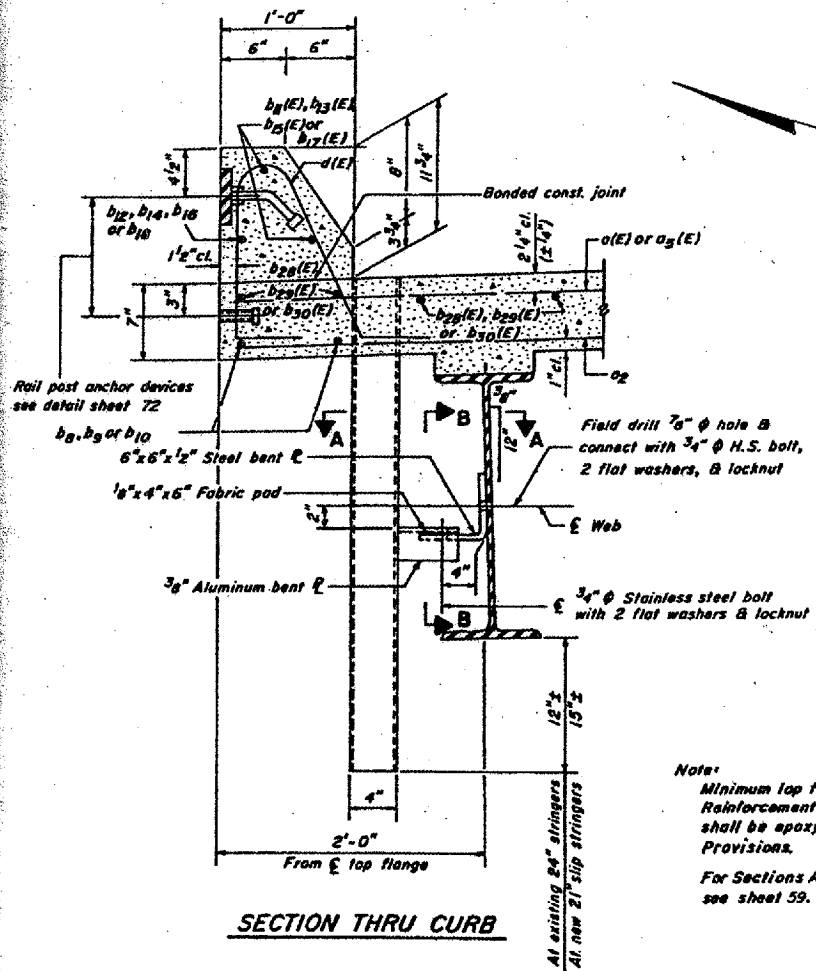
SECTION THRU CURB

Note:
Minimum lap for #6 Bars = 2'-8"
Reinforcement bars designated (E)
shall be epoxy coated. See Special
Provisions.
For Sections A-A, B-B & Drain details
see sheet 59.

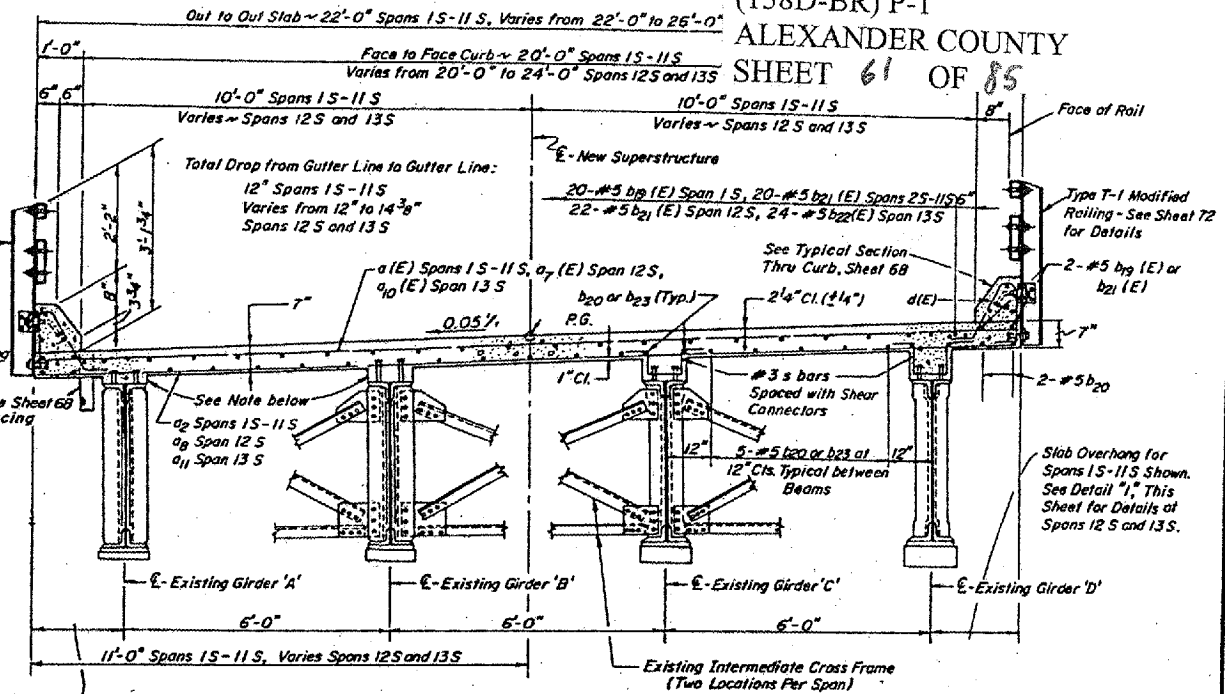
SECTION THRU NEW DECK
(LOOKING NORTH)

2'-0" Spans 1S-11S (Shown)
Varies from 2'-0" at E-Pier 11S to 4'-0" at End of Slab at Pier 13S for Spans 12 S and 13 S.
Typical Both Fascias - See Fascia Offset below.

NOTE:
Shallow haunches shown. See Layout, Sheet 65 & Shear Connector Details, Sheet 67 for #5, #6 & #8 requirements at Girders A & B with deep haunches.

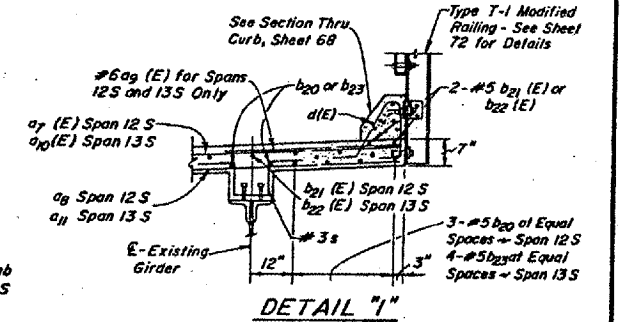
DETAIL "1"

NOTE: Girders 'B' and 'C' are located a distance of 3'-0" to the West and East of Short Chord respectively.
Typical All Spans

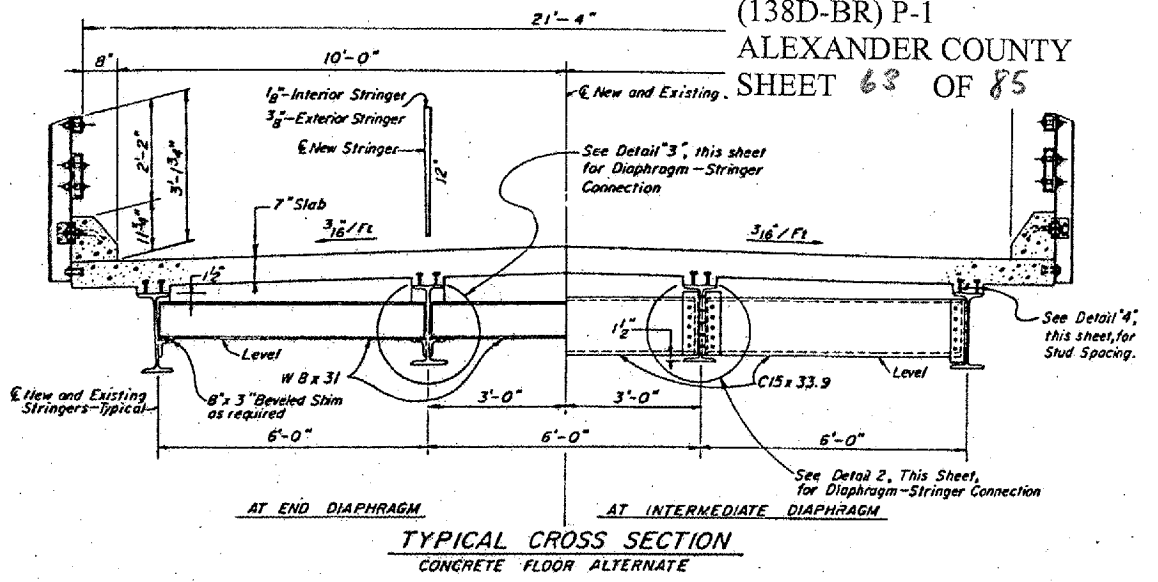
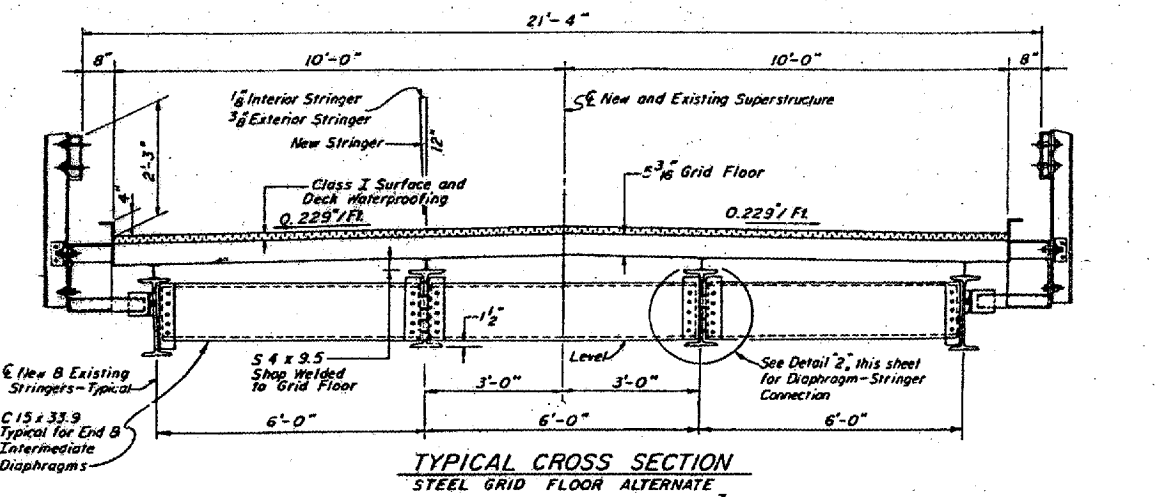
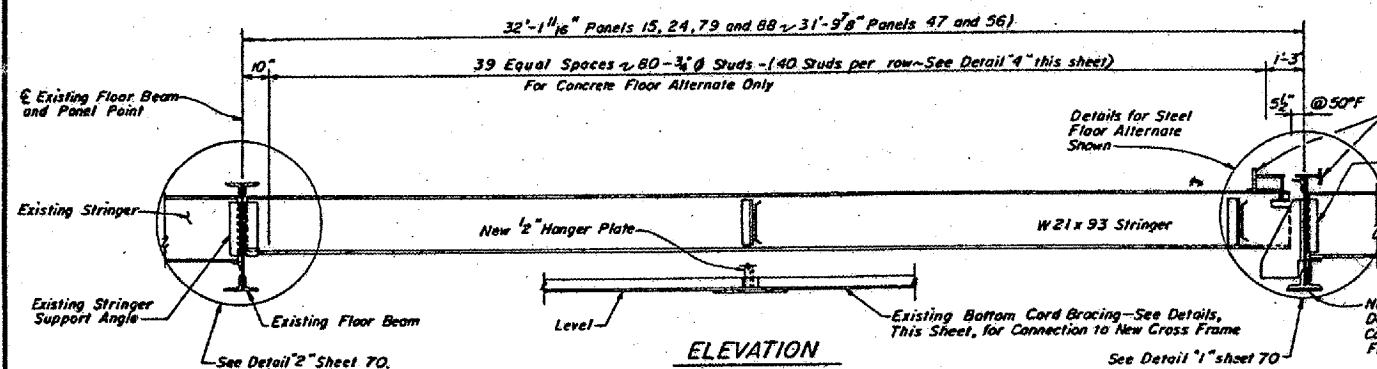
SLIP STRINGER SPAN REMOVAL AND REPLACEMENT

NOTE:
New Expansion Joint Support Beams, Brackets, and Floor Beam Bottom

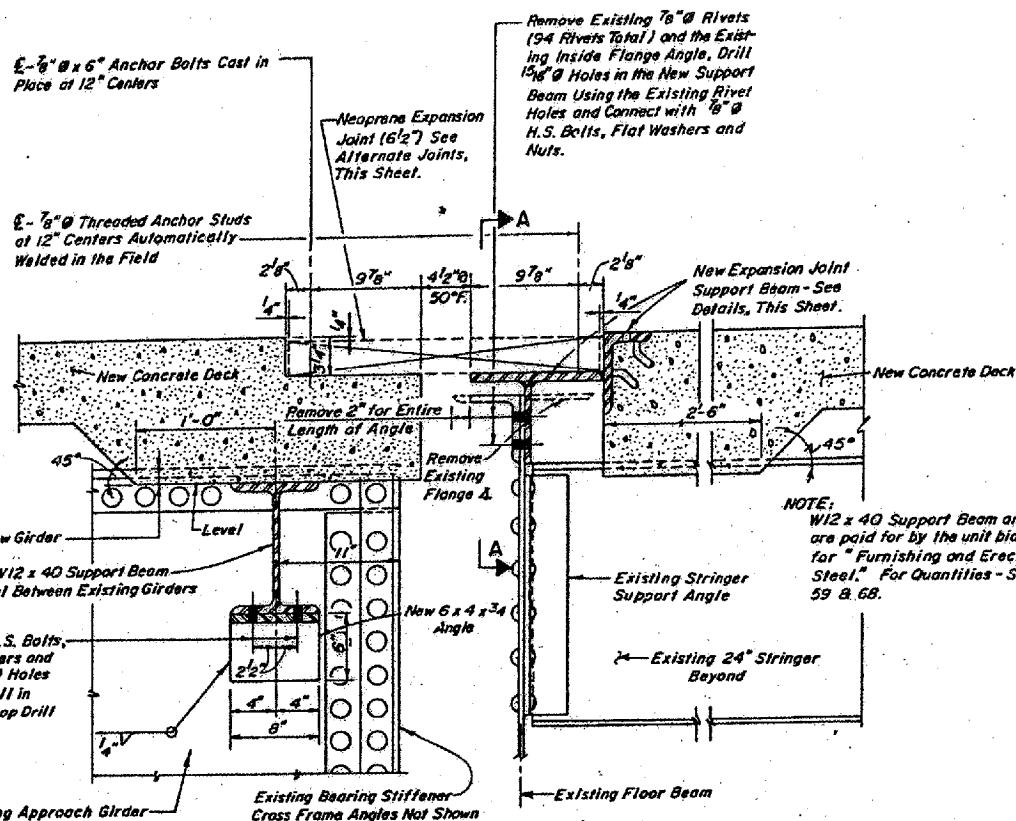
SECTION AT PIER "A" AND "H" EXPANSION JOINTS
(PIER "A" SHOWN, PIER "H" SIMILAR)

NOTE:
Joint openings shall be adjusted in accordance with Article 503.07(c) of the Standard Specifications when the deck is poured at an ambient temperature other than 50°F.

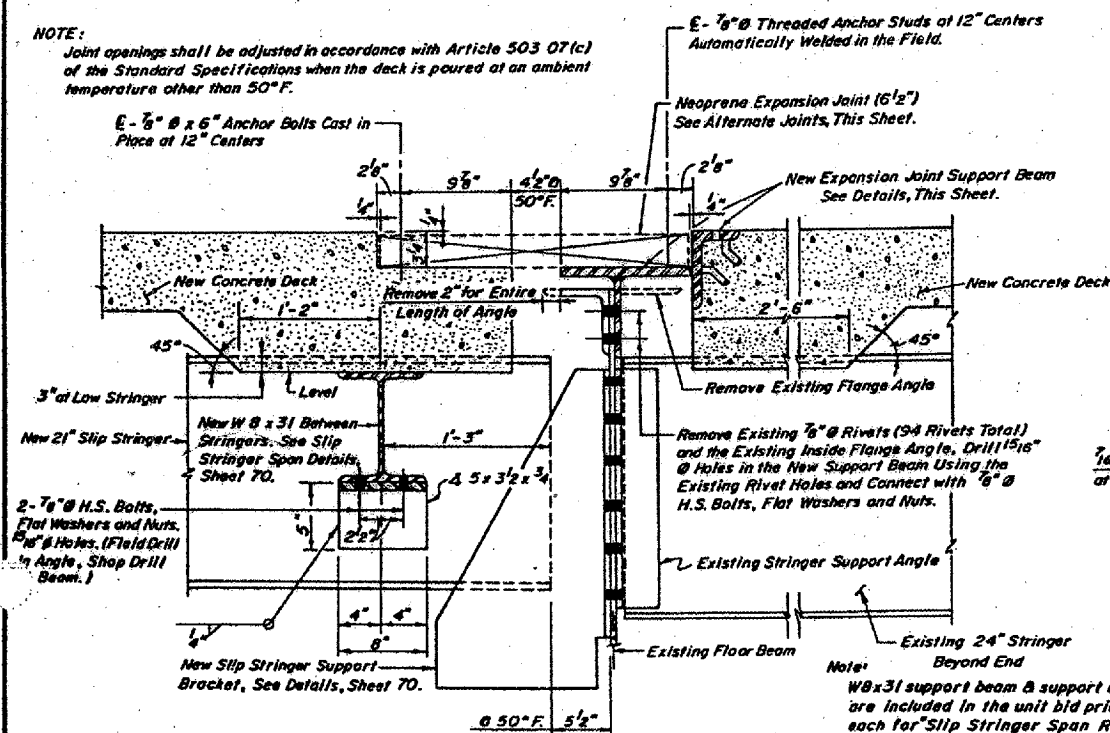
SECTION AT SLIP STRINGER EXPANSION JOINTS
(TYPICAL PANEL POINTS 15, 23, 47, 55, 79 & 87)

MODEL
TRANSFLEX, MODEL 650
NEOPRENE EXPANSION JOINTS (6 1/2")
(SEE SPECIAL PROVISIONS)

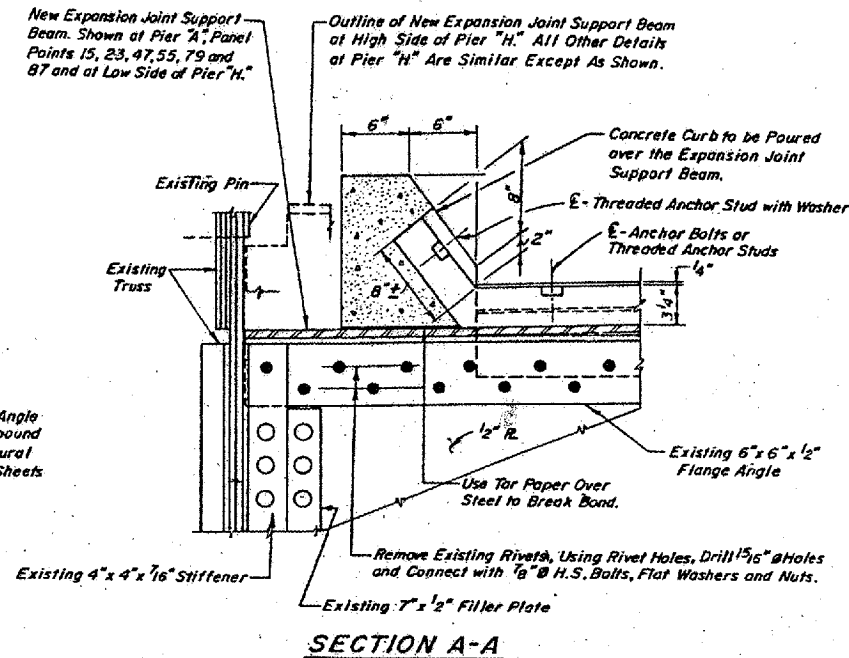
SECTION A-A

NOTE:
Expansion Joint Support Beams are paid for by the unit bid price per pound for "Furnishing and Erecting Structural Steel." For Quantities See Table of Bill of Material, This Sheet.

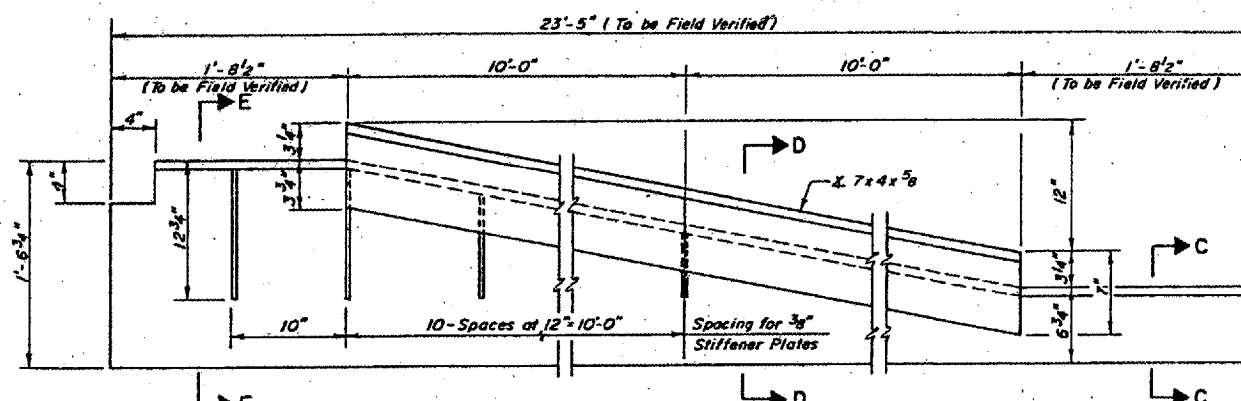
EXPANSION JOINT SUPPORT BEAM DETAIL
(AT PIER "H")

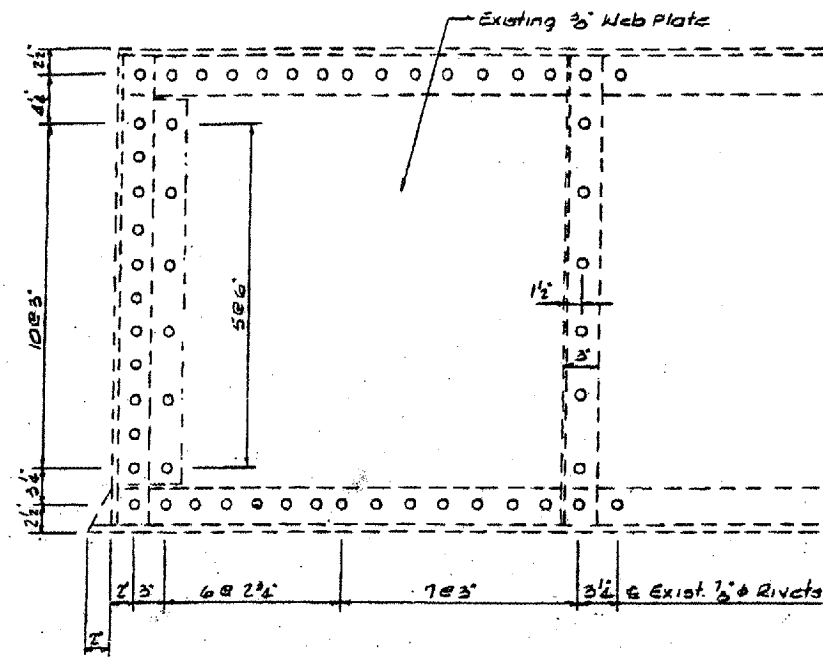
TYPICAL GIRDER ELEVATION AT BEARING

MO. APPROACH GIRDERS G1 & G2

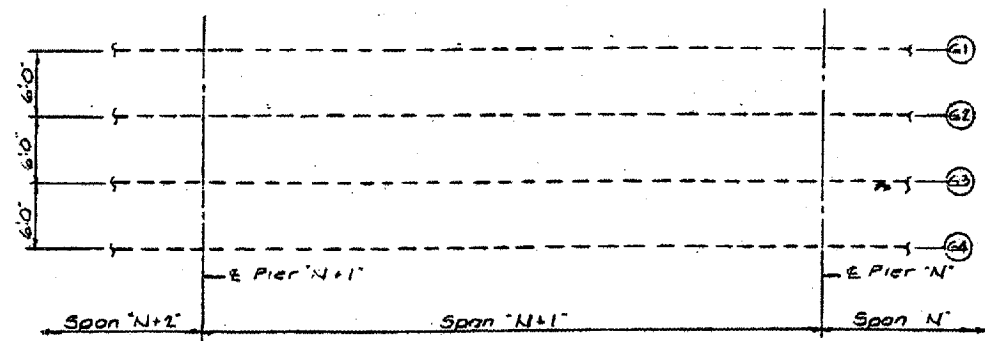
TYPICAL EXISTING GIRDER LAYOUT

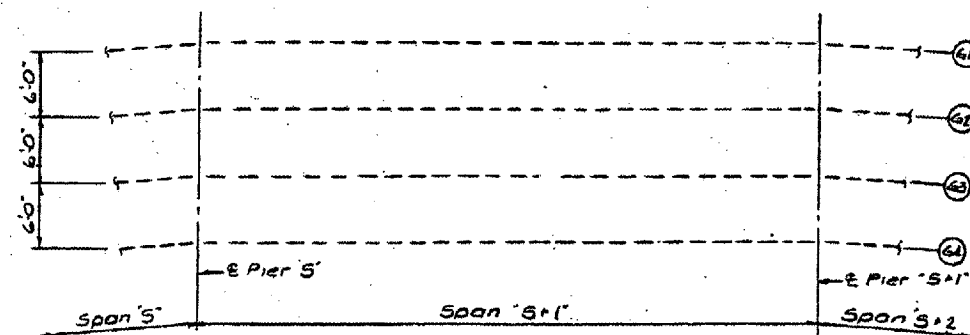
TYPICAL EXISTING GIRDER LAYOUT

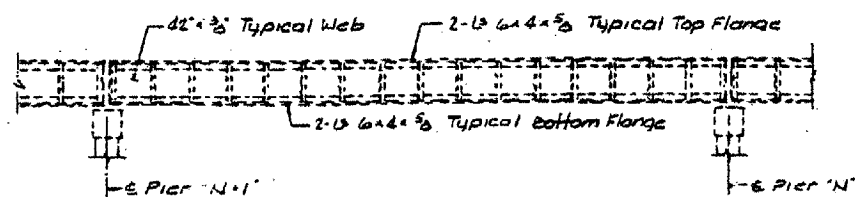
GIRDER ELEVATION

ILLINOIS APPROACH GIRDERS

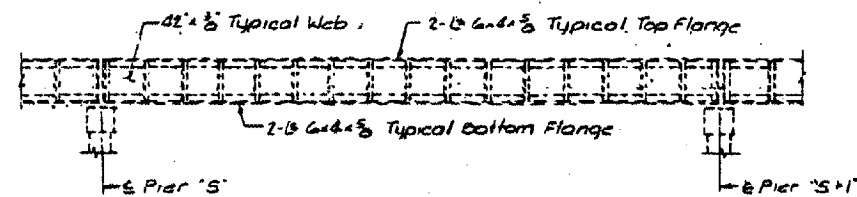
GIRDER ELEVATION

MISSOURI APPROACH GIRDERS

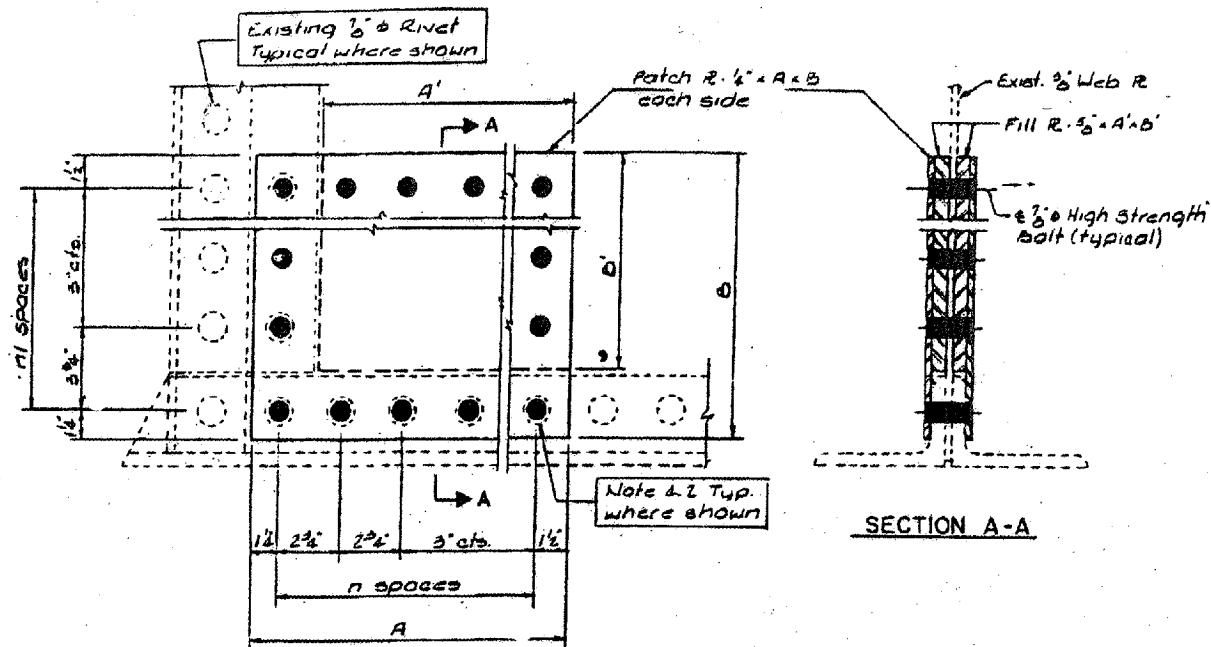
REPAIR DETAIL - TYPE 1

NOTE 2.1: 2 SPLICE PLATES AND 2 FILL PLATES ARE REQUIRED AT EACH TYPE 1, TYPE 1A, TYPE 2 AND TYPE 2A REPAIR LOCATION.
 NOTE 2.2: DRILL OUT 6 PLUG WELDED RIVET HOLES IN THE LOWER FLANGE AND WEB ANGLES AND REPLACE WITH 7/8" DIAMETER BOLTS.

- 4.1 Contractor to field verify this dimension prior to fabrication.
- 4.2 Remove existing 1/2 inch rivets and replace with 3/8 inch high strength bolts. Typical where shown. Cost of removal shall be incidental to Furnishing & Erecting Structural Steel.
- 4.3 All new bolts shall be 3/8 inch high strength bolts.

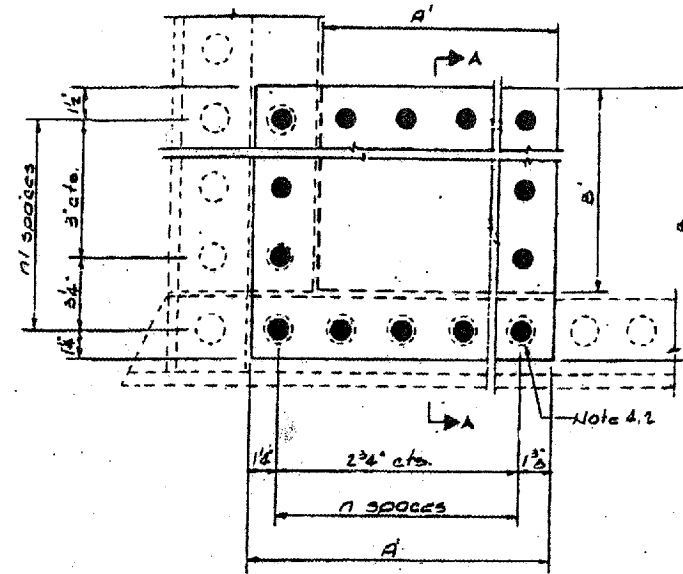
REPAIR DETAIL - TYPE 1A

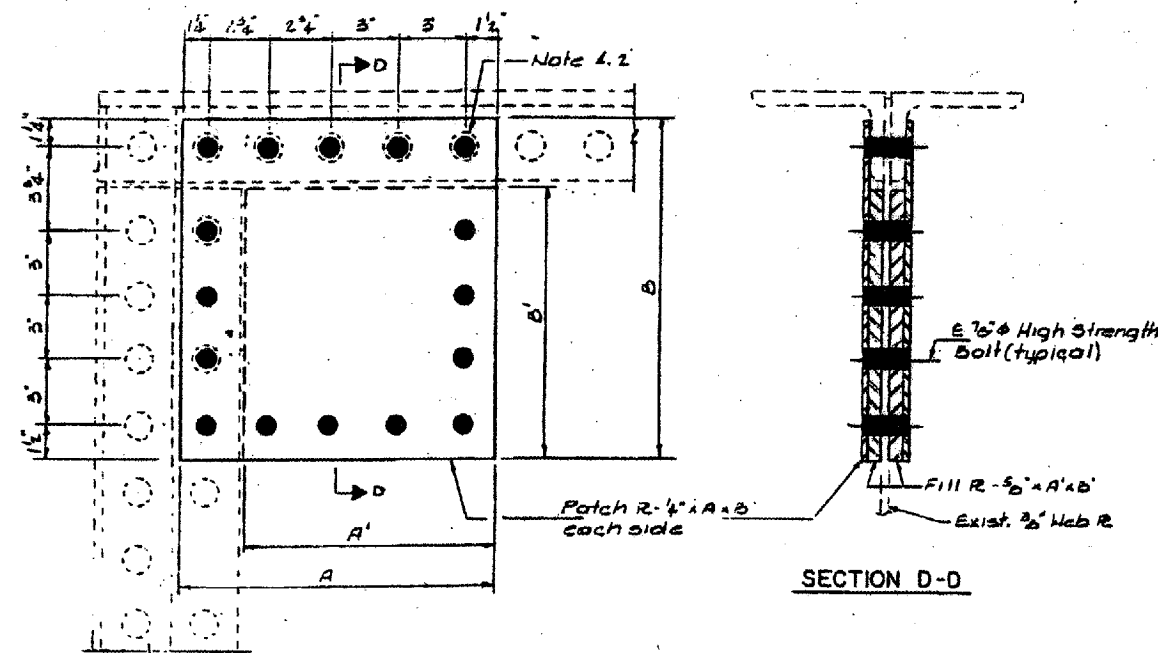
REPAIR DETAIL - TYPE 2

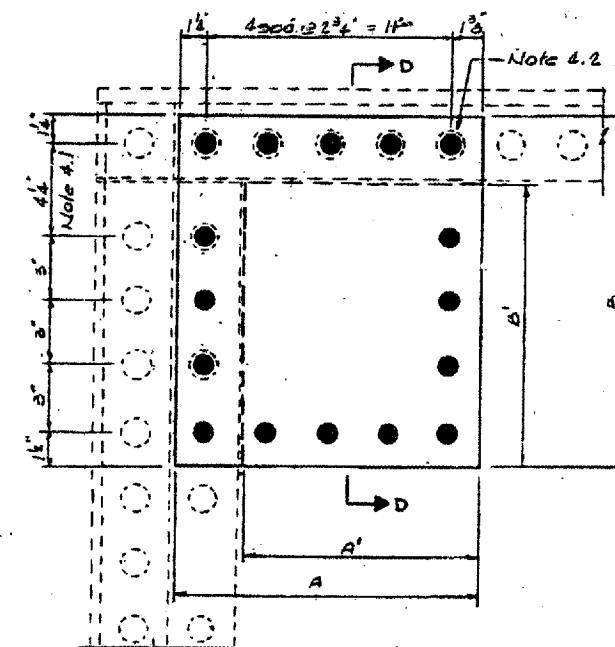
REPAIR DETAIL - TYPE 2A

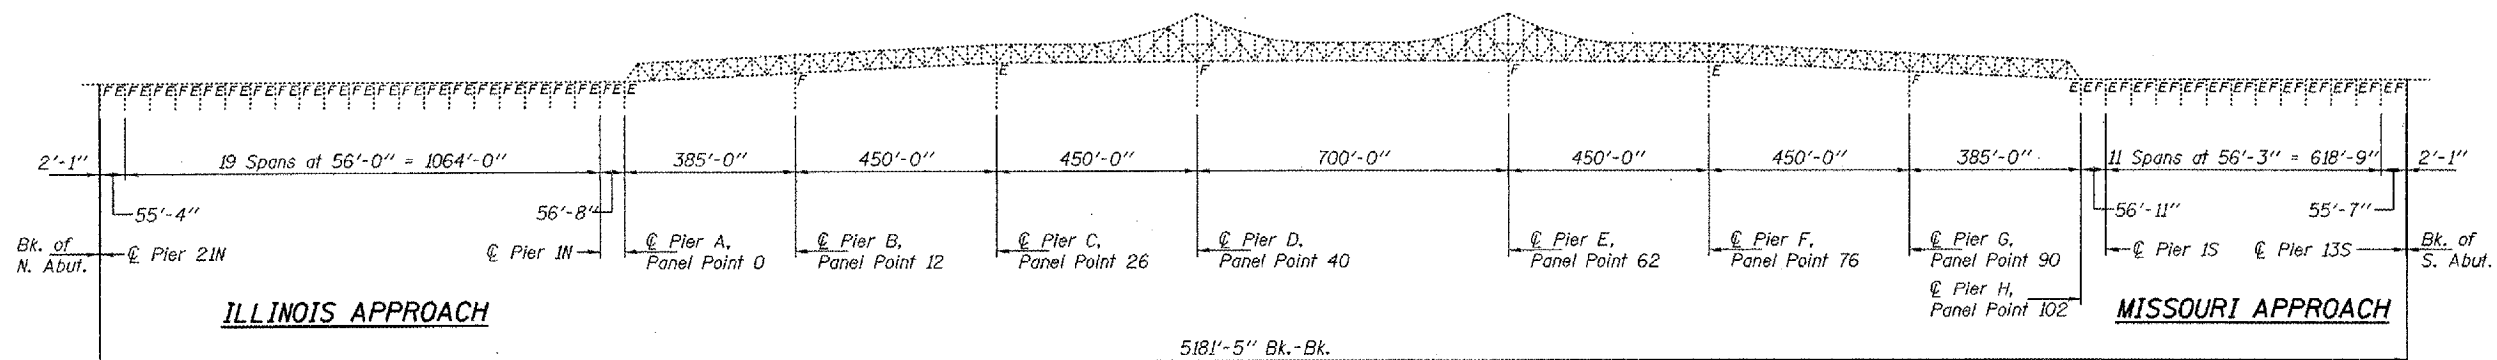
GENERAL ELEVATION

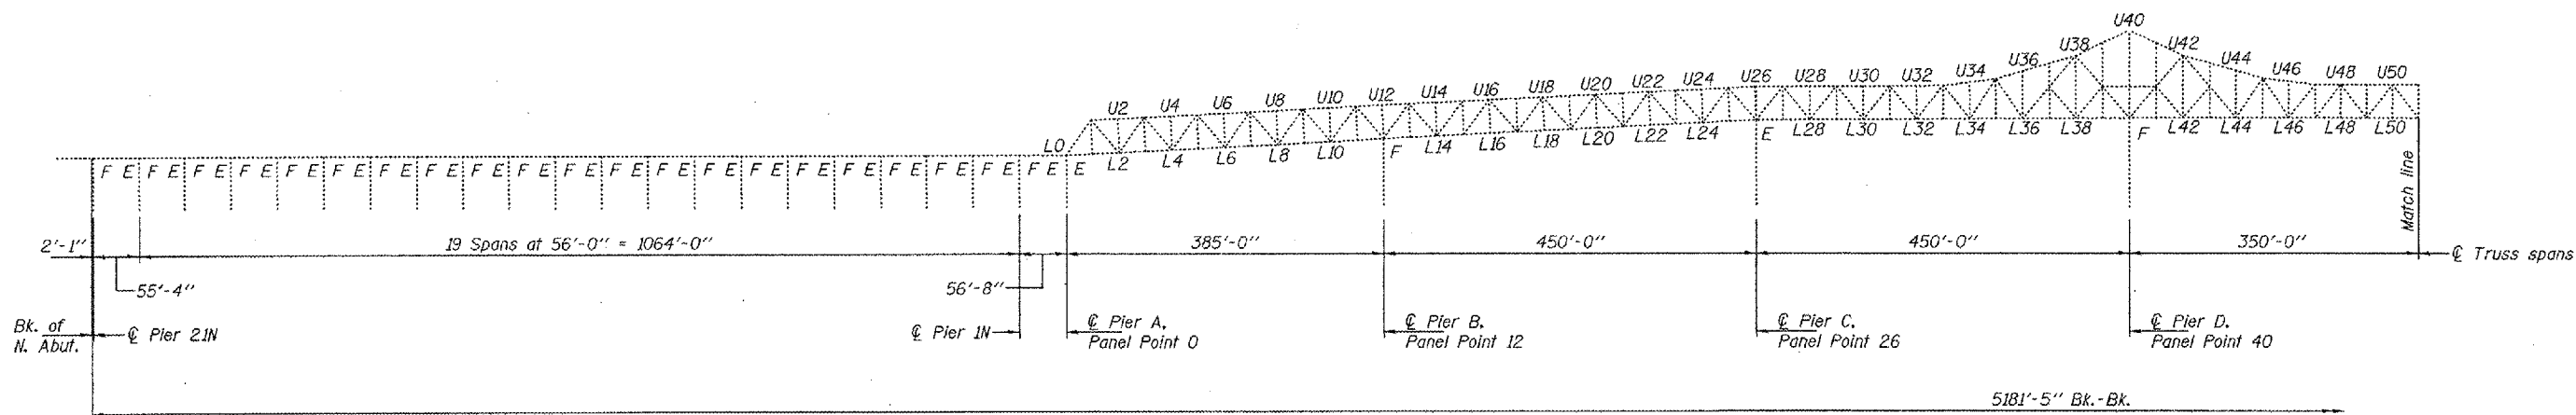
ILLINOIS APPROACH

PARTIAL ELEVATION

- ① - Replace existing 2 1/2" PJS with 1 3/4" Silicone Joint Sealer. See sheet 5 of 13.
- ② - Replace existing Silicone Joint Sealer with Neoprene Expansion Joints, 6 1/2". See sheets 4 thru 6 of 13.

- ③ - Bottom flange repair. See sheet 10 of 13.
- ④ - Remove broken rivets & replace with HS Bolts. See notes, sheet 11 of 13.
- ⑤ - Replace missing bolts with new HS Bolts. See notes, sheet 11 of 13.

- ⑥ - Lower chord repair. See sheet 9 of 13.
- ⑦ - Stringer/girder web repair. See sheets 7 & 8 of 13.
- ⑧ - Remove & replace stringer connector angle. See sheet 10 of 13.

- ⑨ - Floor beam web repair. See sheets 8 & 9 of 13.
- ⑩ - Remove & replace safety loop. See sheet 11 of 13.
- ⑪ - Remove & replace horizontal strut. See sheet 11 of 13.

- ⑫ - Weld repair. See sheet 12 of 13.
- ⑬ - Fill plate repair. See sheet 12 of 13.
- ⑭ - Remove & replace gusset plate. See sheet 12 of 13.
- ⑮ - Grind. See sheet 13 of 13.

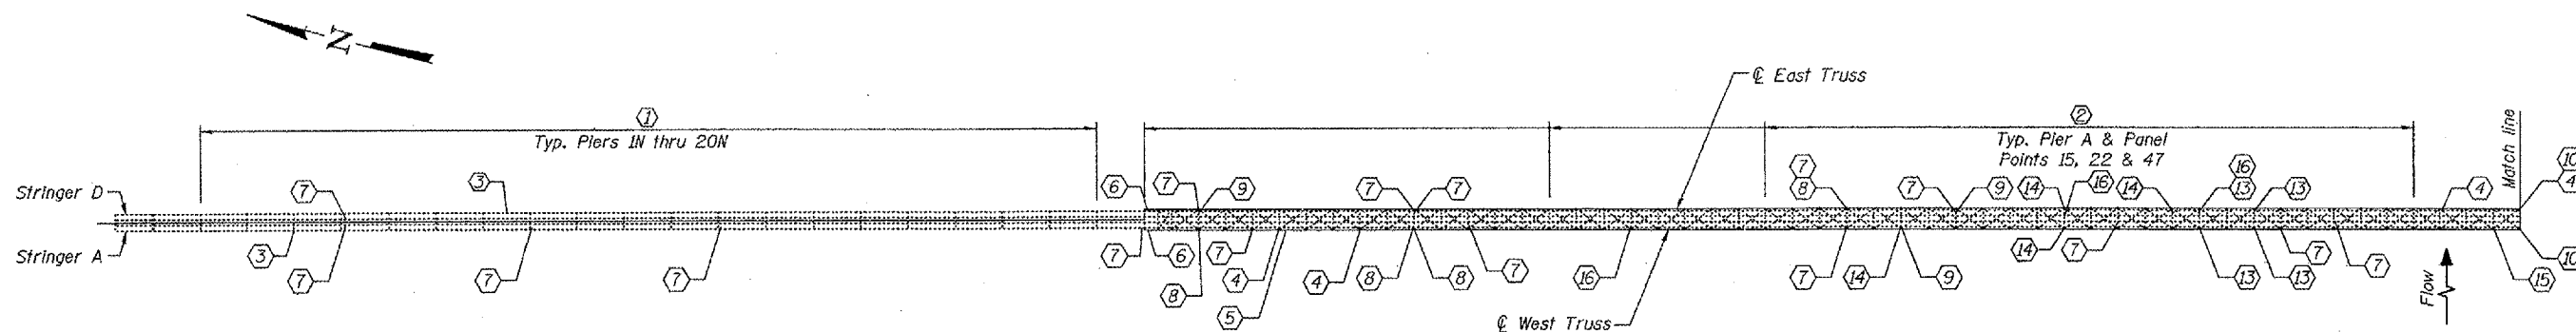
PARTIAL PLAN

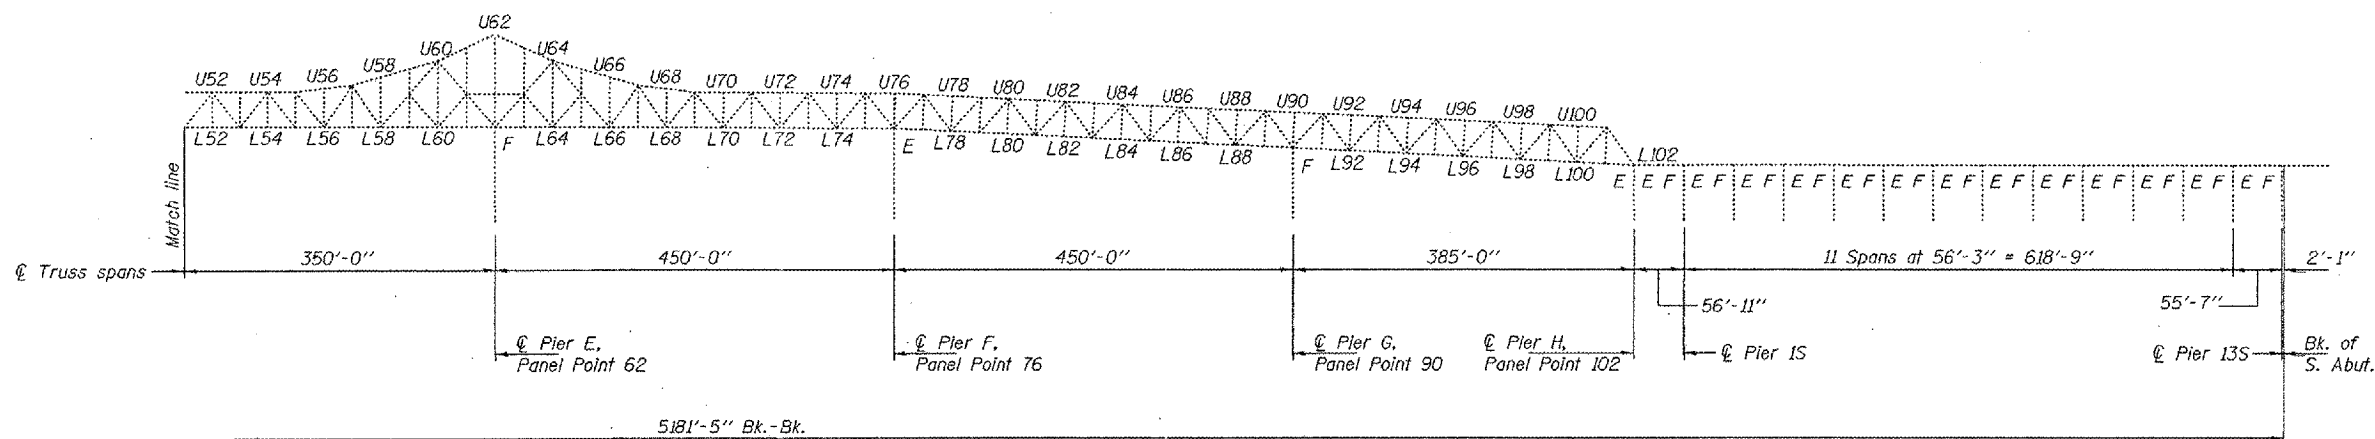
MISSOURI APPROACH

PARTIAL ELEVATION

- ① - Replace existing 2 1/2" PJS with 1 3/4" Silicone Joint Sealer. See sheet 5 of 13.
- ② - Replace existing Silicone Joint Sealer with Neoprene Expansion Joints, 6 1/2". See sheets 4 thru 6 of 13.

- ③ - Bottom flange repair. See sheet 10 of 13.
- ④ - Remove broken rivets & replace with HS Bolts. See notes, sheet 11 of 13.
- ⑤ - Replace missing bolts with new HS Bolts. See notes, sheet 11 of 13.

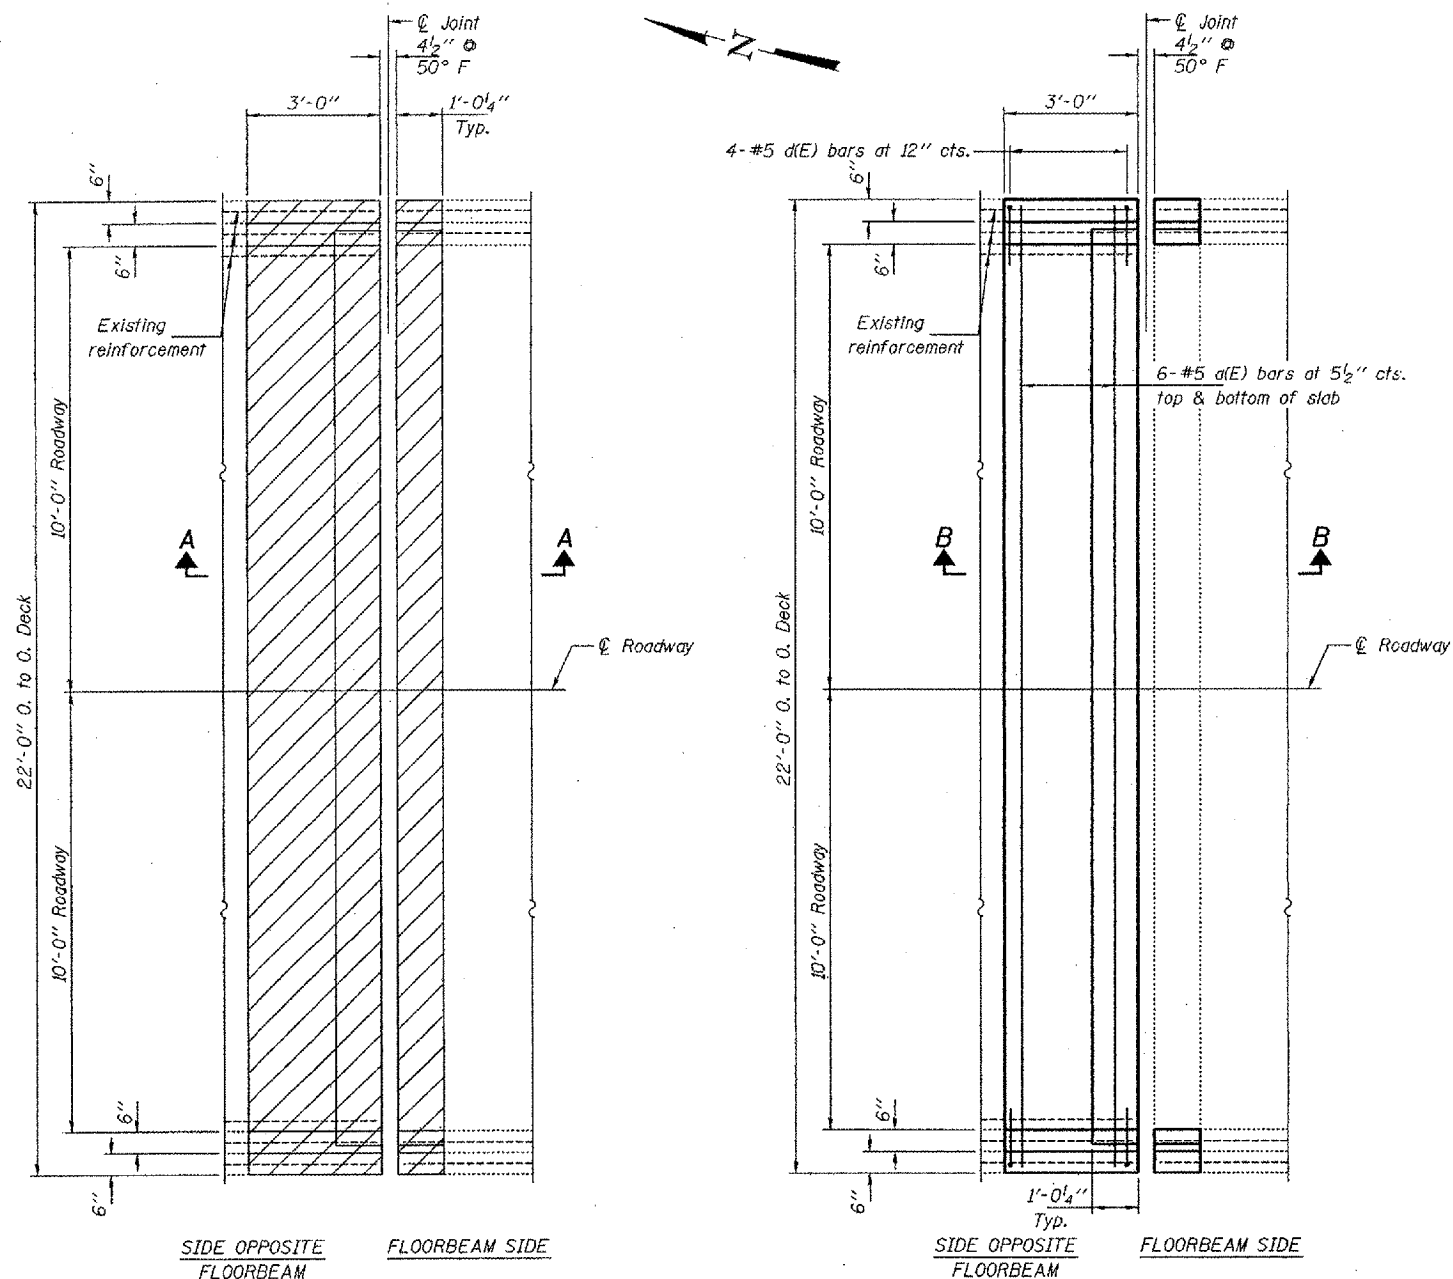
SIDE OPPOSITE FLOORBEAM FLOORBEAM SIDE

**PARTIAL PLAN
SHOWING CONCRETE REMOVAL**

Notes:
For Sections C-C, D-D & E-E, see sheet 5 of 13.
Hatched areas indicate
Concrete removal.

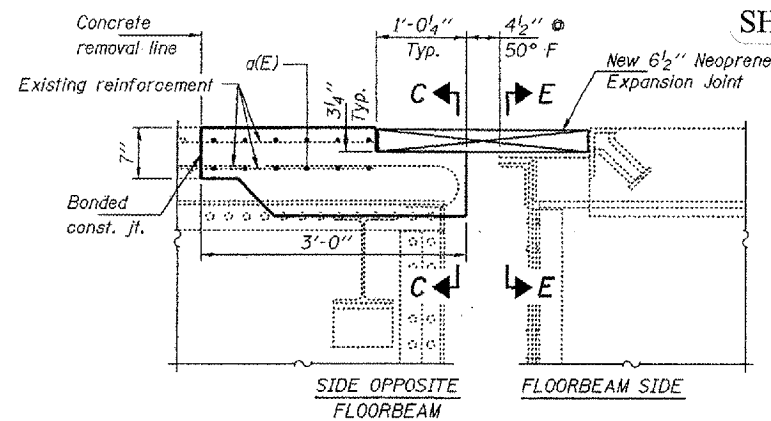
**SECTION B-B
AT PIERS A & H**
(Pier A shown. Pier H similar by rotation)

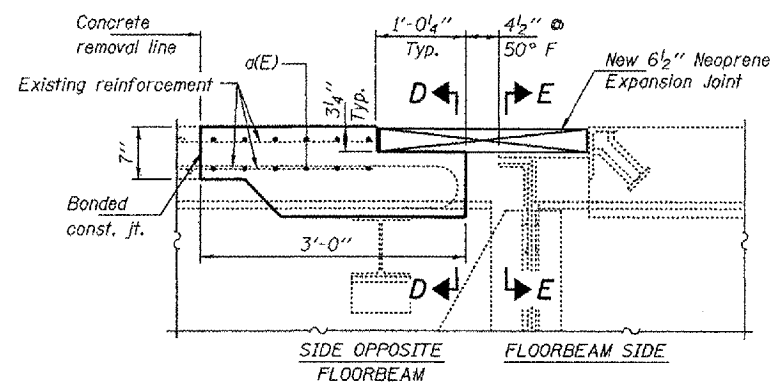
**SECTION B-B
AT PANEL POINTS 15, 23, 47, 55, 79 & 87**
(Panel Points 15, 47 & 79 shown.
Panel Points 23, 55 & 87 similar by rotation)

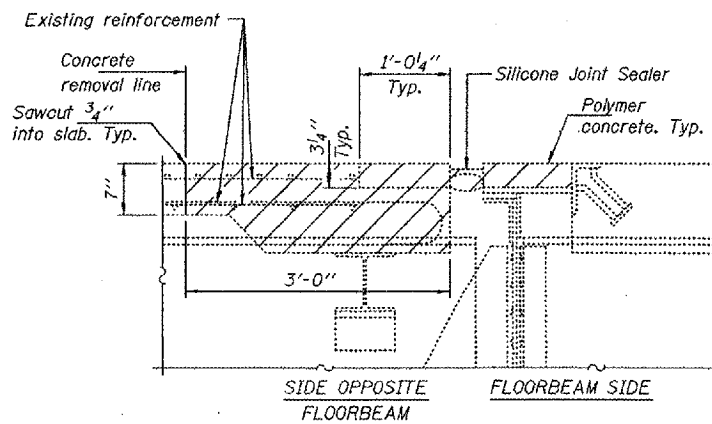
**SECTION A-A
AT PIERS A & H, & PANEL POINTS 15, 23, 47, 55, 79 & 87**
(Pier A & Panel Points 15, 47 & 79 shown.
Pier H & Panel Points 23, 55 & 87 similar by rotation)

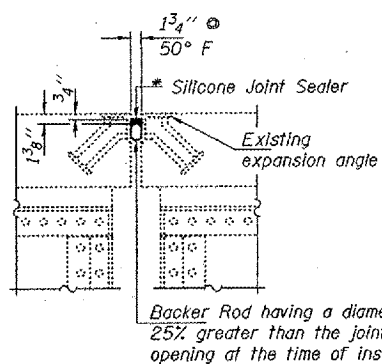
**SECTION AT PIERS 19N & 20N
& PIERS 1S THRU 12S**

REPAIR 1

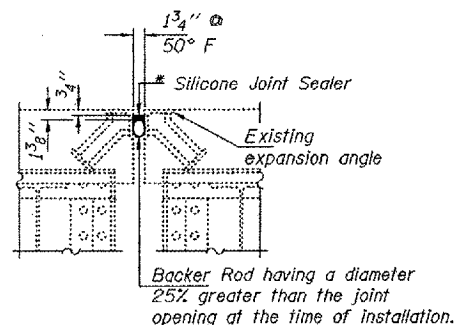
SECTION AT PIERS IN THRU 18N

* Remove existing PJS, & replace with Silicone Joint Sealer as shown.

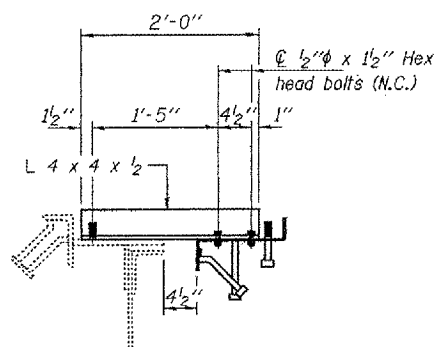
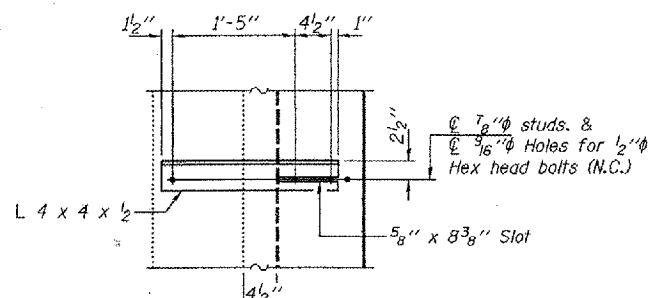
CROSS SECTION

PLAN

ALIGNMENT ANGLE DETAIL

Note: Alignment System shall be in place prior to the deck pour and remain until the concrete has cured.

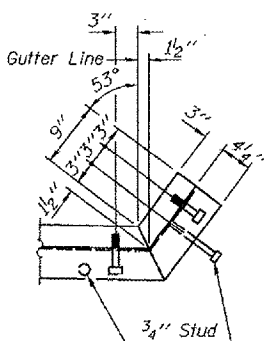
END FRAME TREATMENT

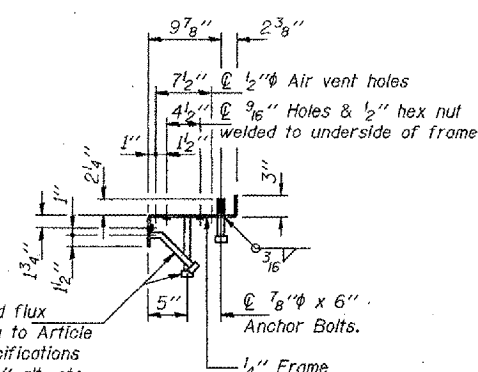
SIDE OPPOSITE
FLOORBEAM
FRAME DETAIL

Cost of Frame is included with Neoprene Expansion Joint (6 1/2'')

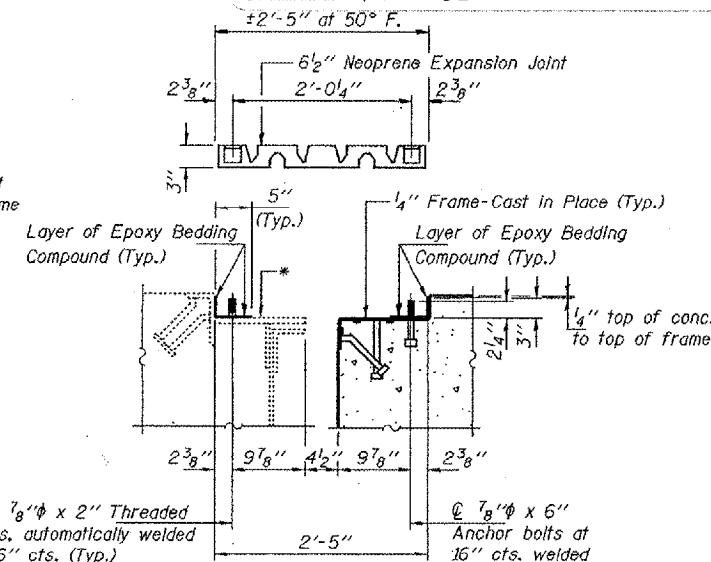
**SECTION THRU NEOPRENE
EXPANSION JOINT (6 1/2'')**
(TRANSFLEX MODEL 650)

* After removal of the existing polymer concrete, all existing threaded studs welded to the top flange shall be removed, and the remaining weld shall be ground smooth. The steel surface shall be blast cleaned according to SSPC-SP10 and primed with organic zinc rich paint. Cost included with Neoprene Expansion Joint, 6 1/2'.

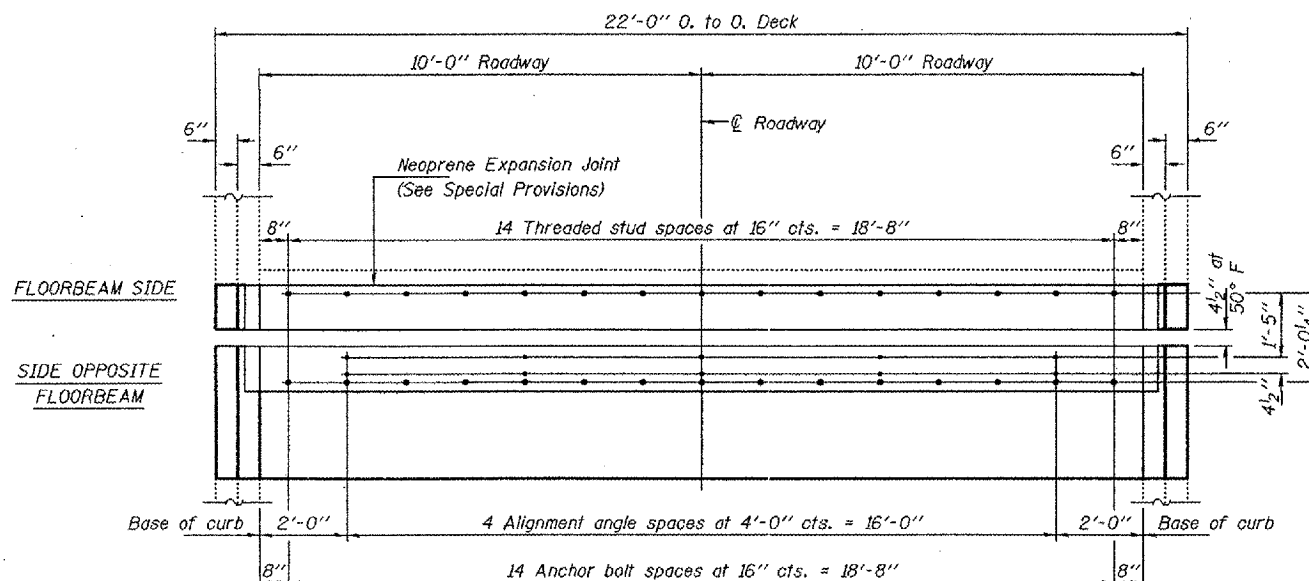
PLAN NEOPRENE EXPANSION JOINT

(Looking south at Pier A & Panel Points 15, 47 & 79.
Pier H & Panel Points 23, 55 & 87 similar by rotation)

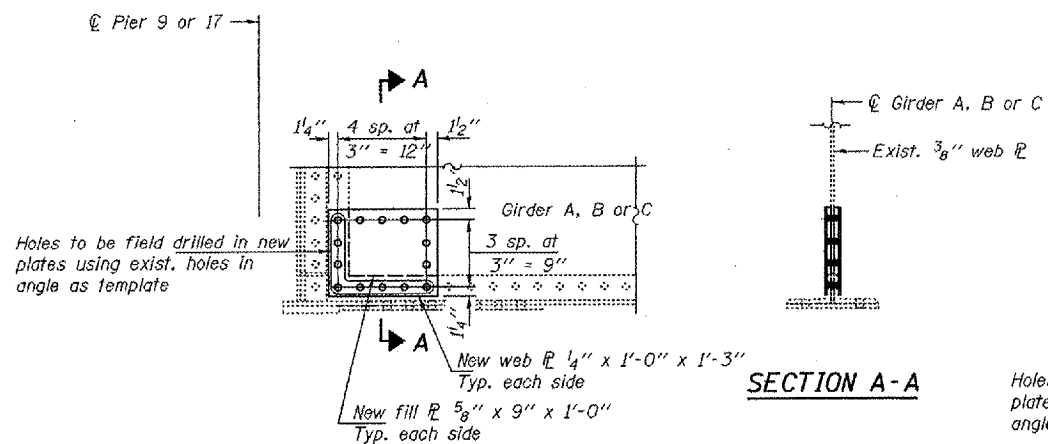
ELEVATION
Looking east

REPAIR 7
Pier 9, Girder B
Pier 17, Girders B & C

- ⑥ - Lower chord repair. See sheet 9 of 13.
- ⑦ - Stringer/girder web repair. See sheets 7 & 8 of 13.
- ⑧ - Remove & replace stringer connector angle. See sheet 10 of 13.

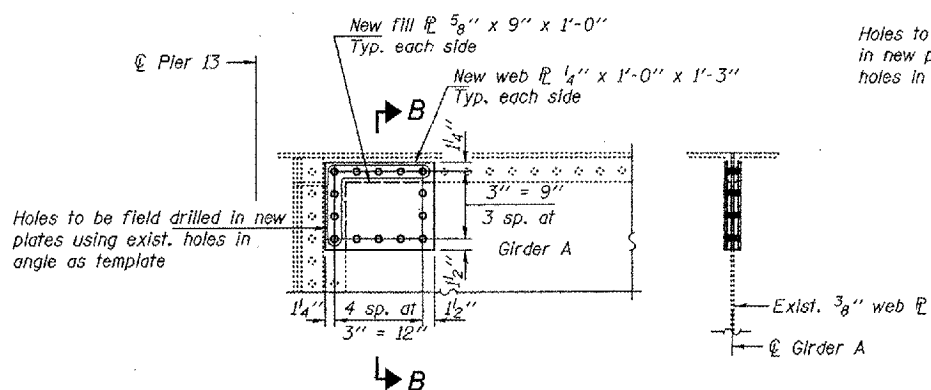
ELEVATION
Looking east

REPAIR 7
