**PROPOSED
HIGHWAY PLANS**

FAS ROUTE 944 (U.S. 60/62)
SECTION (138D-BR) P-1
ALEXANDER COUNTY, ILLINOIS
MISSISSIPPI COUNTY, MISSOURI
C-99-002-06

IMPROVEMENT LOCATION
STRUCTURE 002-0005
PAINT STRUCTURAL STEEL
AT SPECIFIED LOCATIONS

BRIDGE NO. 1
 STRUCTURE 002-0005
 FOR INFORMATION ONLY

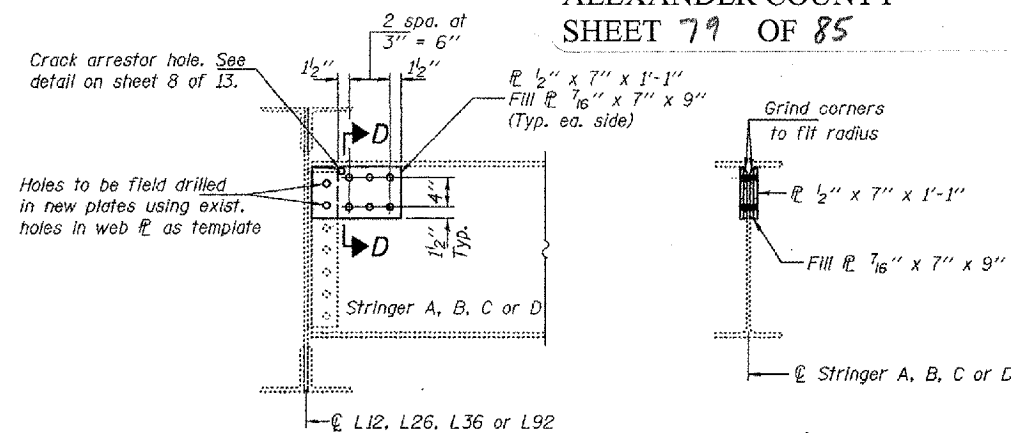
ELEVATION - STRINGER END

L12, looking west
L26, Stringer A, looking west
L26, Stringer D, looking east
L36, looking east
L92, looking west

REPAIR 7
L12, Stringer B
L26, Stringers A & D
L36, Stringer A
L92 Stringers C & D

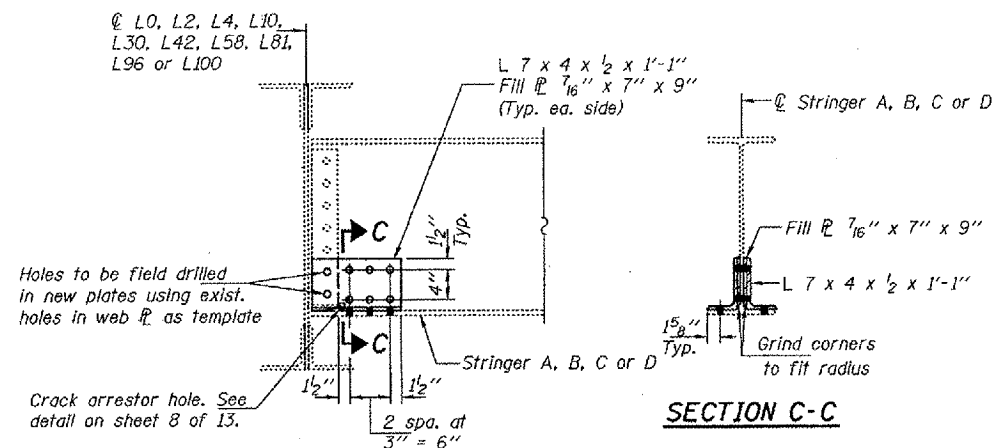
ELEVATION - STRINGER END
REPAIR 7

Looking east except as noted:
L4, looking west
L10, Stringer A, looking west
L10, Stringer D, looking east

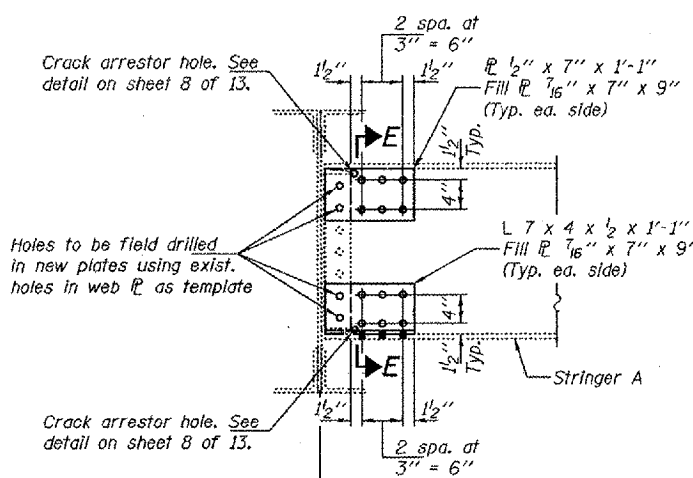
ELEVATION - STRINGER END
(Looking west)

REPAIR 7

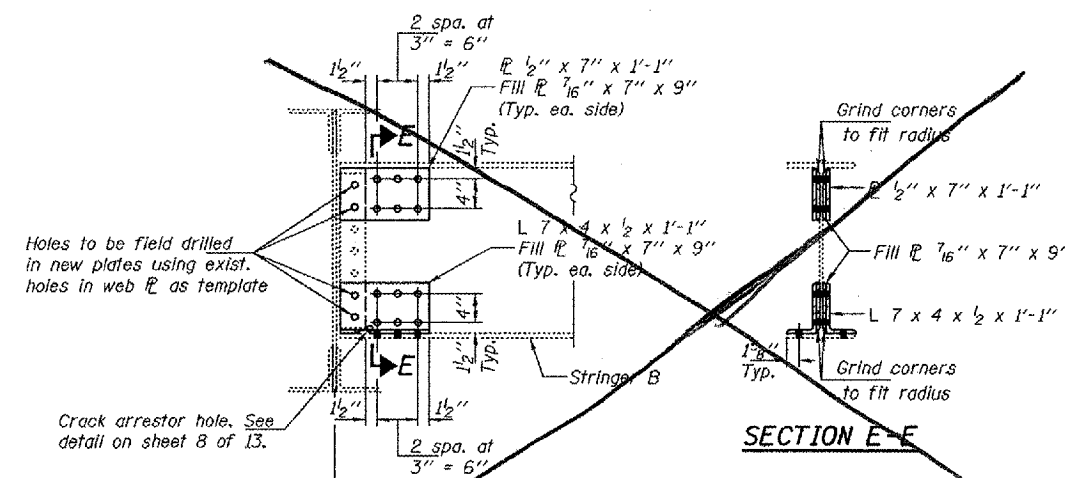
ELEVATION - STRINGER END
(Looking west)

REPAIR 7

Note:
Temporary shoring & cribbing will not be required provided that upper & lower repairs are not done simultaneously.

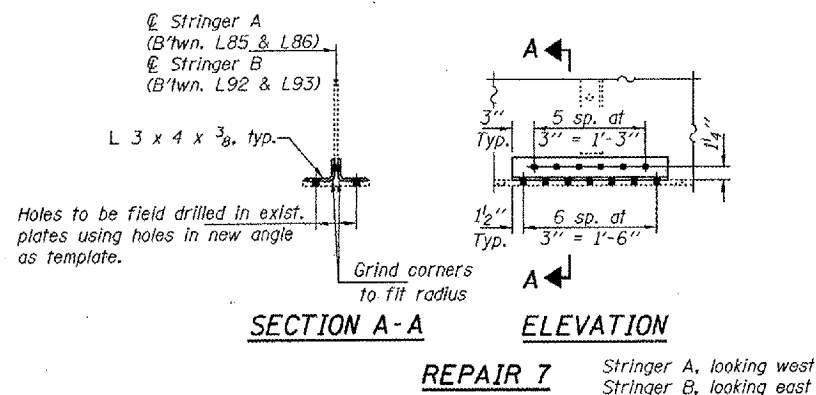
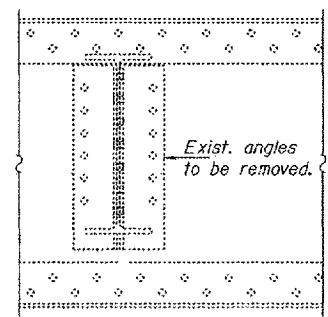
ELEVATION
(Existing)

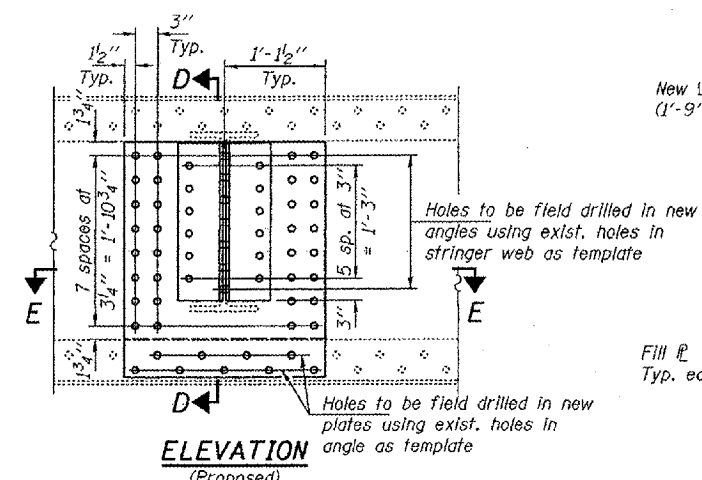
ELEVATION
(Proposed)

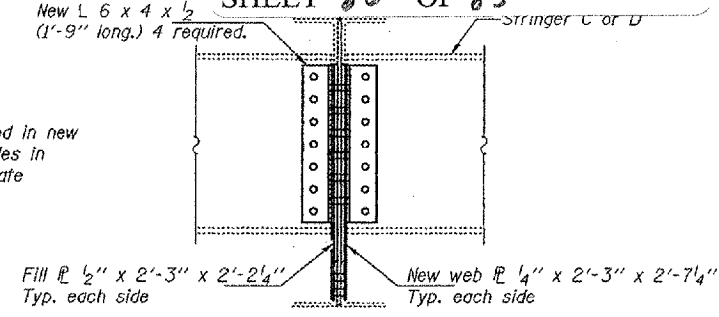
SECTION D-D

Note:
Temporary shoring & cribbing
of stringer end is required.

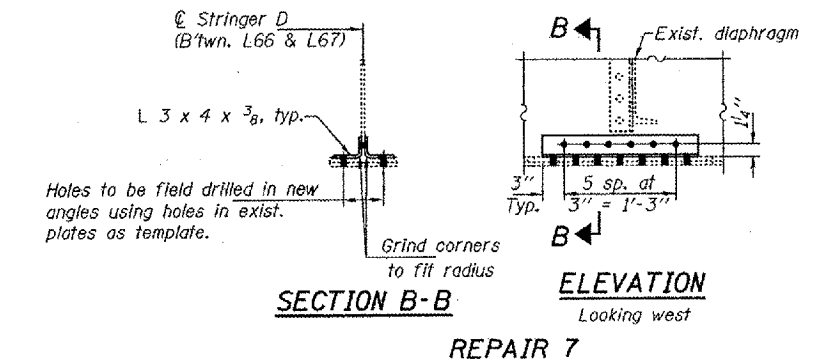
SECTION B-B

ELEVATION

REPAIR 7

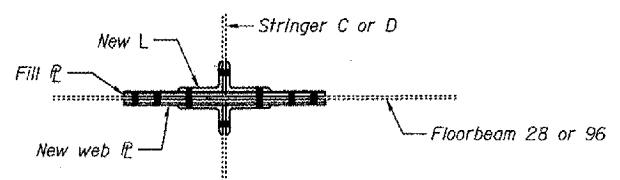
SECTION E-E

REPAIR 9

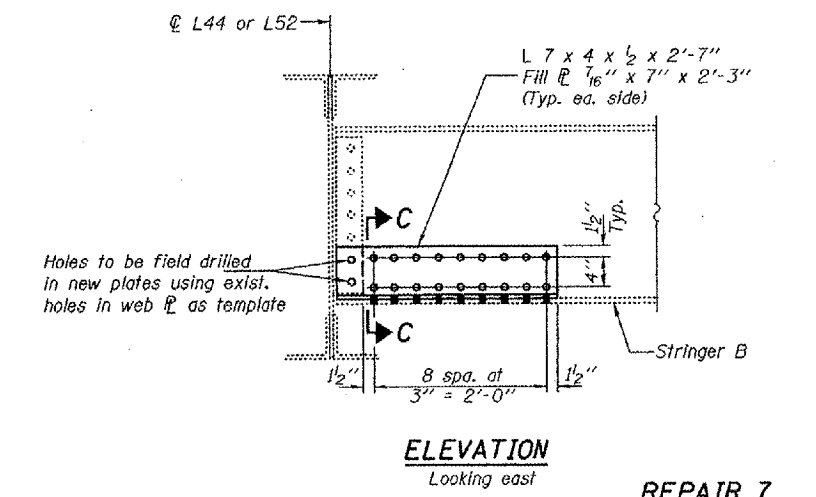
ELEVATION

Looking east

REPAIR 7

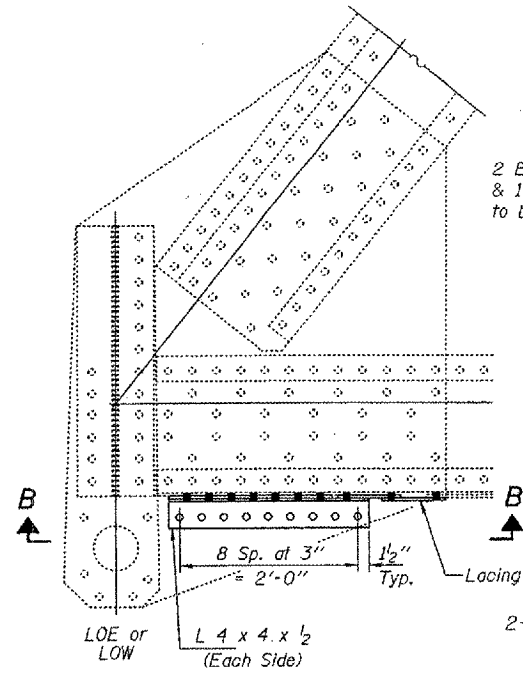
ELEVATION LOWER CHORD REPAIR

REPAIR 6

- ⑥ - Lower chord repair. See sheet 9 of 13.
- ⑦ - Stringer/girder web repair. See sheets 7 & 8 of 13.
- ⑧ - Remove & replace stringer connector angle. See sheet 10 of 13.

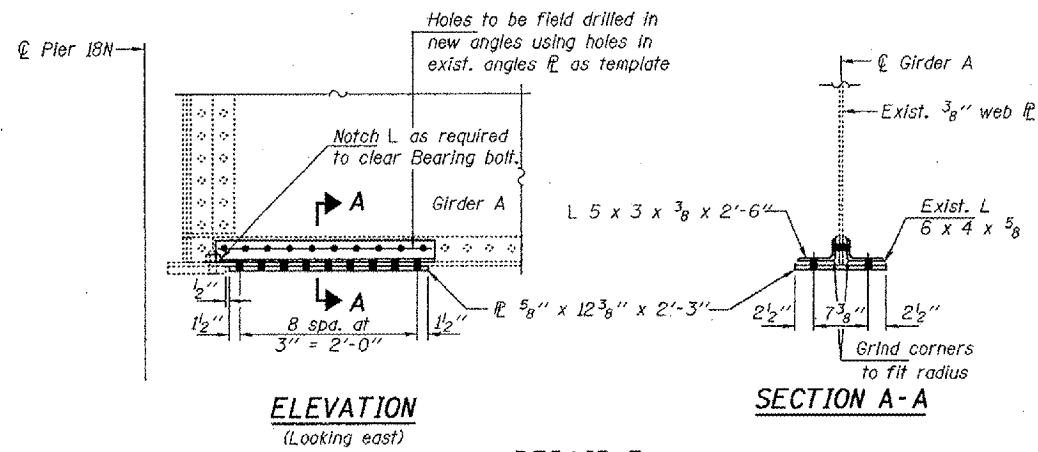
REPAIR 3

- ③ - Bottom flange repair. See sheet 10 of 13.
- ④ - Remove broken rivets & replace with HS Bolts. See notes, sheet 11 of 13.
- ⑤ - Replace missing bolts with new HS Bolts. See notes, sheet 11 of 13.

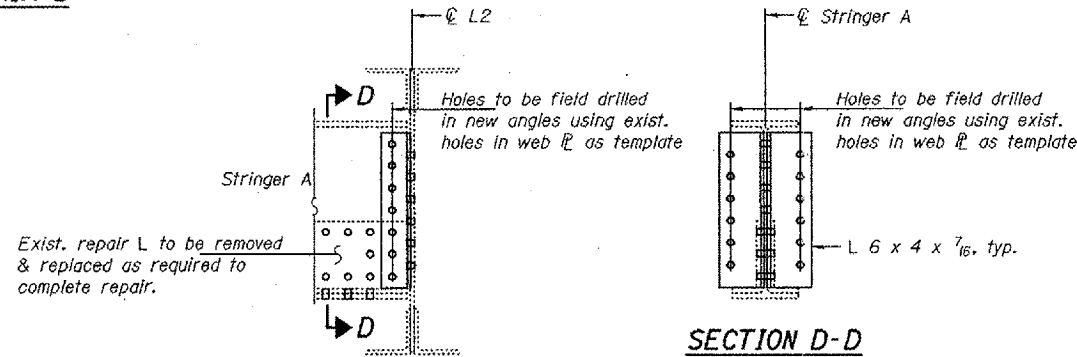
REPAIR 8

Note:
Temporary shoring & cribbing
of stringer end is required.

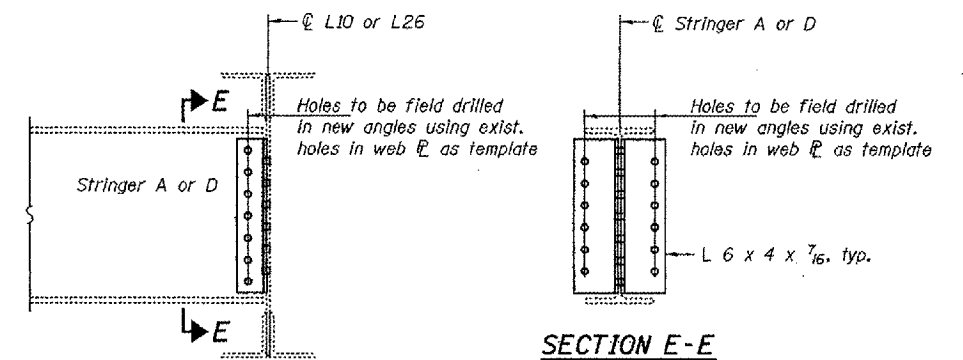
REPAIR 8

L10, Stringers A & D
L26, Stringer D

Note:
Temporary shoring & cribbing
of stringer end is required.

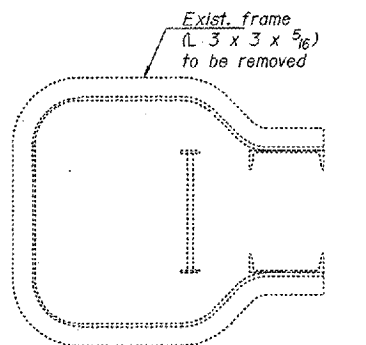
REPAIR 10
SAFETY LOOP ANGLE REPAIR
Typ. each truss

Existing

- ⑨ - Floorbeam web repair. See sheets 8 & 9 of 13.
- ⑩ - Remove & replace safety loop. See sheet 11 of 13.
- ⑪ - Remove & replace horizontal strut. See sheet 11 of 13.

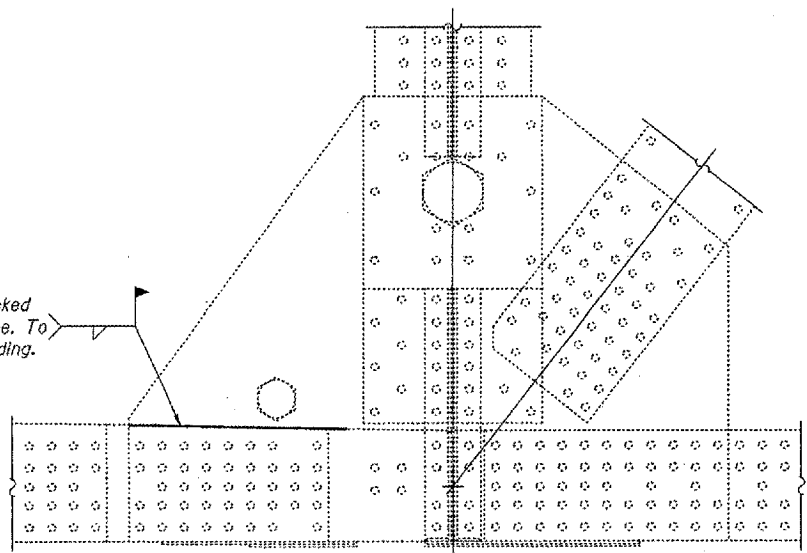
Existing 2 9/16" cracked
weld on outside face. To
be removed by grinding.

L55
REPAIR 12

- ⑫ - Weld repair. See sheet 12 of 13.
- ⑬ - Fill plate repair. See sheet 12 of 13.
- ⑭ - Remove & replace gusset plate. See sheet 12 of 13.
- ⑮ - Grind. See sheet 13 of 13.

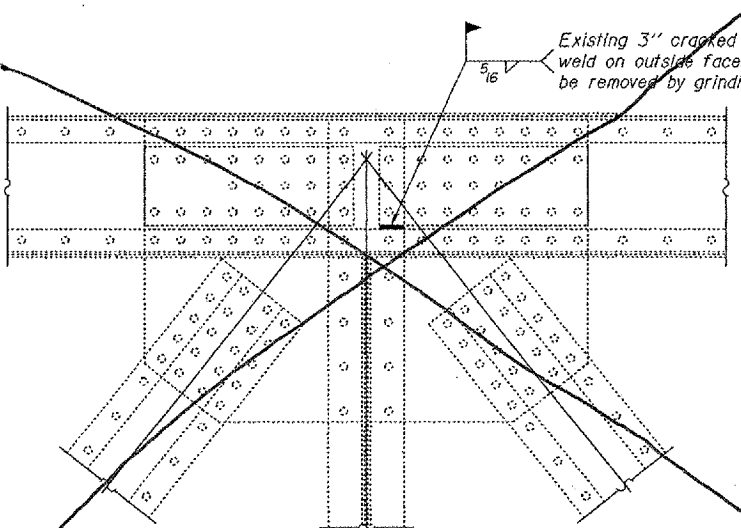
Existing 3" cracked
weld on outside face. To
be removed by grinding.

U80W
INSIDE FACE

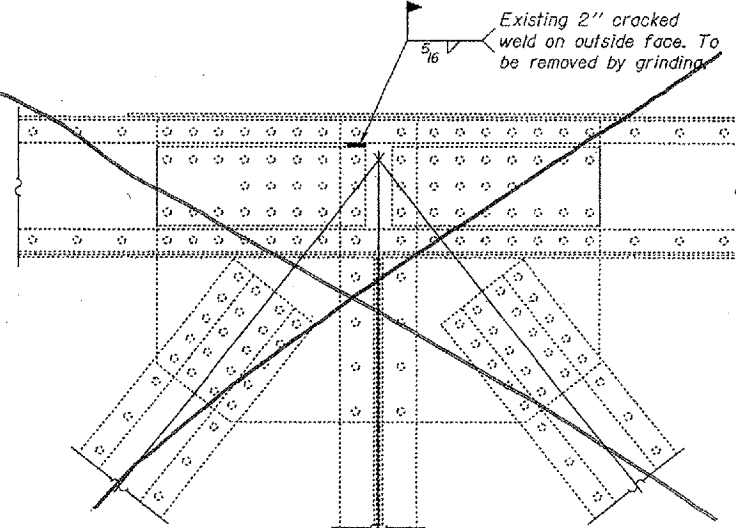
Existing 2" cracked
weld on outside face. To
be removed by grinding.

REPAIR 12
OUTSIDE FACE

Note:
The cost of weld removal &
field welding is included with
Structural Steel Repair.

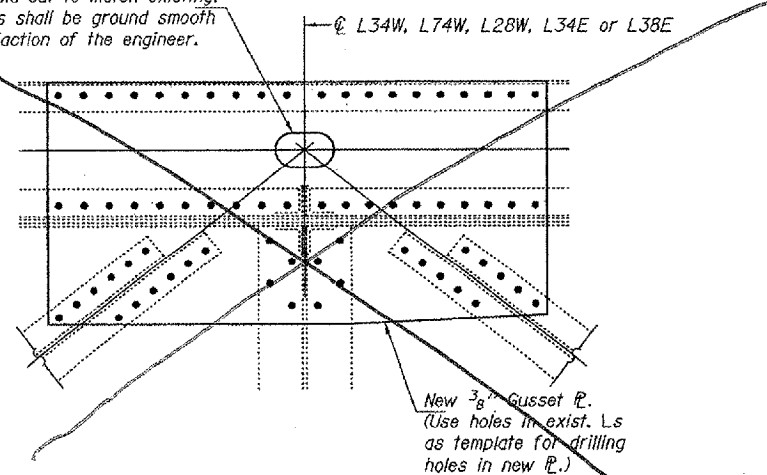
Handhole. Field cut to match existing.
All cut edges shall be ground smooth
to the satisfaction of the engineer.

GUSSET PLATE REPAIR
REPAIR 14

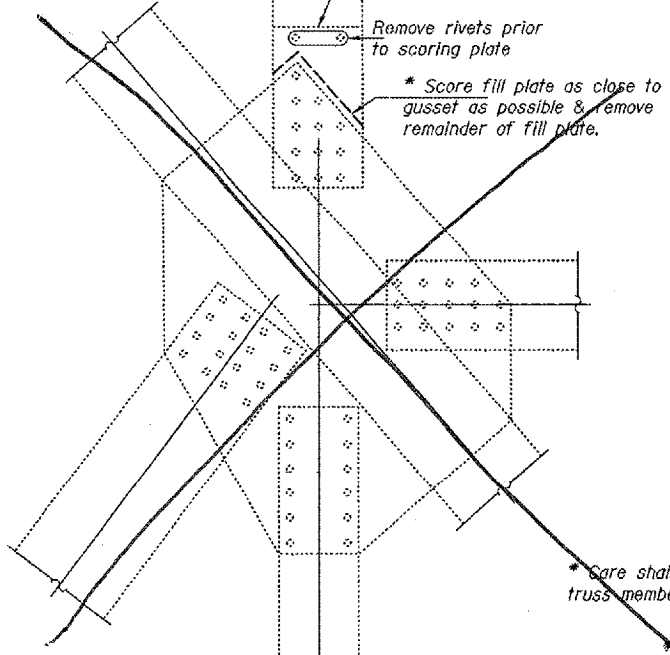
U39E-L39E, U39W-L39W,
U41E-L41E, U41W-L41W,
U61E-L61E, U61W-L61W,
U63W-L63W or U63E-L63E
REPAIR 13

Existing 4" cracked
weld on outside face. To
be removed by grinding.

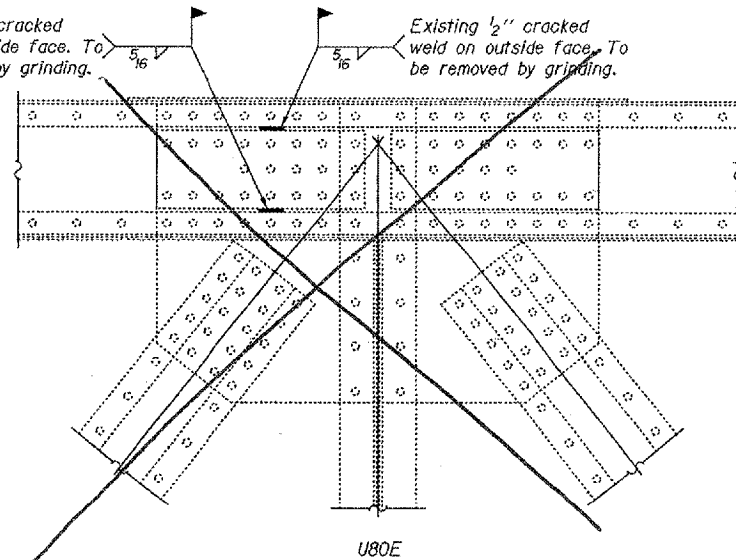
U80E
INSIDE FACE
REPAIR 12

Existing 1/2" cracked
weld on outside face. To
be removed by grinding.

* Care shall be taken not to damage any
truss members during the removal process.

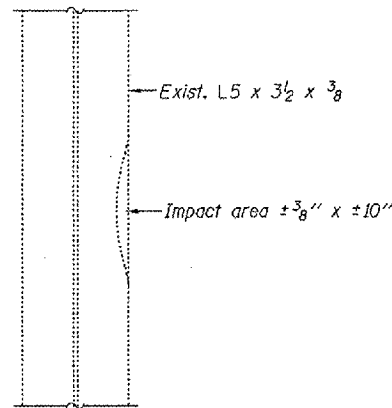
REPAIR 16
L18W-U18W, looking west

Impacted areas shall be straightened.
See special provision Straighten Bent Members.
Cost included with Straighten Bent Members.
Typical for repair 16.

Grind existing nicks, gouges and shallow cracks in the damaged areas as detailed. Ground surfaces shall be inspected for cracks using magnetic particle testing prior to initiating any straightening operations. Cost included with Structural Steel Repair. Any cracks that cannot be removed by grinding approximately 1/4\"/>
