STATE OF ILLINOIS  
DEPARTMENT OF TRANSPORTATION

**REPAIR DETAILS**  
 SN 099-0171

SHEET NO. 2 3 SHEETS	F.A.U. RTE. 0327	SECTION 112 BR-I-1	COUNTY WILL	TOTAL SHEETS 28	SHEET NO. 13
	FED. ROAD DIST. NO. ILLINOIS FED. AID PROJECT			CONTRACT NO. 60H86

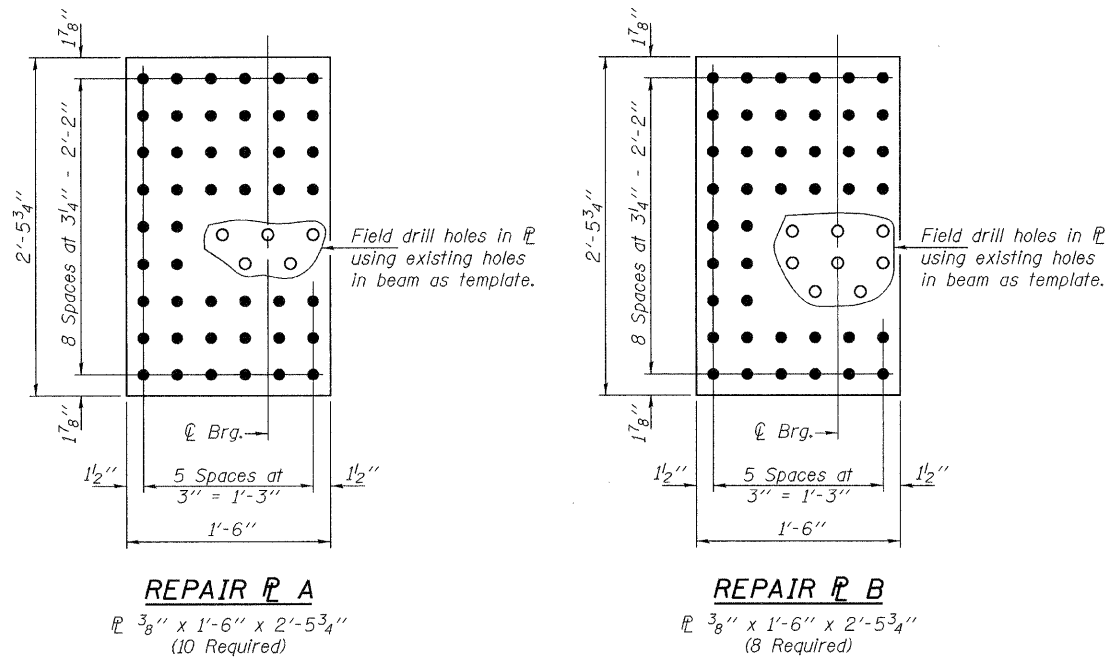
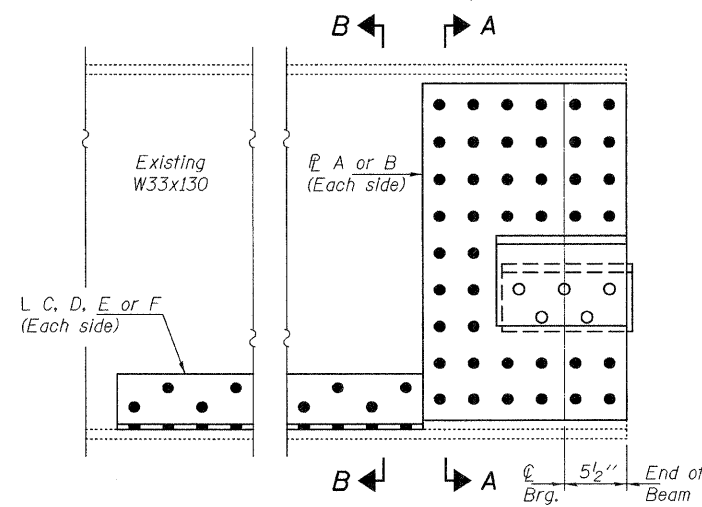
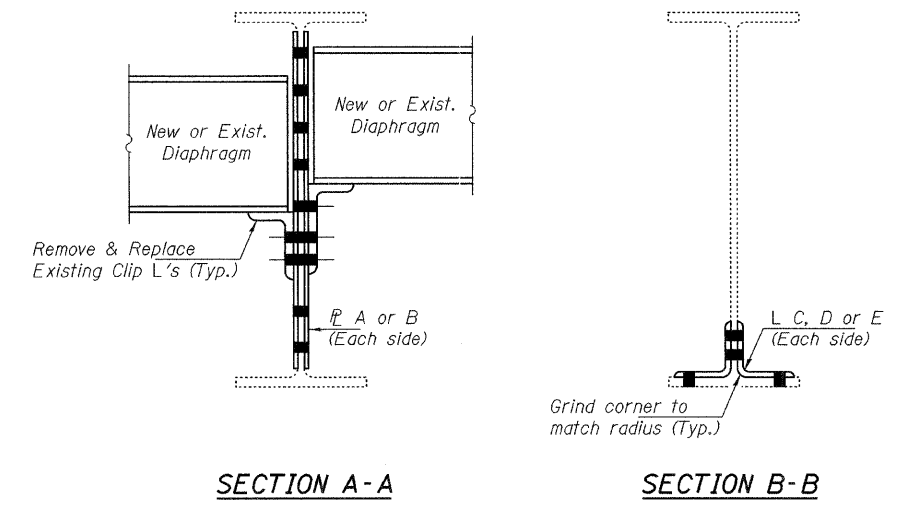
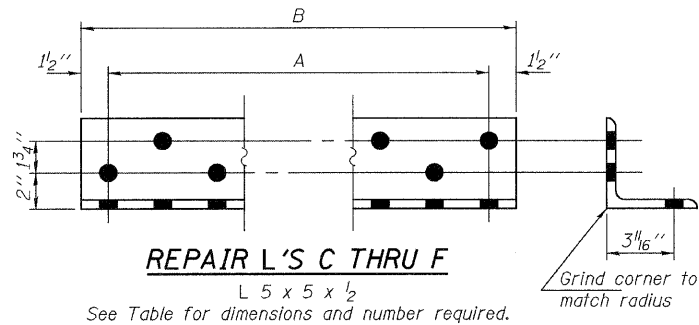
**TYPICAL BEAM END REPAIR DETAIL**  
 New or Existing Diaphragms not shown for clarity.

Repair	Plates	Angles	Looking
(B)	A	none	West
(C)	A	C	West
(D)	A	F	East
(E)	A	C	West
(F)	B	none	West
(G)	B	E	East
(H)	B	C	East
(I)	B	D	West
(J)	A	D	East

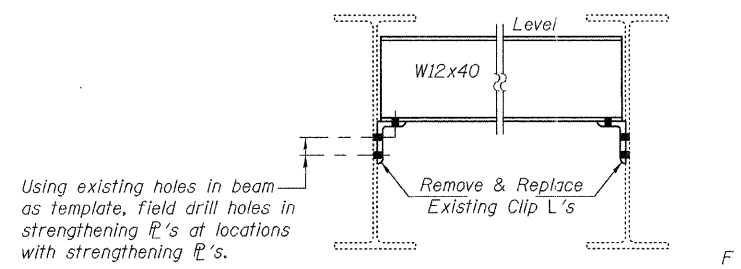
**DIAPHRAGM REPLACEMENT DETAIL**

**Notes:**  
 Strengthening & Repair PL's & L's not shown for clarity.  
 Natural camber of new beam shall be placed upward for fabrication.  
 Cost of furnishing and installing PL's & L's included with Structural Steel Repair.  
 New diaphragms & clip angles are included with Furnishing & Erecting Structural Steel.
