**ABBREVIATED STRUCTURE GEOTECHNICAL REPORT  
RAMP RECONSTRUCTION AT KAMPSVILLE FERRY**

**IL 108 KAMPSVILLE FERRY  
SECTION 101RS-LOT-1  
CALHOUN AND GREENE COUNTY, ILLINOIS  
PTB 183 ITEM 15 - IL ROUTE 108**

**CONTRACT NO. 76L96  
JOB NO.: P-98-040-16 / D-90-040-16  
STRUCTURE NO. TBD**

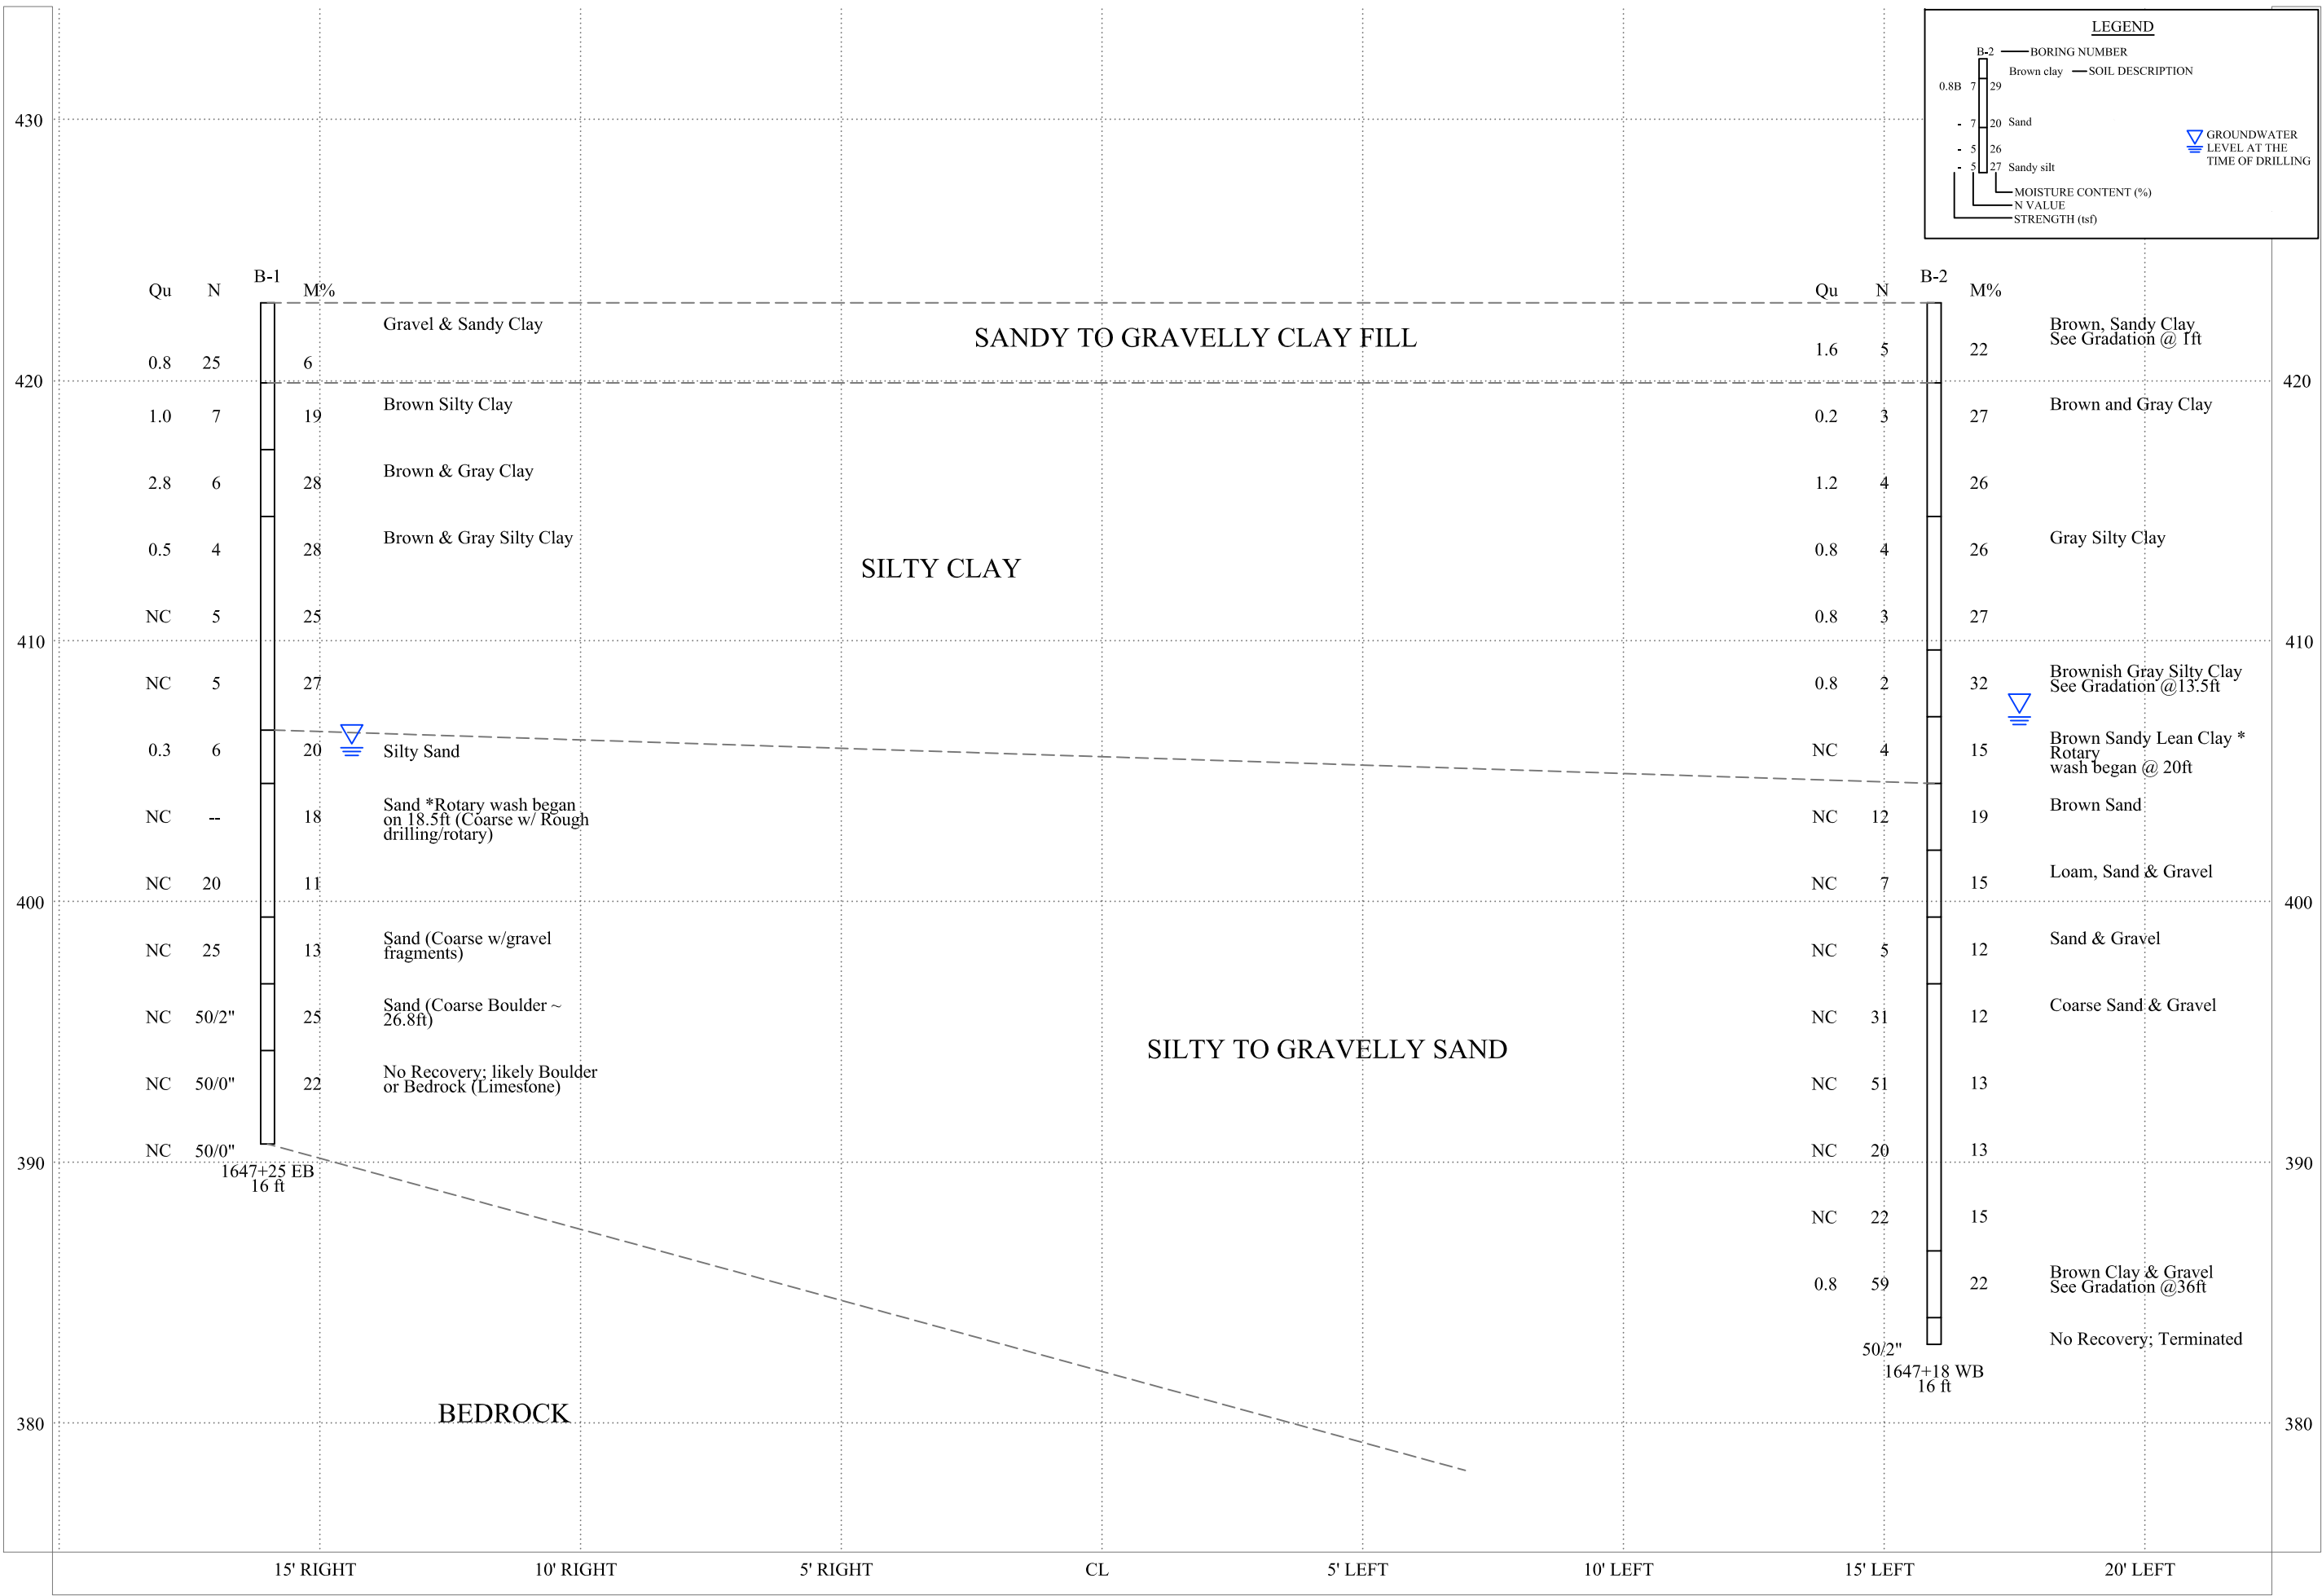
VARIATIONS IN SUBSURFACE CONDITIONS MAY AND LIKELY EXIST BETWEEN BORINGS. DASHED HORIZONS ARE INTERPRETED AND ARE SHOWN FOR ILLUSTRATION ONLY.

The Unconfined Compressive Strength (UCS) Failure Mode is indicated by (B-Bulge, S-Shear, P-Penetrometer)  
The SPT (N value) is the sum of the last two blow values in each sampling zone (AASHTO T206)
