STATE OF ILLINOIS
 DEPARTMENT OF TRANSPORTATION

MAIN SPAN GUSSET PLATE STRENGTHENING - 9A
 S.N. 082-6001 MLK BRIDGE OVER MISSISSIPPI RIVER

SHEET NO. S54A OF S138 SHEETS

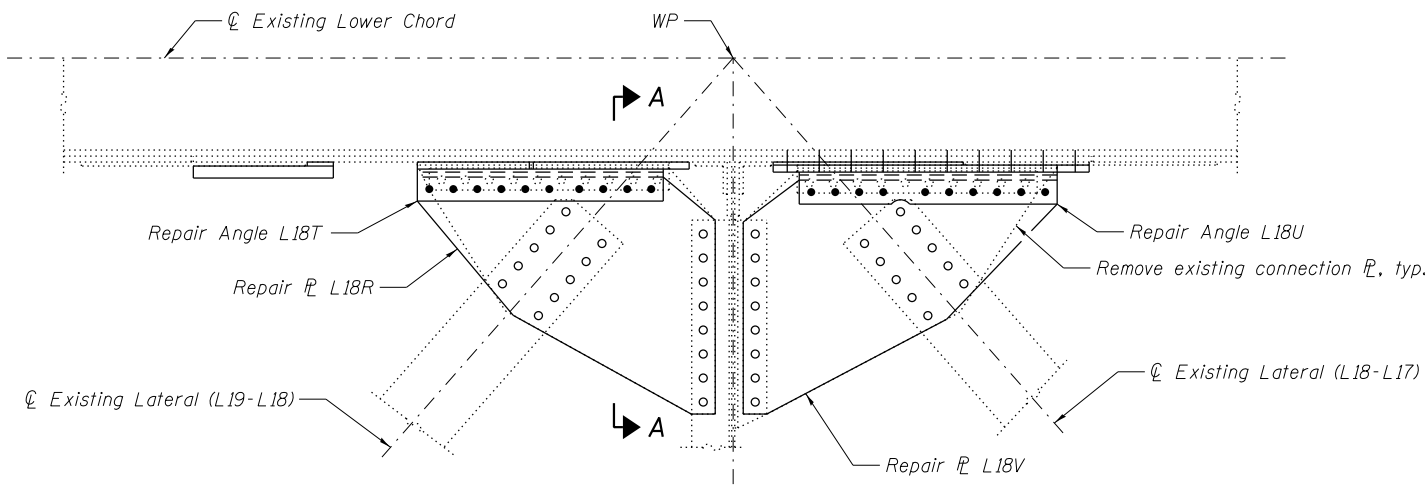
LOWER LATERAL AT PANEL POINT L18N AND L18S
(L18'N AND L18'S SIMILAR)
 (Span 10)

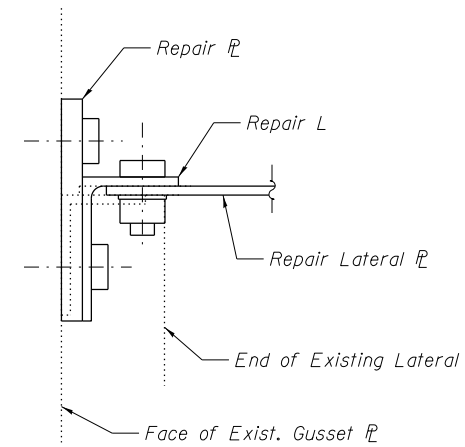
SECTION A-A

Note A:
 Field drill holes using existing holes as template.
 Remainder of holes may be shop or field drilled.
