CONCRETE REMOVAL & REPAIR
NORTH ABUTMENT
STRUCTURE NO. 025-0001

SHEET NO. 18 27 SHEETS	F.A.I. RTE.	SECTION	COUNTY	TOTAL SHEETS	SHEET NO.
	57	(25-3HB)I-2	EFFINGHAM	1416	1372
SN 025-0001			CONTRACT NO. 74296		
FED. ROAD DIST. NO. 7 ILLINOIS FED. AID PROJECT

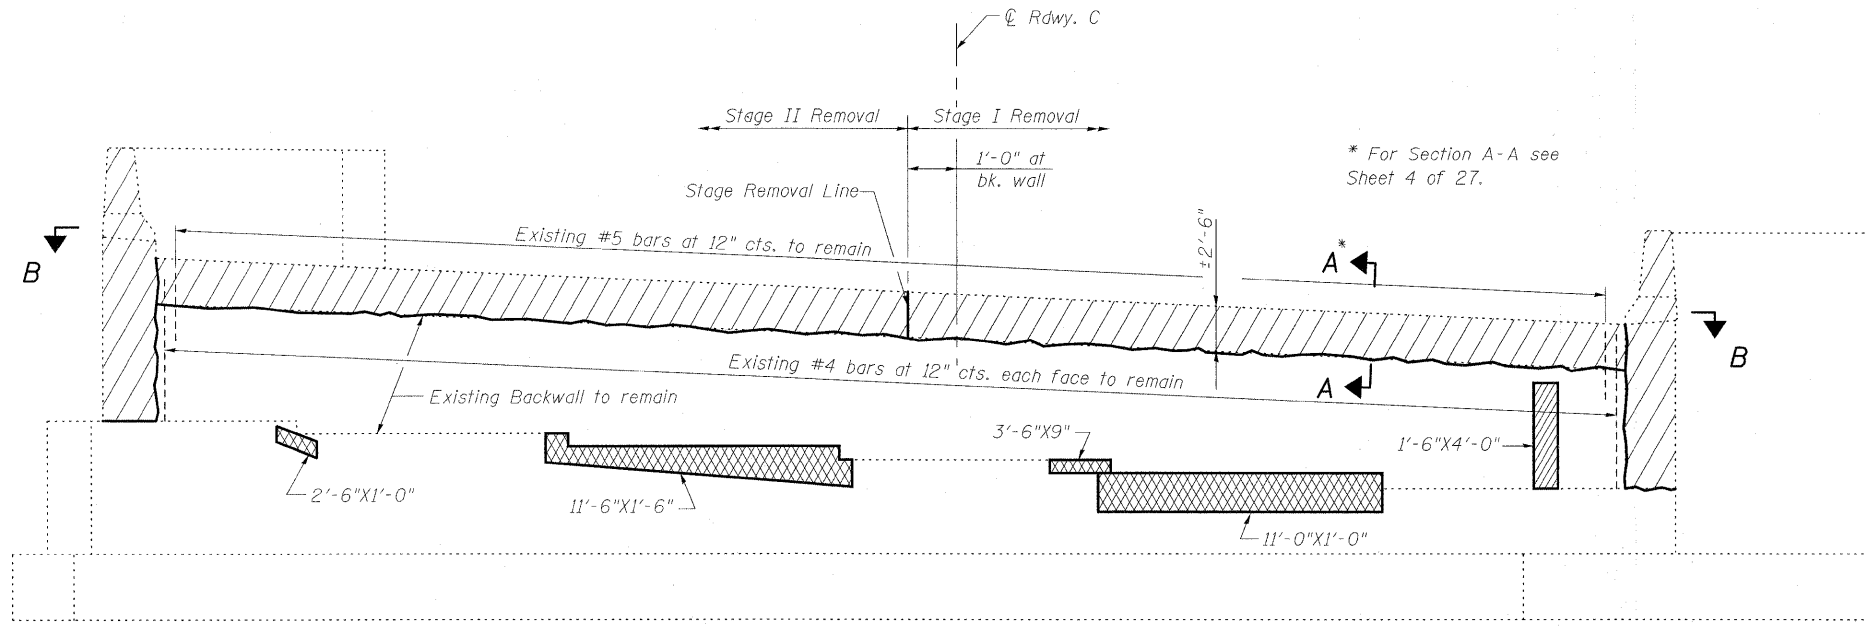
ELEVATION
(Looking North)

- Indicates Structural Repair of Concrete
- Indicates Unsound Concrete Removal
- Indicates Concrete Removal
- Indicates Slope-wall Removal
