STATE OF ILLINOIS
DEPARTMENT OF TRANSPORTATION

BRIDGE REPAIRS
FAI 64 (WB) OVER US 45
WAYNE COUNTY
SN 096-0053 (WB)

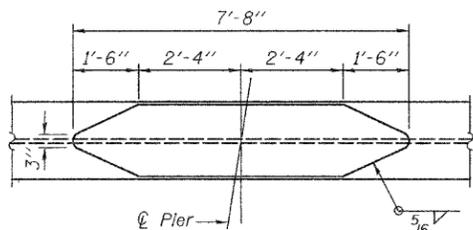
TOP & BOTTOM COVER PLATE
PL 3/16" x 13" x 7'-8" (NTR). (2 Ea.)

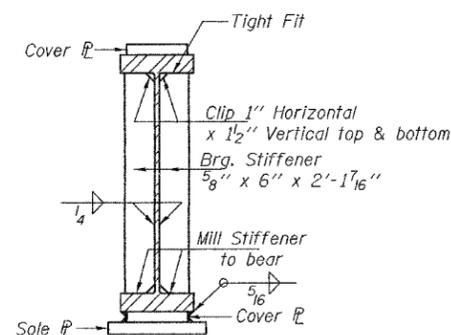
SECTION C-C

SHEAR CONNECTORS

3/4" Granular or solid flux filled headed studs, conforming to the requirements of Art. 706.32 of the Standard Specifications, automatically end welded to flange. (144 Required)

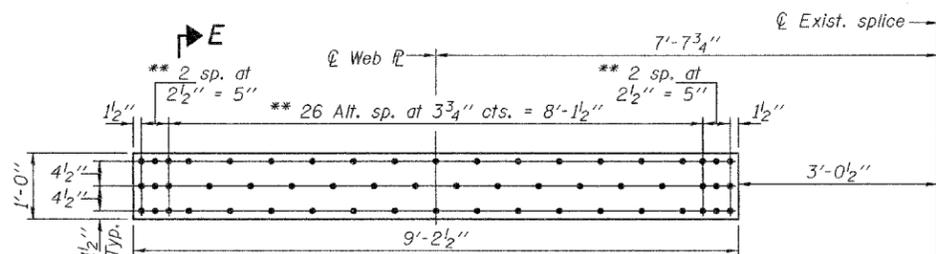
ELEVATION BEAM 1

WEB STRENGTHENING PLATE BEAM 6
PL - 1/2" x 1'-0" x 9'-2 1/2" (NTR). (1 ea. side)

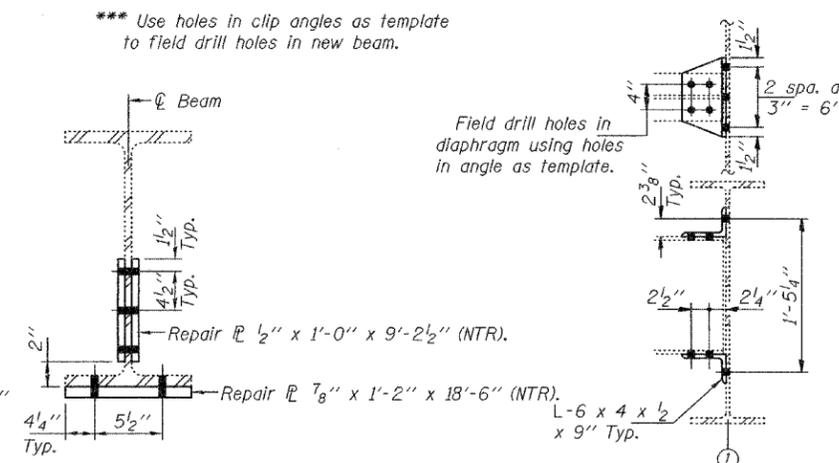
SECTION E-E

CLIP ANGLE REPLACEMENT DETAIL

Notes:
Existing clip angles are to be removed from the existing interior diaphragm by the air-arc method. All weld material remaining on the existing diaphragm shall be ground smooth.
Diaphragm connection holes shall be 1 5/16" for 3/4" bolts.
Two hardened washers shall be required at diaphragm connections.
Natural camber of new beam shall be placed upward for fabrication.
Cost included with Furnishing and Erecting Structural Steel.
