STATE OF ILLINOIS
DEPARTMENT OF TRANSPORTATION

DETAILS
STRUCTURE NO. 095-0045

F.A.I. RTE. 64	SECTION 95-1(2)RS-1	COUNTY WASHINGTON	TOTAL SHEETS 126	SHEET NO. 118
			CONTRACT NO. 76D20	
ILLINOIS FED. AID PROJECT

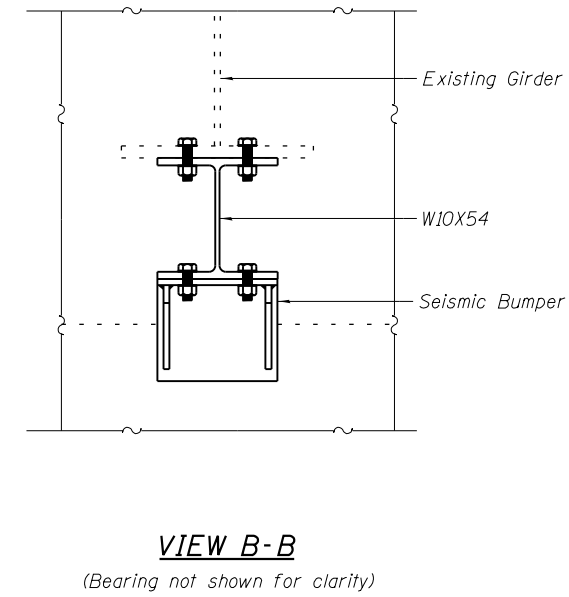
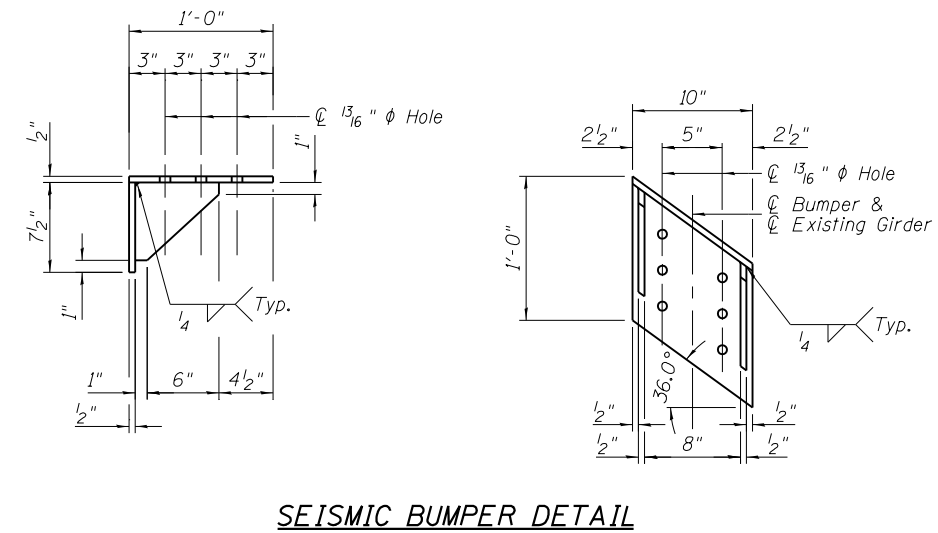
Note:
 New steel and connection bolts are included in Structural Steel Repair.
 Two hardened washers required for each set of oversized holes.
 Cost of drilling holes in bottom flange of existing girders shall be included in Structural Steel Repair.
 Seismic bumper shall be installed parallel to front face of abutment.
