STATE OF ILLINOIS  
DEPARTMENT OF TRANSPORTATION

SHEET NO. 8 33 SHEETS	F.A.I. RTE. 80	SECTION (81-1B)M-4	COUNTY ROCK ISLAND	TOTAL SHEETS 46	SHEET NO. 27
	SN 081-0011			CONTRACT NO. 64F31	
	FED. ROAD DIST. NO. 7   ILLINOIS FED. AID PROJECT

**CANTILEVER FLOORBEAM REPLACEMENT  
SINGLE GIRDER SPANS - 1  
I-80 OVER  
MISSISSIPPI RIVER  
STRUCTURE NO. 081-0011**

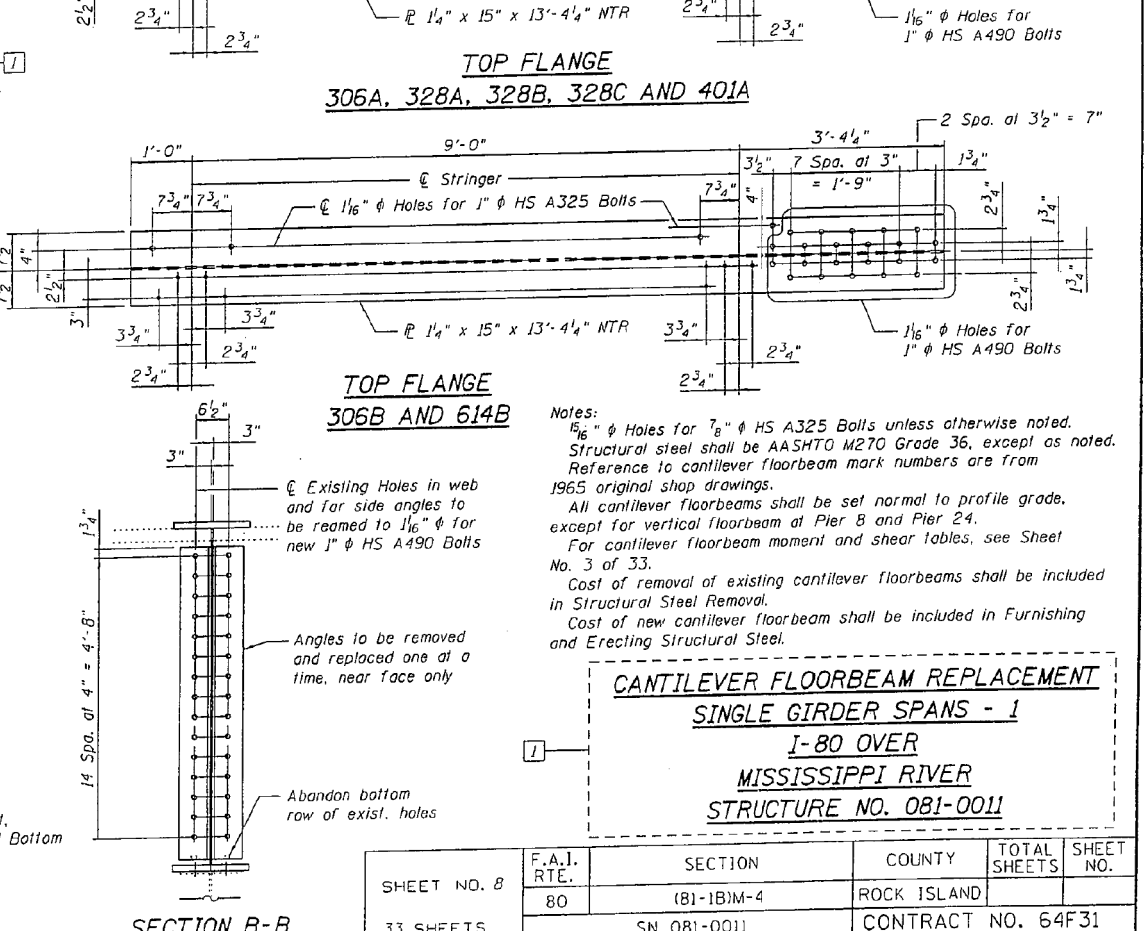
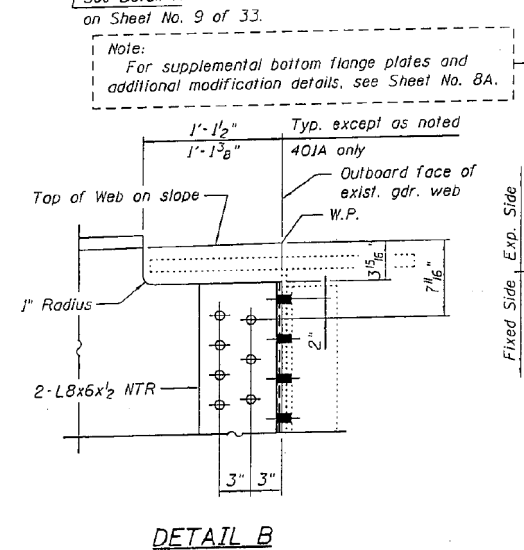
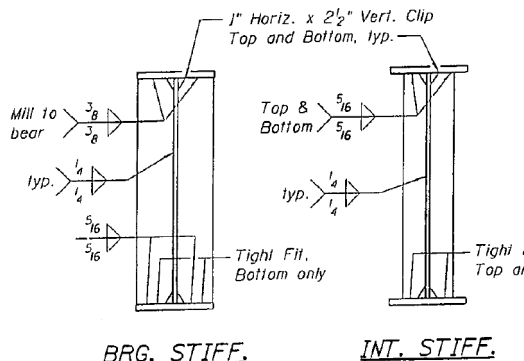
- Cantilever Floorbeam Replacement Procedure at Single Girder Spans**
- 1) Remove existing cantilever floorbeam bracket by removing fasteners in the outstanding leg of the web connection angles and the top and bottom flanges. The existing tie plate may remain connected to the interior floorbeam.

- 2) Remove the existing girder web fasteners in connection angle, one at a time, and switch orientation ensuring that the shank of fastener is an outboard side of girder, replace nuts finger tight.

- 3) Remove the existing nuts and outboard connection angle on one side only and replace the nuts finger tight.
  - 4) Clean and paint existing steel in area of removed connection angle. Protect the threaded ends of the existing fasteners to prevent damage and or painting of the fastener threads.

- 5) Remove existing girder web fasteners from cleaned and painted area one at a time, ream existing hole in girder and inboard connection angle to 1 1/8" diameter, and install a new 1" diameter H.S. A490 bolt with the shank on the outboard side of the girder and with the nut finger tight. At four locations along connection angle use 1" diameter barrel pins instead, spaced equally at approximately every fourth bolt.

- 6) Install new connection angle and fully tighten nuts for girder web connection. Replace barrel pins with new 1" diameter H.S. A490 bolts.
  - 7) Repeat Steps 2, 3, 4 and 5 for the second connection angle.

- 8) Install new cantilever floorbeam and finger tighten nuts for top and bottom flange connections. Maintain support of the new cantilever floorbeam until the entire connection has been completed.

- 9) Install second new connection angle and finger tighten nuts for girder web connection.
  - 10) Install bolts in cantilever floorbeam web connection with finger tightened nuts.

- 11) Ensure mill to bear condition for cantilever floorbeam bottom flange to girder web, then fully tighten all newly installed bolts.
