**STATE OF ILLINOIS  
DEPARTMENT OF TRANSPORTATION**

**NORTH ABUTMENT REPAIRS  
STRUCTURE NO. 060-0220SB**

SHEET NO. 17 OF 19 SHEETS

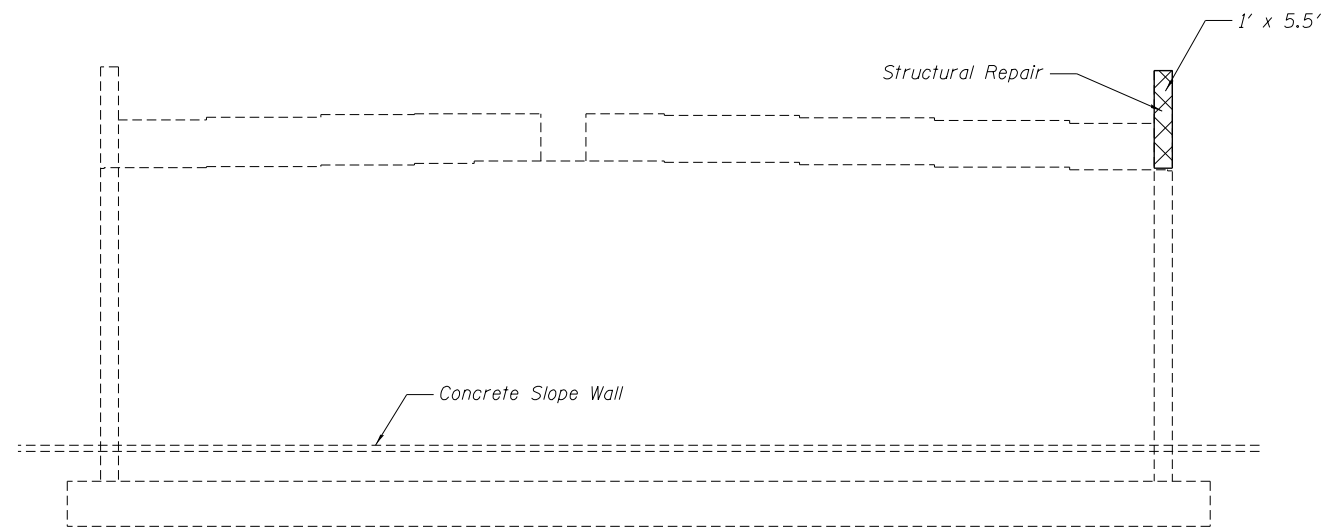
ELEVATION

Structural Repair of Concrete < 5"

Structural Repair of Concrete > 5"

Rope texture not required on repaired concrete surface.
