DECK REPAIR PLAN

FILE NAME =	USER NAME = #USER#	DESIGNED -	REVISED -	STATE OF ILLINOIS DEPARTMENT OF TRANSPORTATION	Deck Repair Plan Structure No. 081-0106		F.A.I. RTE. 280	SECTION (81-1B)M-2	COUNTY Rock Island	TOTAL SHEETS 30	SHEET NO. 30	
#FILE#		DRAWN -	REVISED -		SCALE: _____	SHEET NO. 14 OF 14 SHEETS	STA. _____ TO STA. _____	ILLINOIS FED. AID PROJECT				
		CHECKED -	REVISED -									
		DATE -	REVISED -

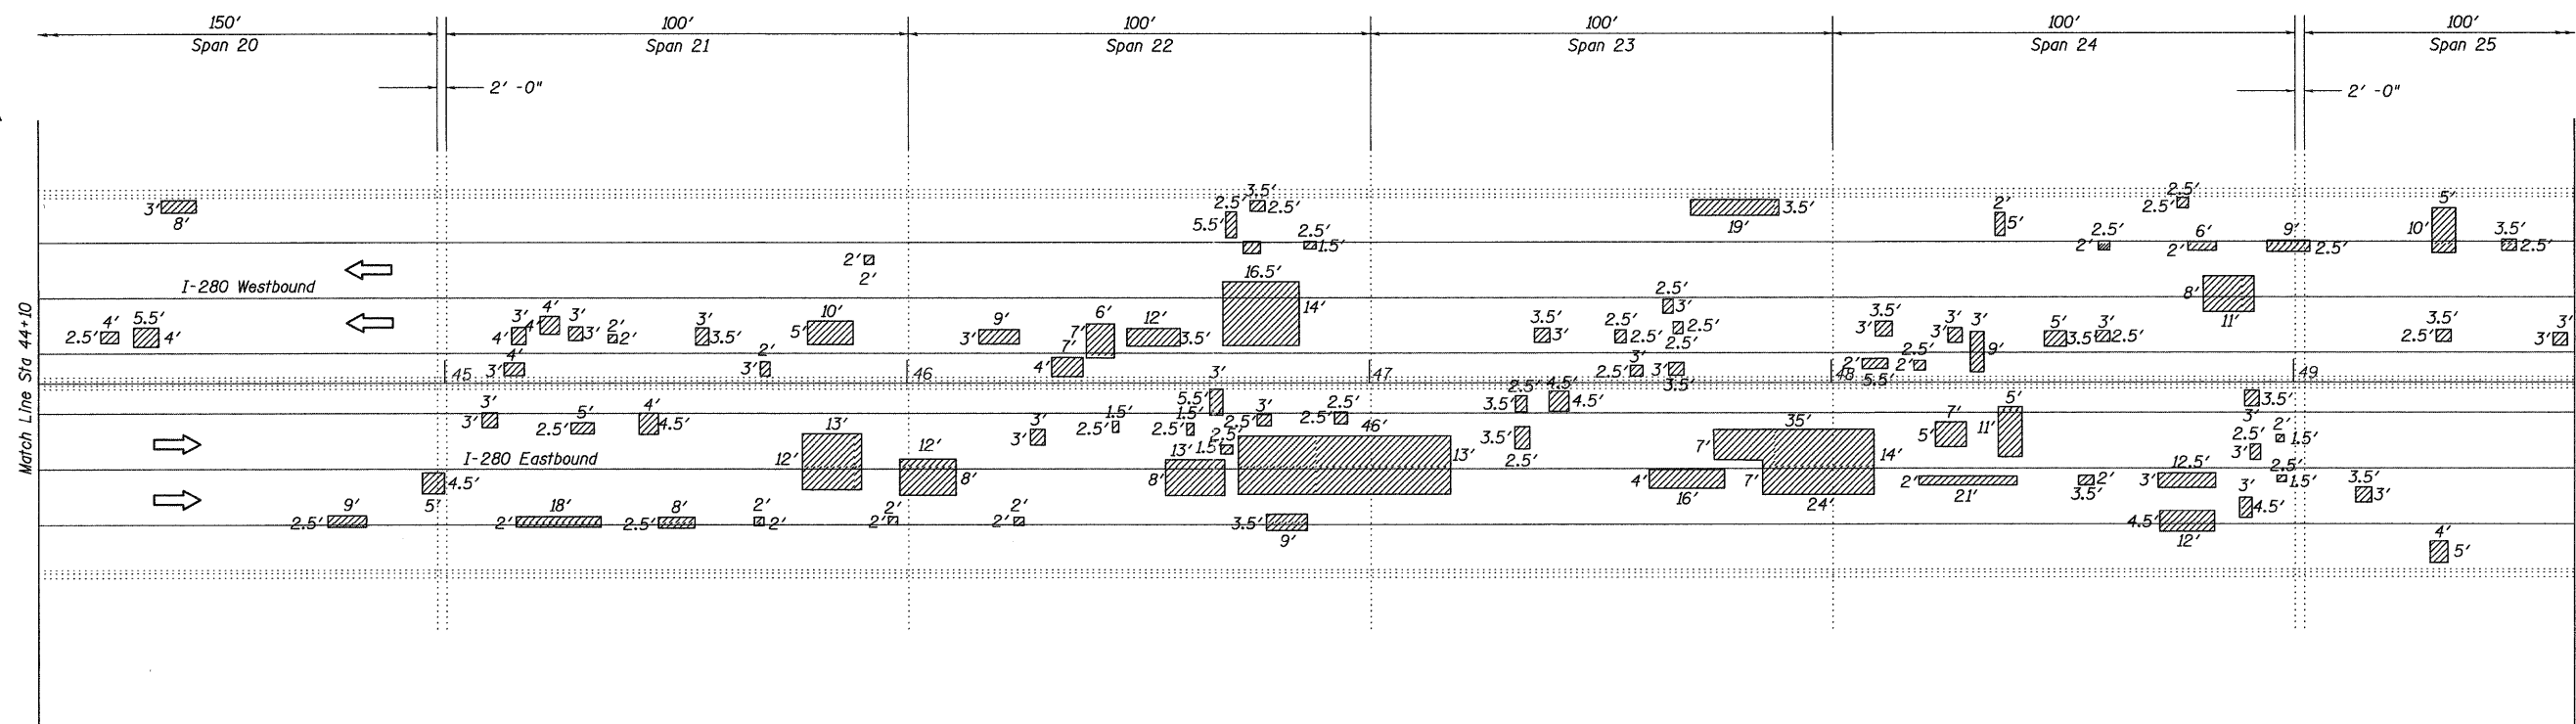
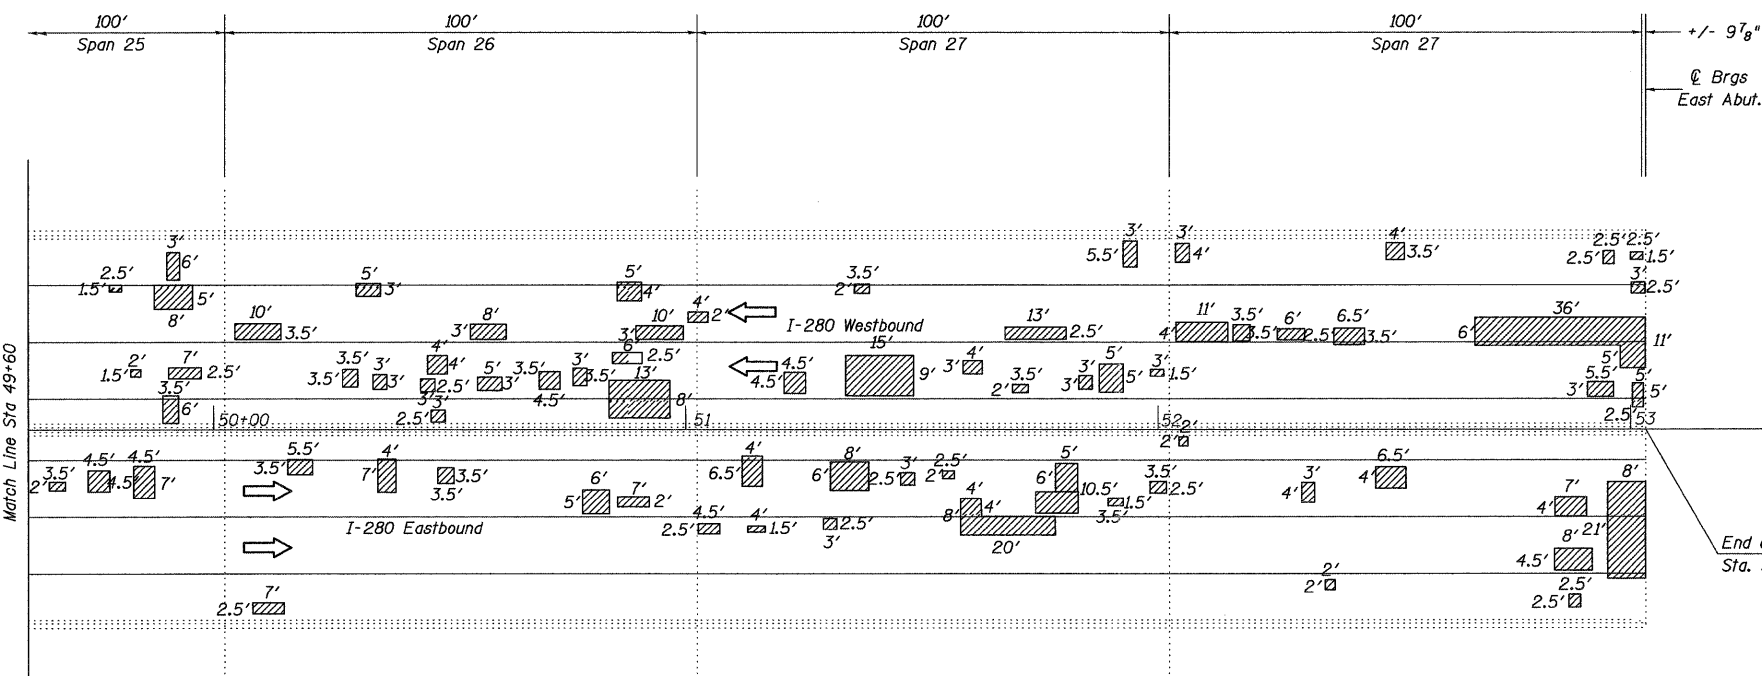
Legend
 Deck Slab Repair (Partial Depth)
 Patches shown are potential areas of deck slab repair. Actual areas to be determined in the field.

Date of Deck Survey: October 2010

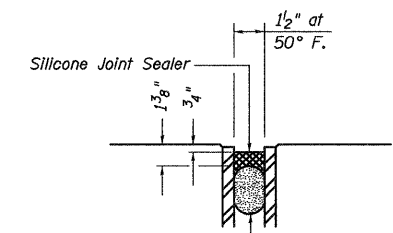
Backer rod having a diameter 25% greater than joint opening at the time of installation.

SILICONE JOINT SEALER DETAIL
Remove deteriorated joint seals in arch span and replace with Silicone Joint Sealer (4 Joints).
