**STATE OF ILLINOIS  
DEPARTMENT OF TRANSPORTATION**

**FOUNDATION LAYOUT  
STRUCTURE NO. 050-0255**  
SHEET NO. 53 OF 535 SHEETS

F.A.P. RTE.	SECTION	COUNTY	TOTAL SHEETS	SHEET NO.
68	(3)BR-3	LASALLE	61	16
CONTRACT NO. 66A20				
ILLINOIS FED. AID PROJECT

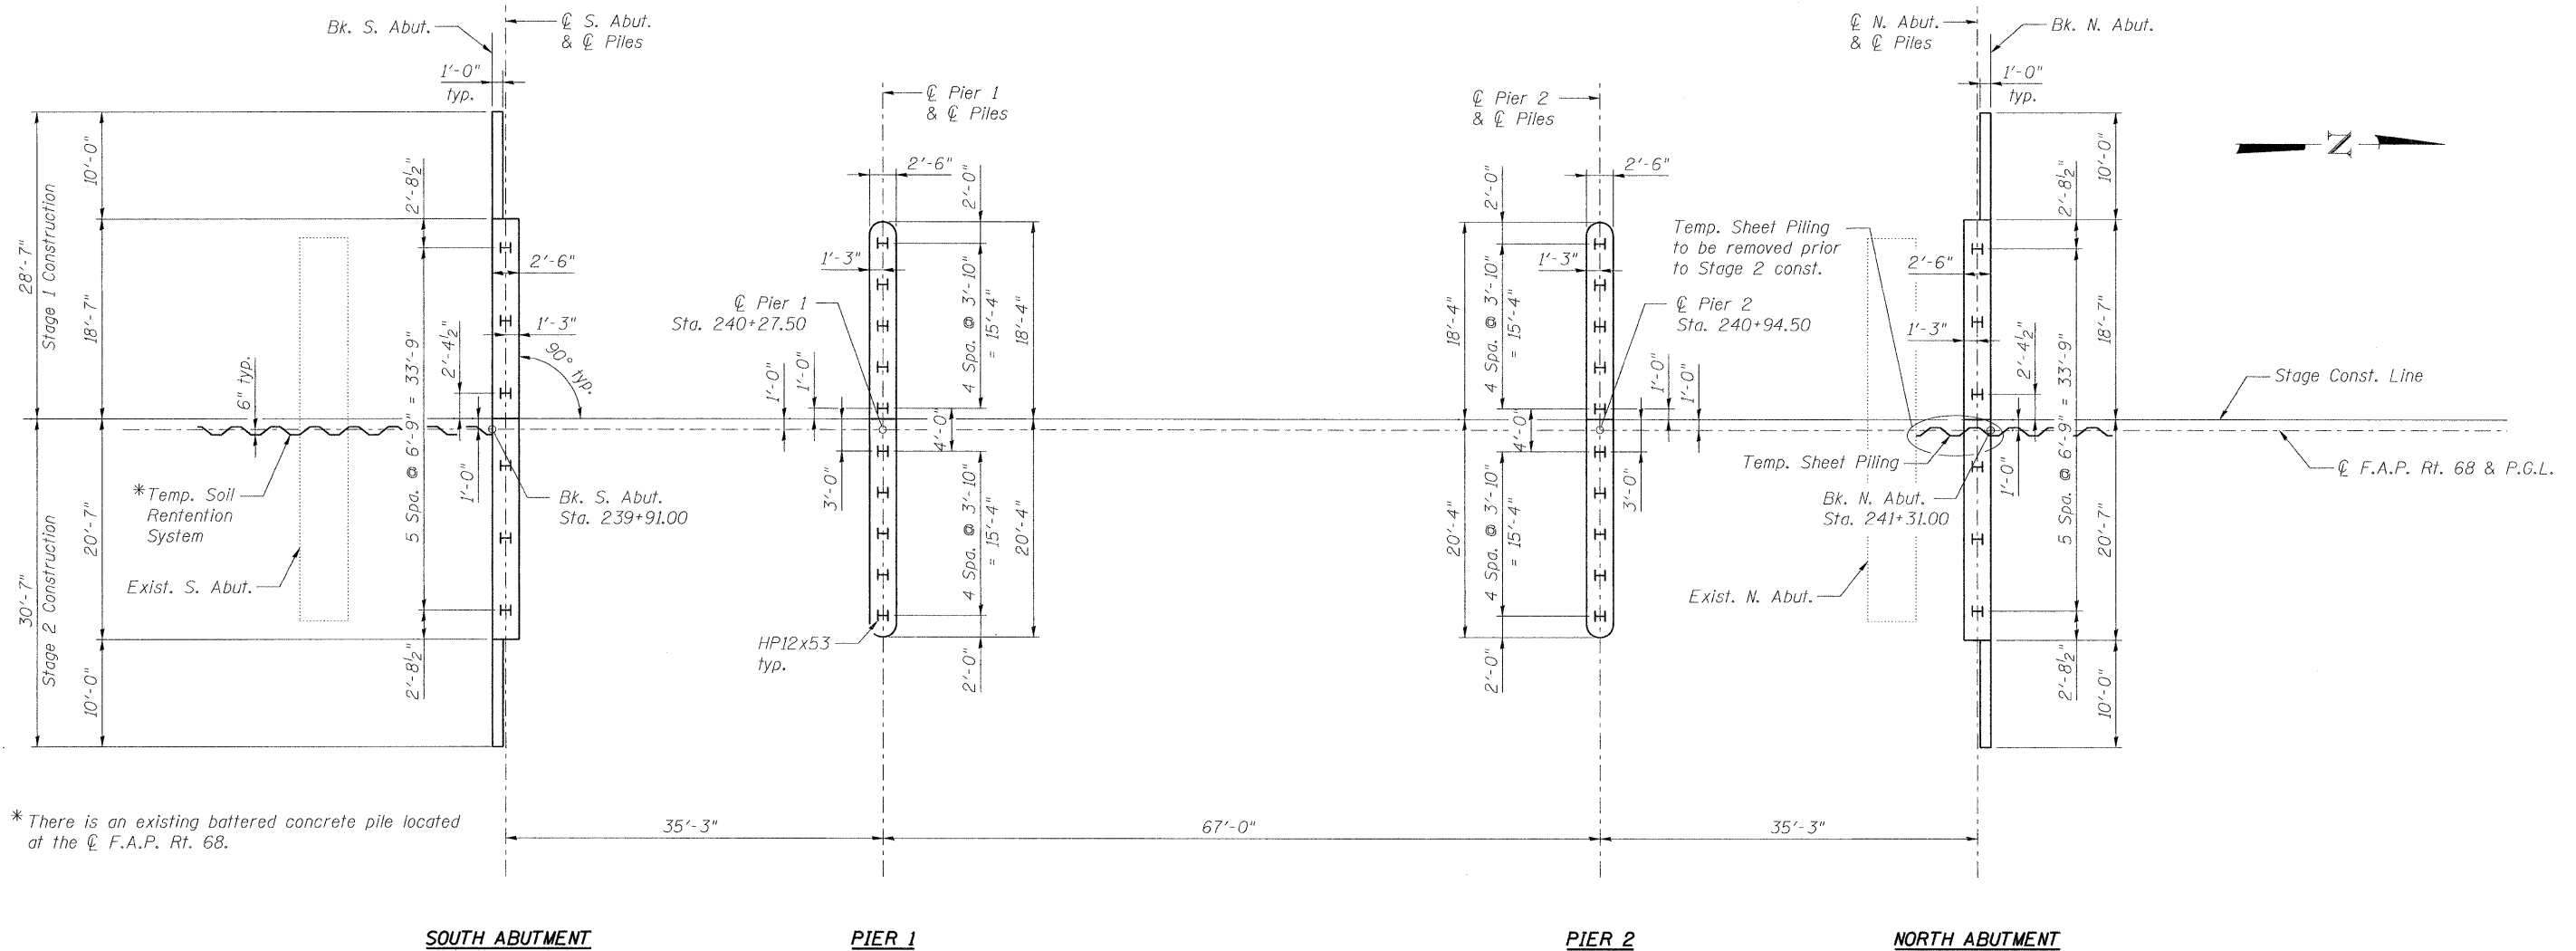
**FOUNDATION LAYOUT**

\* There is an existing battered concrete pile located at the  $\text{C.L.}$  F.A.P. Rt. 68.

- NOTES:**
1. For Abutment details, see sheets S20 and S21 of S35.
  2. For Pier Details, see sheets S22 and S23 of S35.
  3. For HP Pile Details, see sheet S24 of S35.
  4. There will be one test pile at each substructure unit in Stage 1. Location to be determined in the field by the Engineer.
