STATE OF ILLINOIS
DEPARTMENT OF TRANSPORTATION

PARAPET REPAIR
STRUCTURE NO. 082-0167 (E.B.)
STRUCTURE NO. 082-0168 (W.B.)

SHEET NO. A6 OF 21 SHEETS

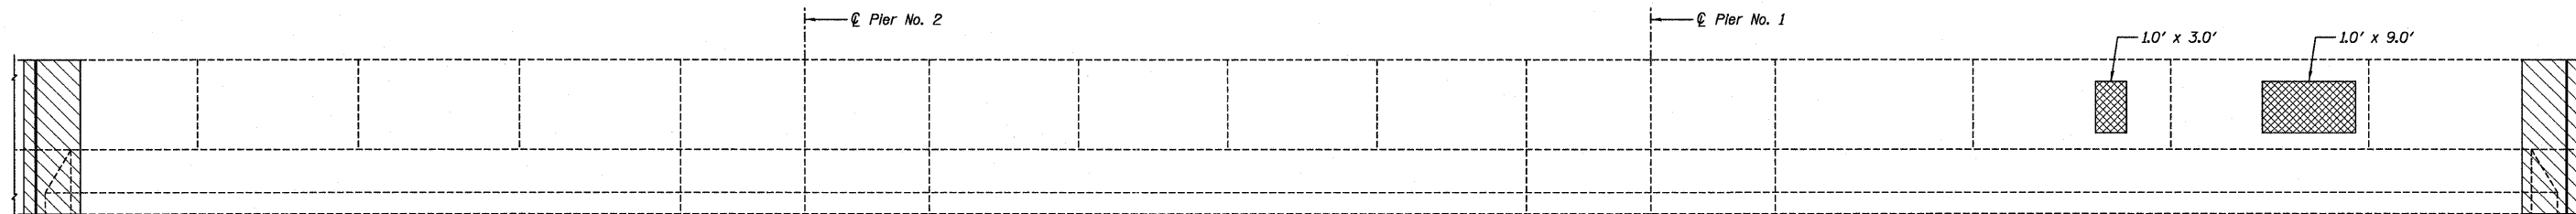
EASTBOUND ROADWAY, INSIDE ELEVATION OF SOUTH PARAPET

- Structural Repair of Concrete (Depth Equal to or Less than 5 Inches)
- Concrete Removal for Expansion Joint Replacement, see Sheets A7 thru A10

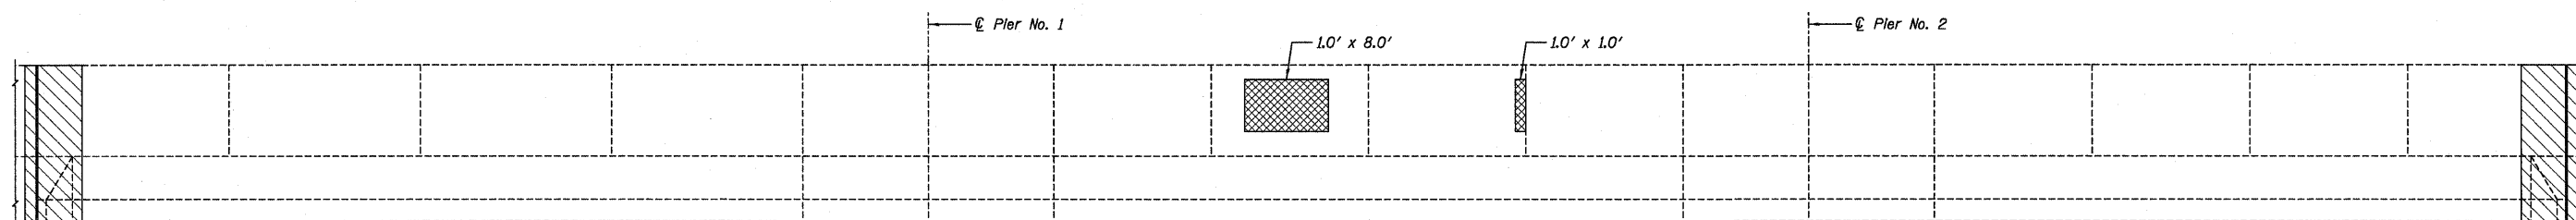
WESTBOUND ROADWAY, INSIDE ELEVATION OF NORTH PARAPET

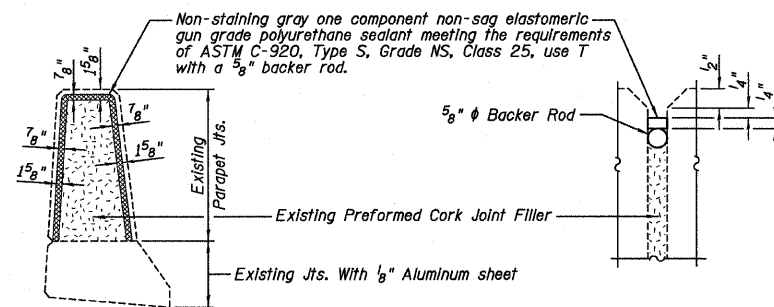
PARAPET JOINT DETAILS
(15 joints per parapet)
