**STATE OF ILLINOIS
DEPARTMENT OF TRANSPORTATION**

**NORTH ABUTMENT REPAIR
STRUCTURE NO. 082-0261**

SHEET NO. C7 OF 10 SHEETS

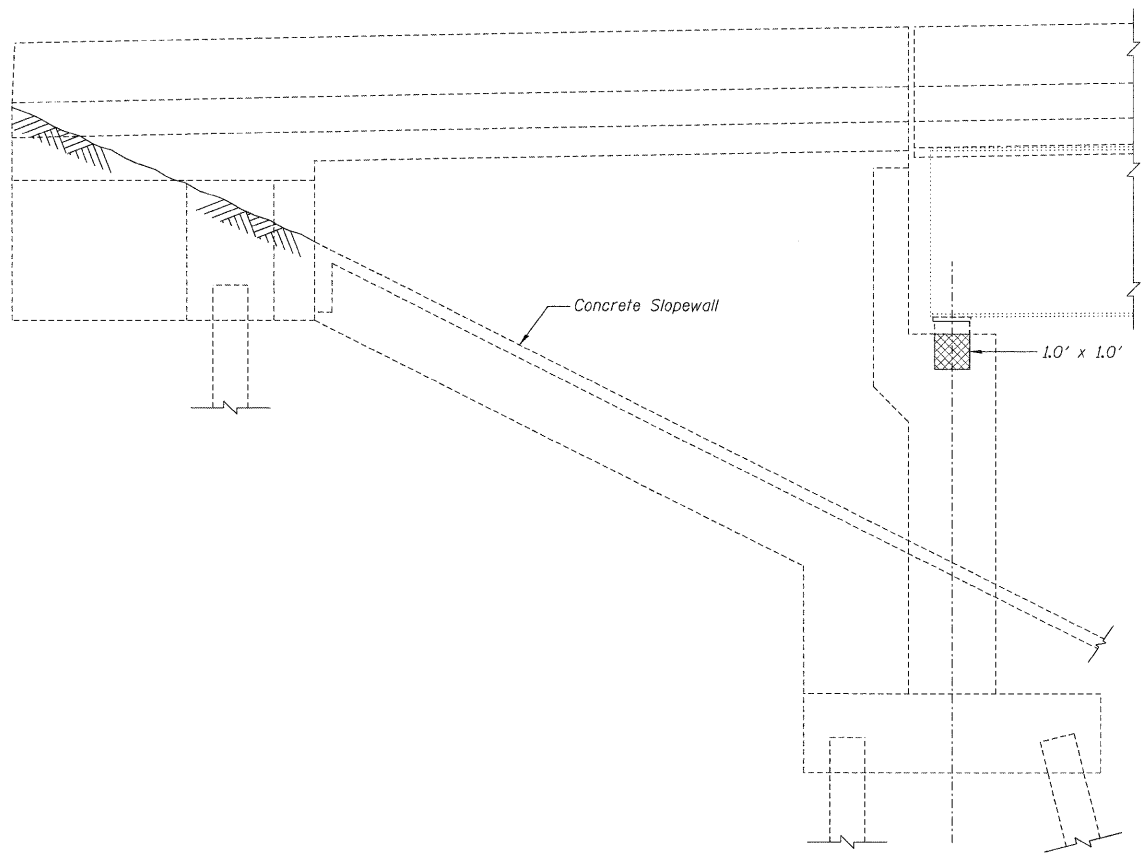
ELEVATION - LOOKING EAST

Structural Repair of Concrete (Depth Equal to or Less than 5 Inches)
