**PPC I-BEAM REPAIR DETAILS  
(PIER 3)  
S.N. 014-0049**

SHEET NO. 15  
17 SHEETS

F.A.P. RTE.	SECTION	COUNTY	TOTAL SHEETS	SHEET NO.
327	14-12BR-1	CLINTON	72	59
CONTRACT NO. 76B27				
FED. ROAD DIST. NO. _ ILLINOIS FED. AID PROJECT

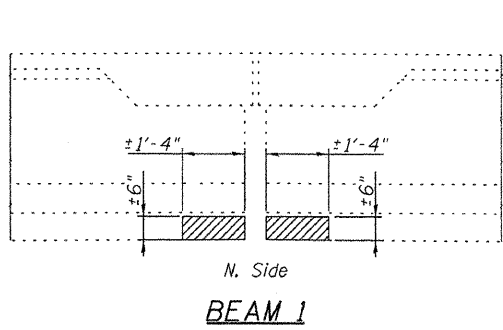
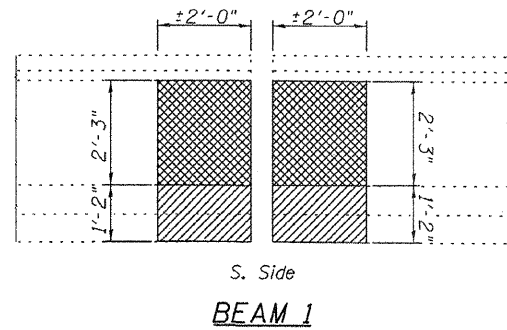
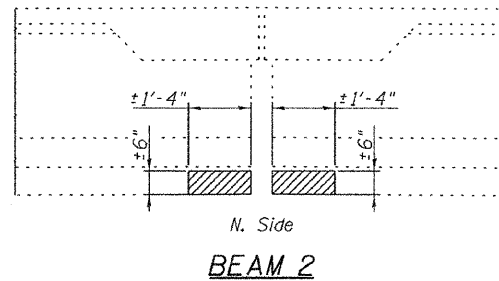
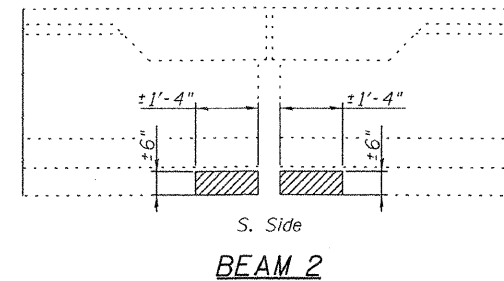
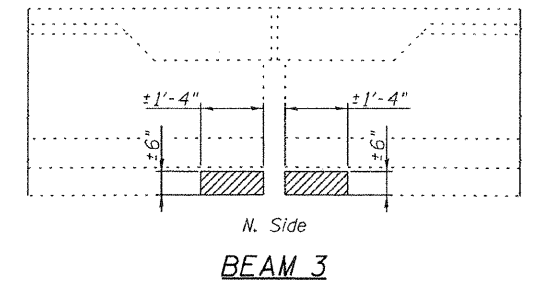
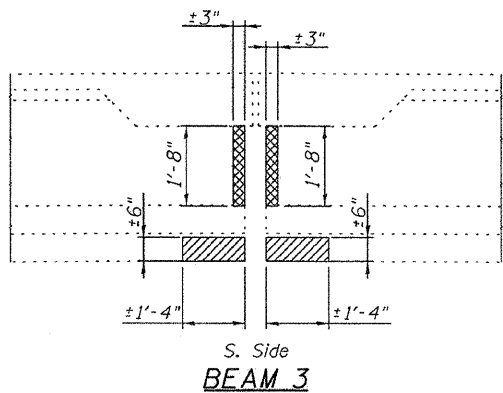
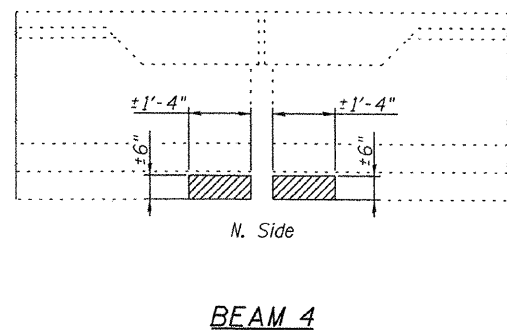
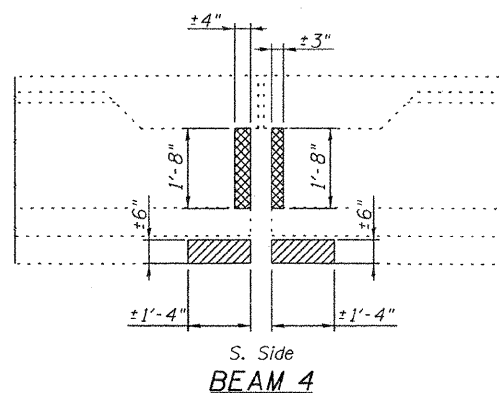
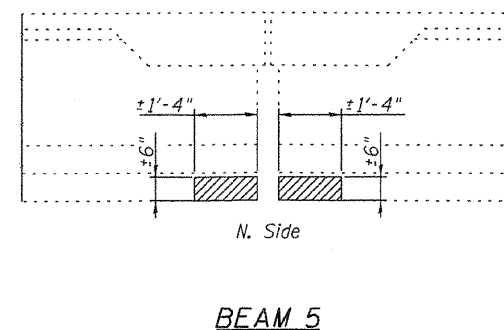
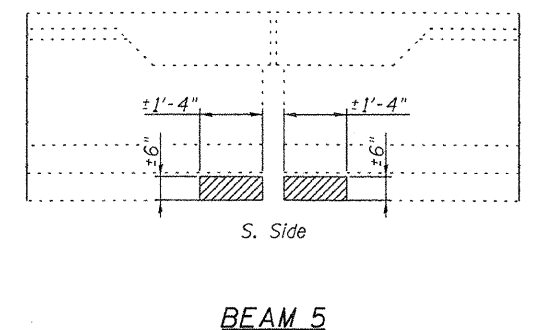
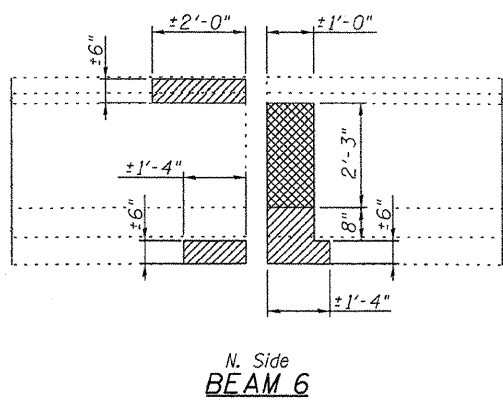
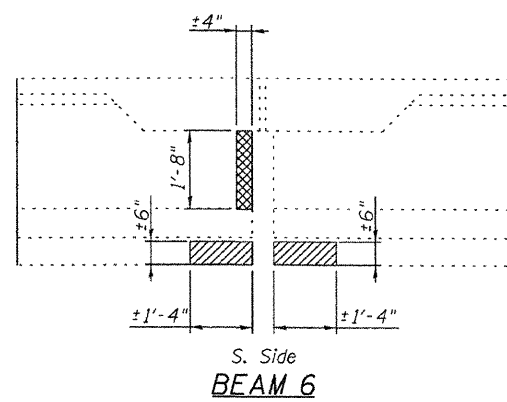
Note: Hatched area indicates approximate area of Structural Repair of Concrete. Cross-hatched area indicates approximate area of Polymer Modified Portland Cement Mortar. Exact repairs are to be determined by the Engineer.

- \* Damaged areas within the beam's flanges are to be repaired per Structural Repair of Concrete (Depth equal to or less than 5") only.
- \*\* Damaged area within the beam's web are to be repaired per Polymer Modified Portland Cement Mortar only.

Item	Unit	Total
* Structural Repair of Concrete (Depth equal to or less than 5")	Sq. Ft.	21.0
** Polymer Modified Portland Cement Mortar	Sq. Ft.	13.6
