STATE OF ILLINOIS
DEPARTMENT OF TRANSPORTATION

SHEET 2
OF 9

DECK PLAN
FAI 70 (EB) OVER
WENDELL BRANCH
FAI ROUTE 70 SECTION 60-10B
MADISON COUNTY
STATION 996+73.85
STRUCTURE NO. 060-0023

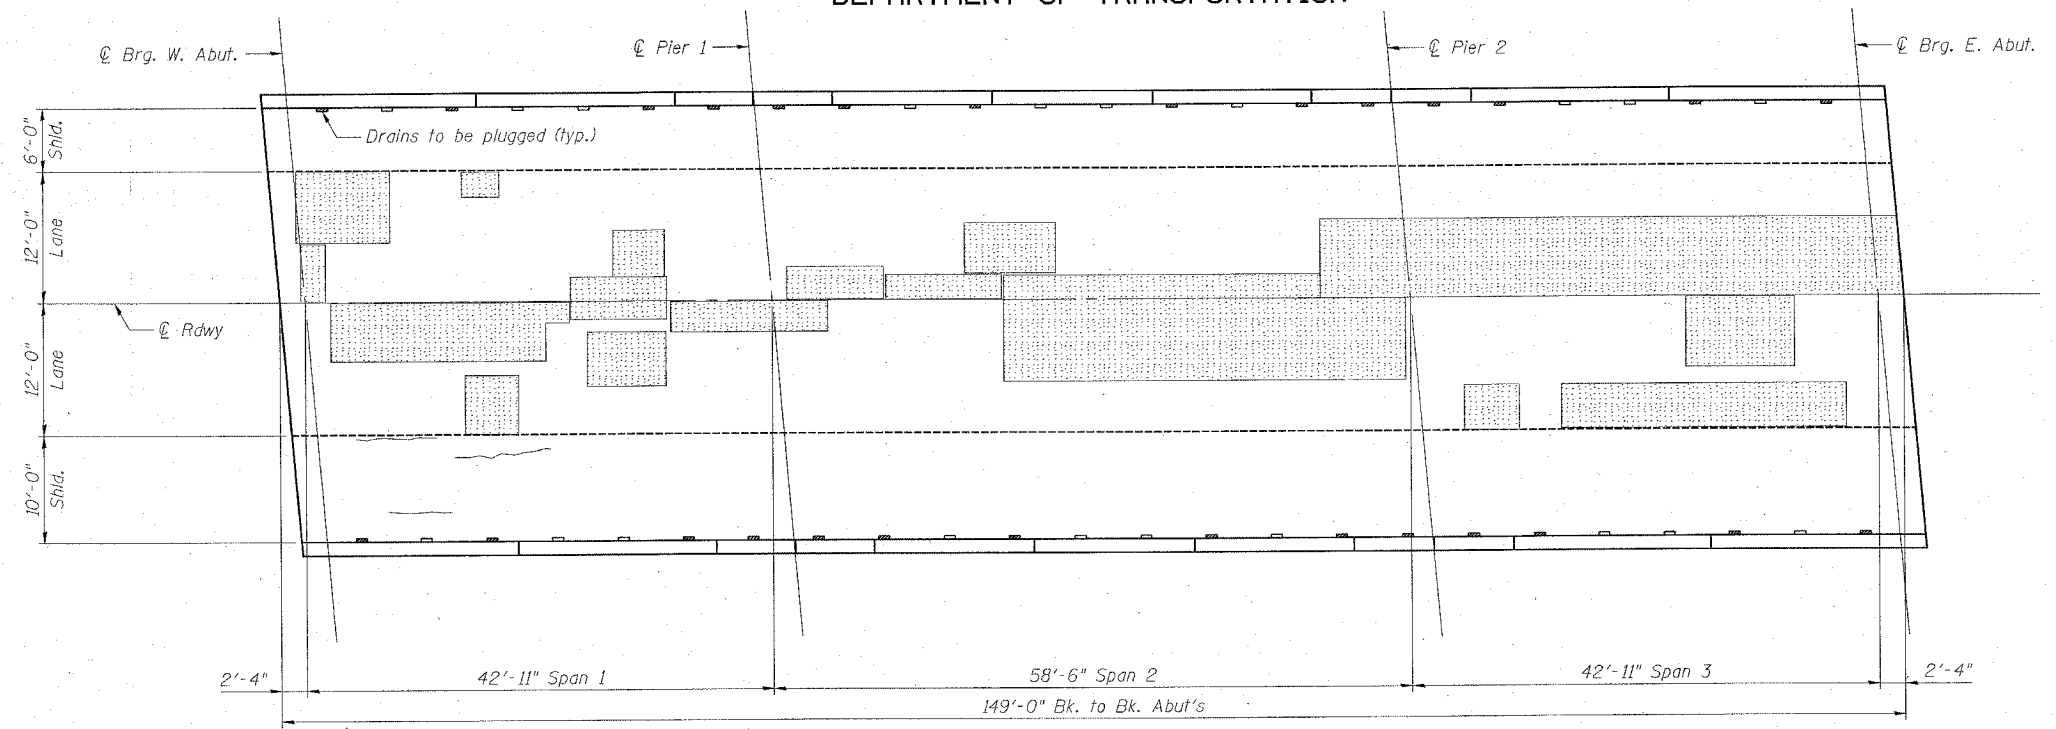
DECK PLAN-TOP

Deck Condition Survey performed 8/15/2006.
The Engineer shall record actual locations of deck repair on the As-Built plans.
Deck Plan-Top represents existing repairs made to the bituminous overlay, but may not represent the condition of the original concrete deck. Estimated quantities are provided for Deck Slab Repair, but actual quantities will be determined by the field Engineer as the work progresses.
