**STATE OF ILLINOIS
 DEPARTMENT OF TRANSPORTATION**

**DECK REPAIR PLAN AND TYPICAL SECTION
 STRUCTURE NO. 050-0129**

SHEET NO. 2 OF 5 SHEETS

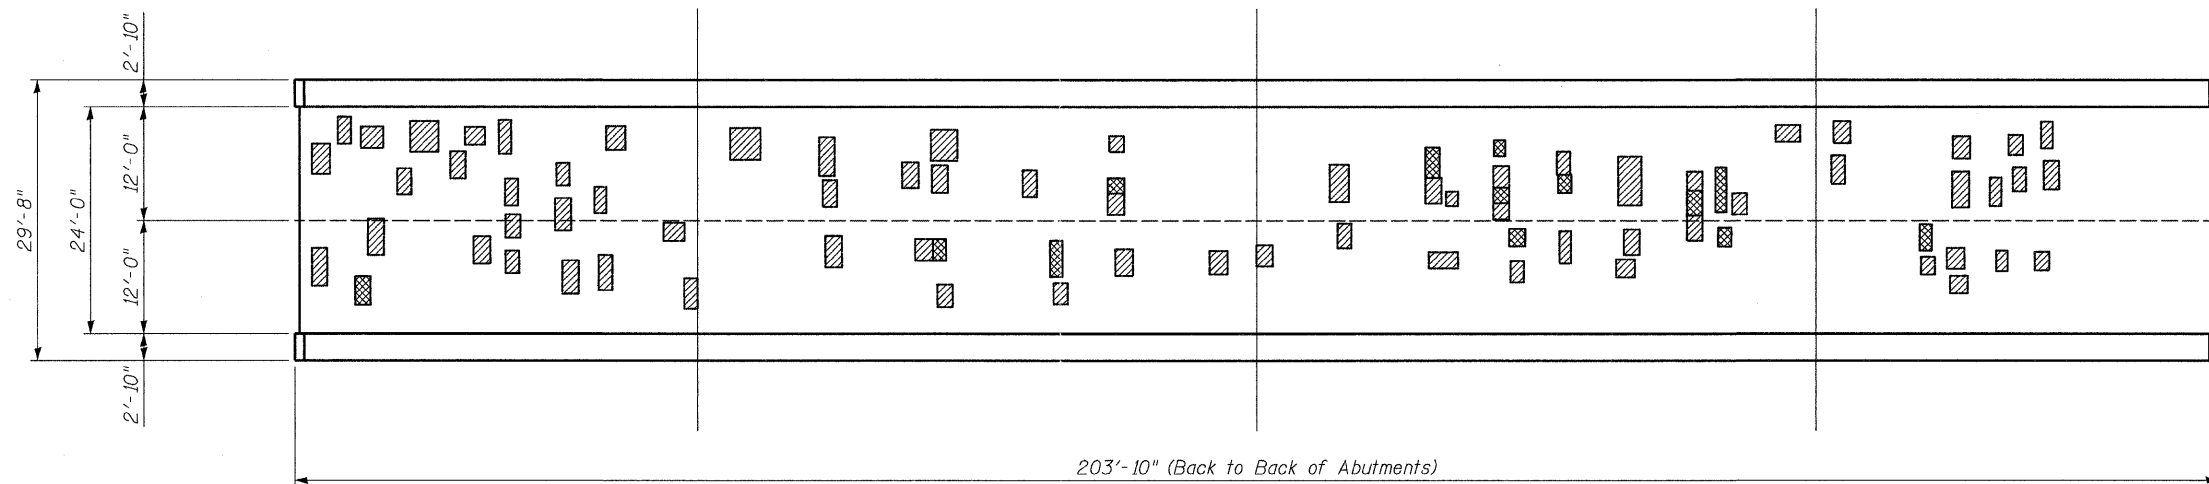
DECK REPAIR PLAN

Notes:
 Areas of deck repairs shown are estimated.
 The Engineer shall show actual locations of deck repairs on As-Built plans.

Infrared deck survey 03/14/11

- Full Depth Repair Area
- Partial Depth Repair Area
