STATE OF ILLINOIS
DEPARTMENT OF TRANSPORTATION

PIER REPAIR DETAILS
STRUCTURE NO. 050-0129

SHEET NO. 4 OF 5 SHEETS

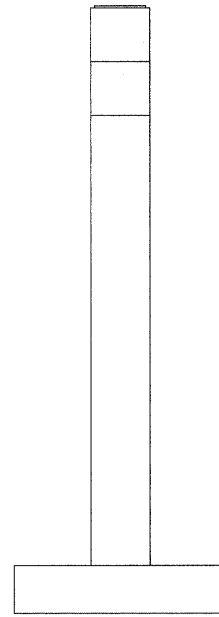
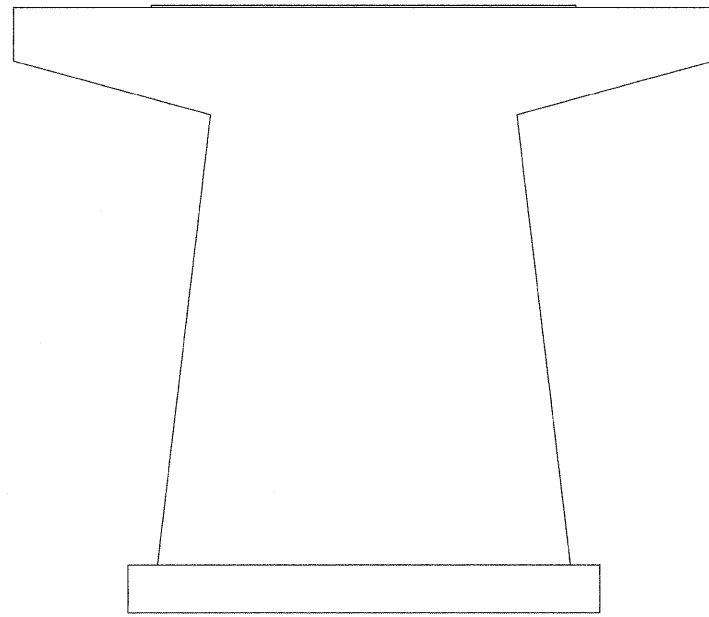
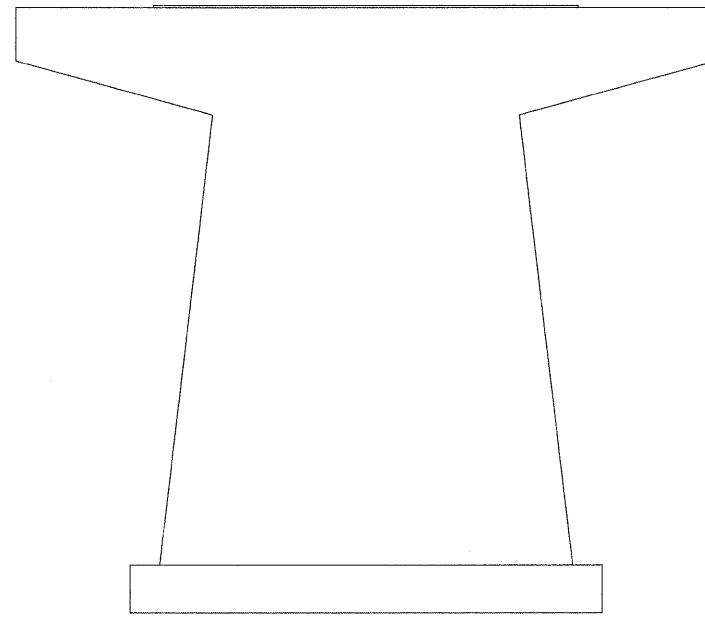
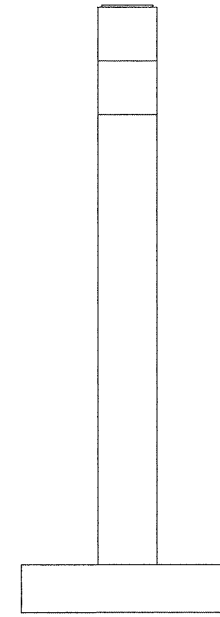
PIER 1
(North)

END VIEW
(Looking East)

ELEVATION
(Looking North)

ELEVATION
(Looking South)

END VIEW
(Looking West)

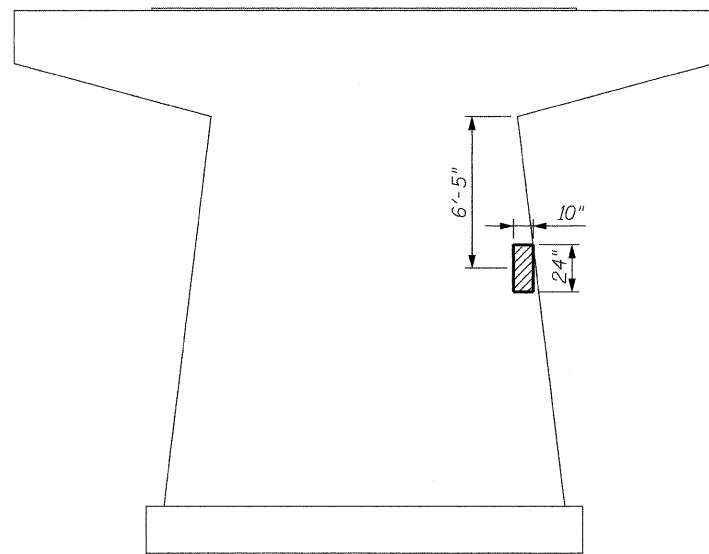
ELEVATION
(Looking North)
2 Sq. Ft. Structural Repair of Concrete (Depth equal to or less than 5 Inches)

Structural Repair of Concrete
(Depth Equal to or less than 5 Inches)

Item	Unit	Total
Structural Repair of Concrete (Depth Equal to or less than 5 Inches)	Sq. Ft.	2
