**DECK REPAIR PLAN**

FILE NAME = 0500130-66A48-DECK-002.DGN	USER NAME =	DESIGNED - JKC	REVISED -	<b>STATE OF ILLINOIS DEPARTMENT OF TRANSPORTATION</b>	<b>DECK REPAIR PLAN AND TYPICAL SECTION STRUCTURE NO. 050-0130</b>	F.A.I. RTE. 80	SECTION (50-2,4)RS-5 & (50-3)RS-6	COUNTY LASALLE	TOTAL SHEETS 109	SHEET NO. 72		
PLOT SCALE =	DRAWN - LAG	REVISED -	SHEET NO. 2 OF 3 SHEETS			CONTRACT NO. 66A48		ILLINOIS FED. AID PROJECT				
PLOT DATE =	CHECKED - JKC	REVISED -

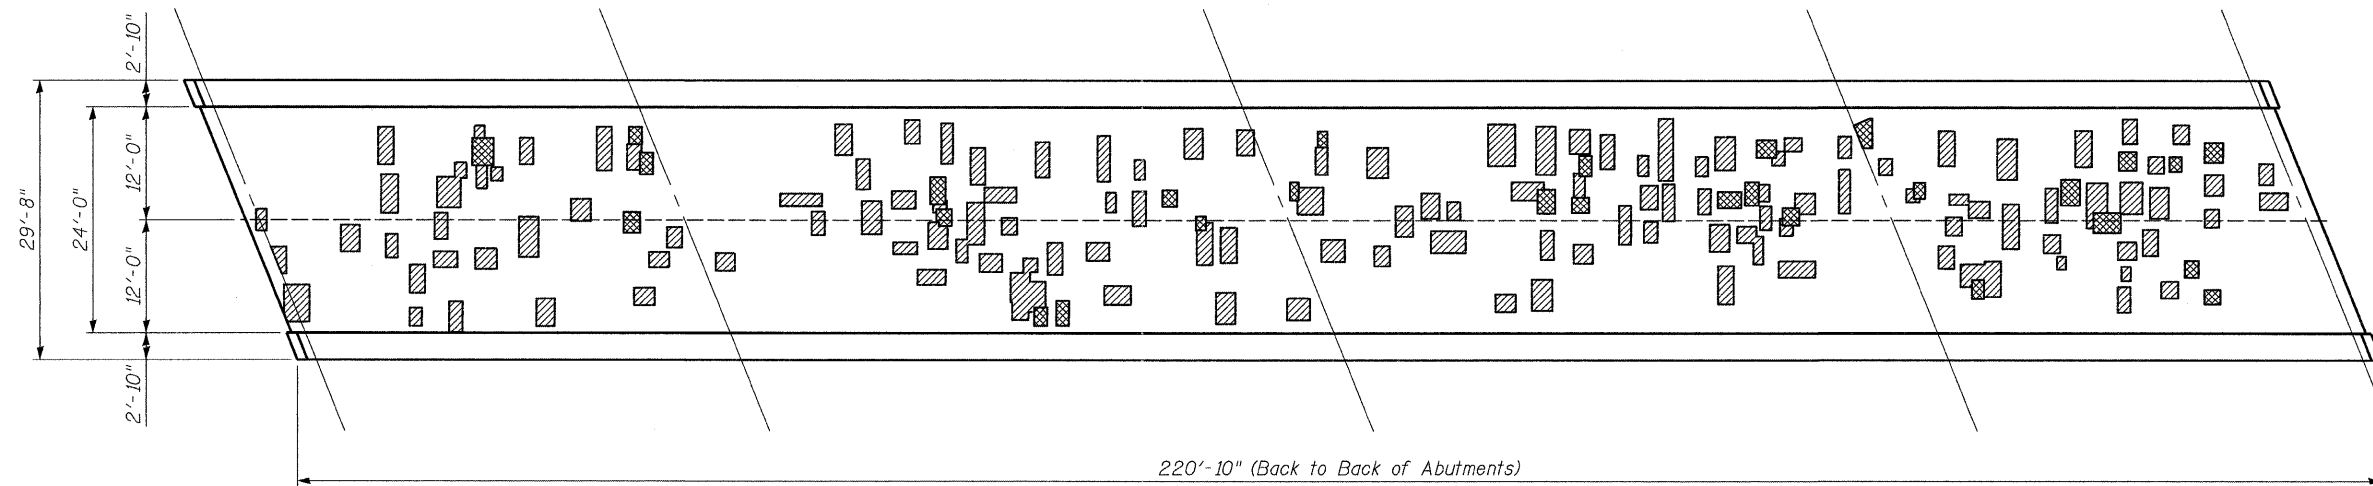
Notes:  
 Areas of deck repairs shown are estimated.  
 The Engineer shall show actual locations of deck repairs on As-Built plans.

Infrared deck survey 03/14/11
