ROUTE NO.	SECTION	COUNTY	TOTAL SHEETS	SHEET NO.
FAP 68	101BR	LIVINGSTON	47	29
STA	TO STA			
FED. ROAD DIST. NO. *	ILLINOIS	FED. AID PROJECT		
DWG. NO. 15 OF 17

CONTRACT NO. 66606

PIER 2
IL 23 OVER PRAIRIE CREEK
FAP ROUTE 68 - SECTION 101BR
LIVINGSTON COUNTY
STATION 280+55.00
STRUCTURE NO. 053-0153

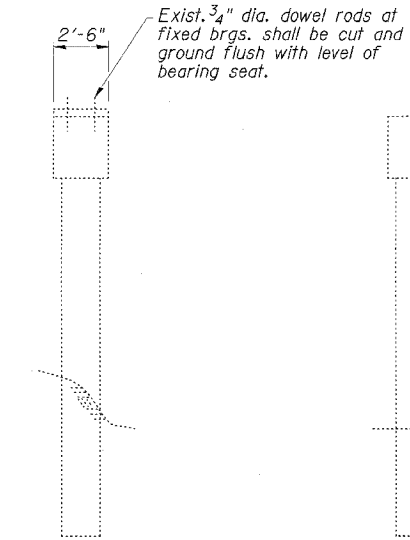
EAST END

EXISTING BEARING SEAT TO BE INSPECTED BY THE ENGINEER AFTER DECK BEAM REMOVAL. DETERIORATED CONCRETE AREAS SHALL BE REPAIRED (ESTIMATED 15 S.F. ADDITIONAL FORMED CONCRETE REPAIR DEPTH < 5") AND CRACKS SHALL BE SEALED (ESTIMATED 20' ADDITIONAL EPOXY CRACK SEALING) IF FOUND.

NOTE: PIER CRACK REPAIR LENGTHS AND FORMED CONCRETE REPAIR AREAS ARE ESTIMATED FROM 3-31-05 SURVEY WORK. ACTUAL LOCATIONS AND QUANTITIES OF REPAIRS SHALL BE SHOWN BY THE ENGINEER ON THE AS-BUILT PLANS FOR THIS SECTION.
