**STATE OF ILLINOIS**  
**DEPARTMENT OF TRANSPORTATION**

**PIER REPAIR DETAILS**  
**WESTBOUND FAI-80 OVER DES PLAINES RIVER**  
**STRUCTURE NO. 099-0057**

SHEET NO. S-25 OF S-35 SHEETS

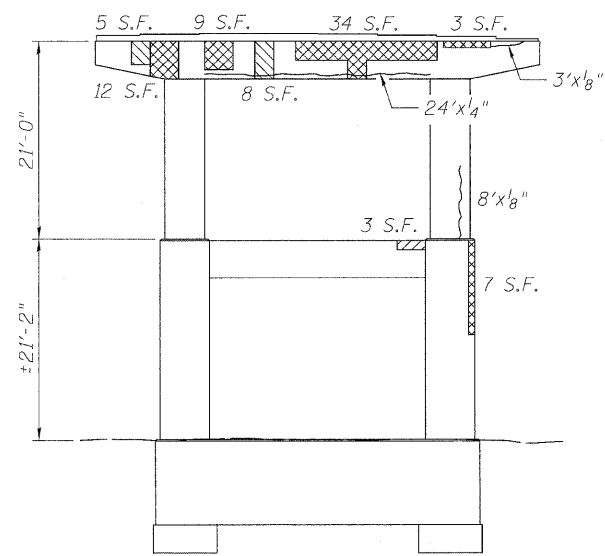
**PIER 5**

Structural Repair of Concrete (Depth < 5") = 98 Sq. Ft.  
 Structural Repair of Concrete (Depth > 5") = 113 Sq. Ft.  
 Epoxy Crack Injection

NOTES: See Sheet S-20 for Temporary Shoring and Cribbing, Special locations.
