STATE OF ILLINOIS
DEPARTMENT OF TRANSPORTATION

PIER 1 REPAIRS
WESTBOUND FAI-80 OVER RAILROAD/GARDNER STREET
STRUCTURE NO. 099-0061

SHEET NO. S-8 OF 14 SHEETS

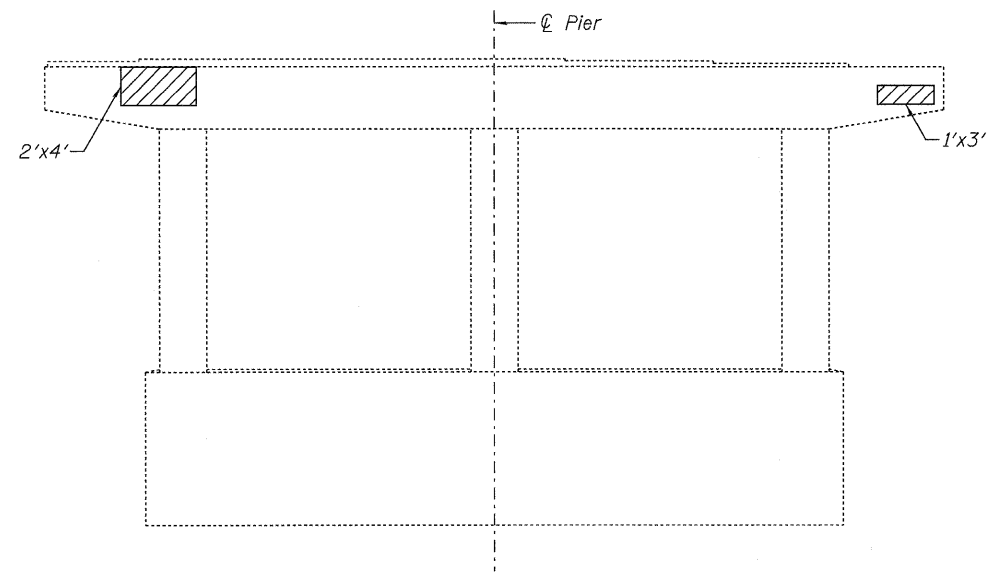
PIER 1 - WEST ELEVATION
Looking East

1. Areas of proposed pier repairs are estimated. Actual type, location and dimensions of pier repairs are to be determined by the Engineer during construction.
