STATE OF ILLINOIS  
DEPARTMENT OF TRANSPORTATION

**ABUTMENT REPAIR**  
**STRUCTURE NO. 016-0377**

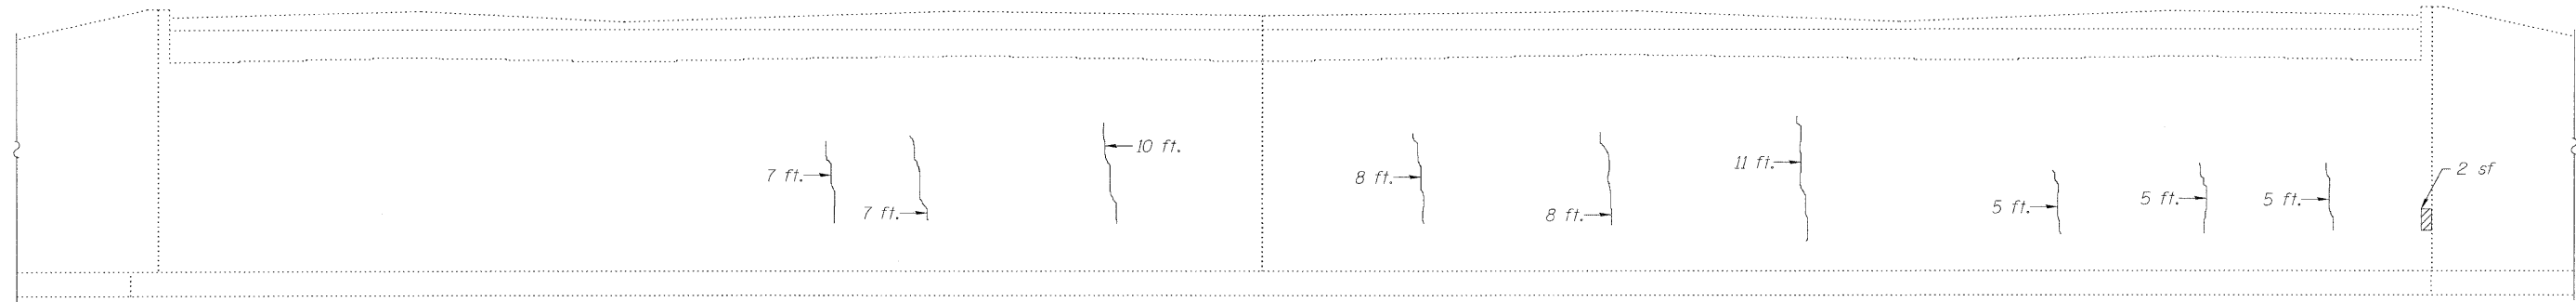
**SOUTH ABUTMENT ELEVATION**  
(Looking South)

Repair of the existing abutments shall include but may not be limited to the areas shown. The actual areas to be repaired will be determined by the Engineer at the time of construction.
